Agreement No. CE 64/2020 (EP) Environmental Team for Tung Chung New Town Extension (West) – Design and Construction

Monthly Environmental Monitoring & Audit Report for October 2023

November 2023

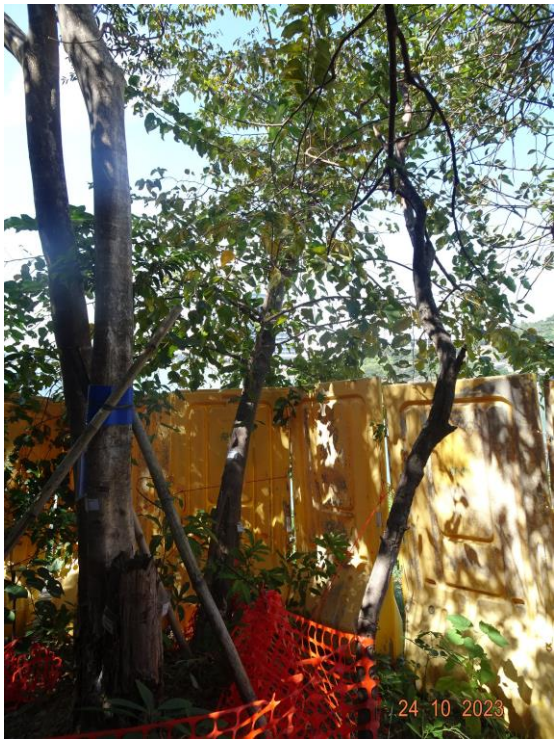
5: U041_Crown

6: U041_Dead stump

7: U041_Wood damage at trunk union

8: U041_Wood damaged by termite

The condition of the individual was closely monitored and reviewed by QB. Application of termiticide was carried out at the individual of *Aquilaria sinensis* (Tree No. U041) under Contract 5. No obvious old termite tracks were found at the individual during the reporting period. Wound wood development was observed at the individual of *Gmelina chinensis* (Tree No. U042) under Contract 5. Application of pesticide was conducted by QB. No fungal fruiting bodies were found at the individual of *Aquilaria sinensis* (Tree No. U043) under Contract 5 and application of fungicide was carried out by QB. Staking was readjusted for both individuals of *Aquilaria sinensis* (Tree No. U041 and U043) under Contract 5 for providing support to the individuals.
