ENVIRONMENTAL TEAM FOR RELOCATION OF SHA TIN SEWAGE TREATMENT WORKS TO CAVERNS – SITE PREPARATION AND ACCESS TUNNEL CONSTRUCTION

MONTHLY ENVIRONMENTAL MONITORING & AUDIT REPORT

SEPTEMBER 2019

Contract No. DC/2018/05 Relocation of Sha Tin Sewage Treatment Works to Caverns – Site Preparation and Access Tunnel Construction

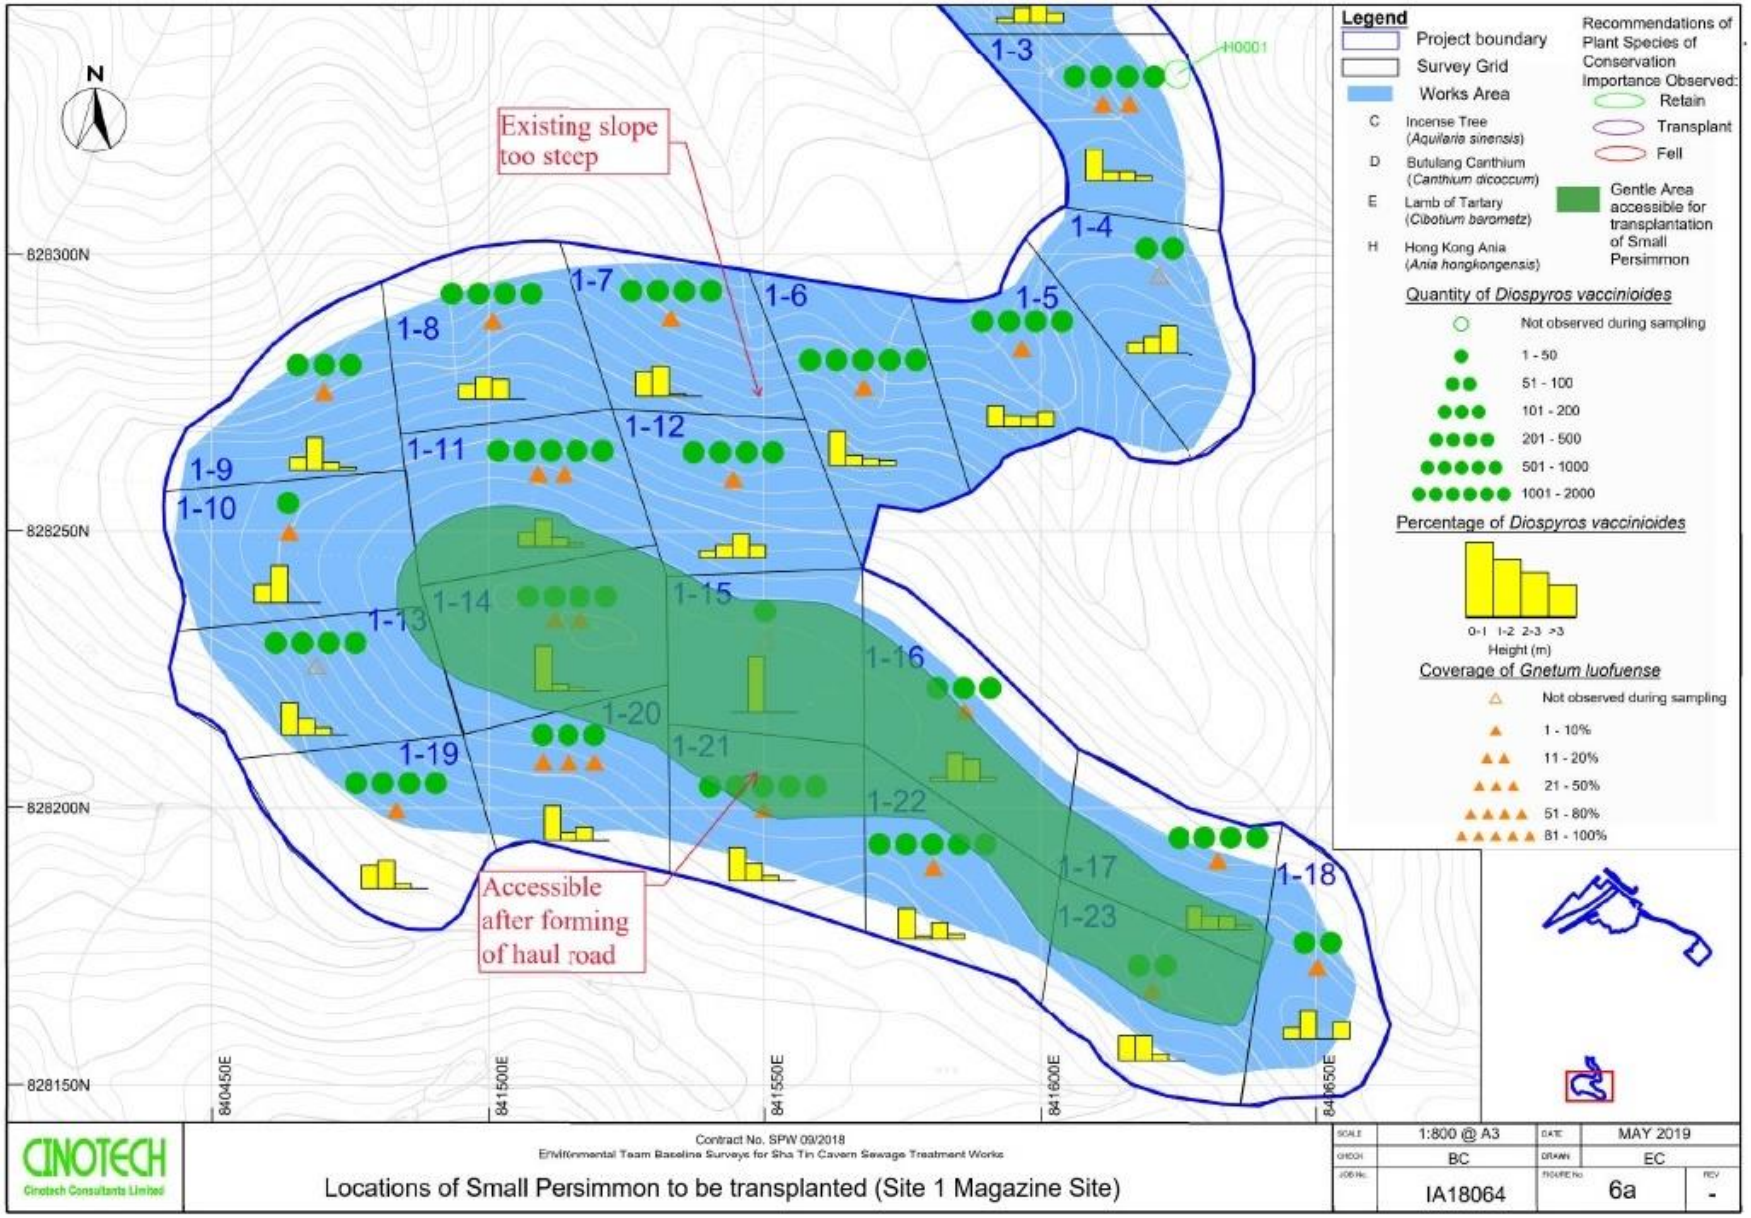
***Figure 1*. Original location of DV0001-DV0040 at Site 1 to be transplanted to the nursery.**

The 1st batch of *Diospyros vaccinioides* transplantation involved 40 nos. of individuals originated from Site 1 (named as DV0001-DV0040) (Figure 1).

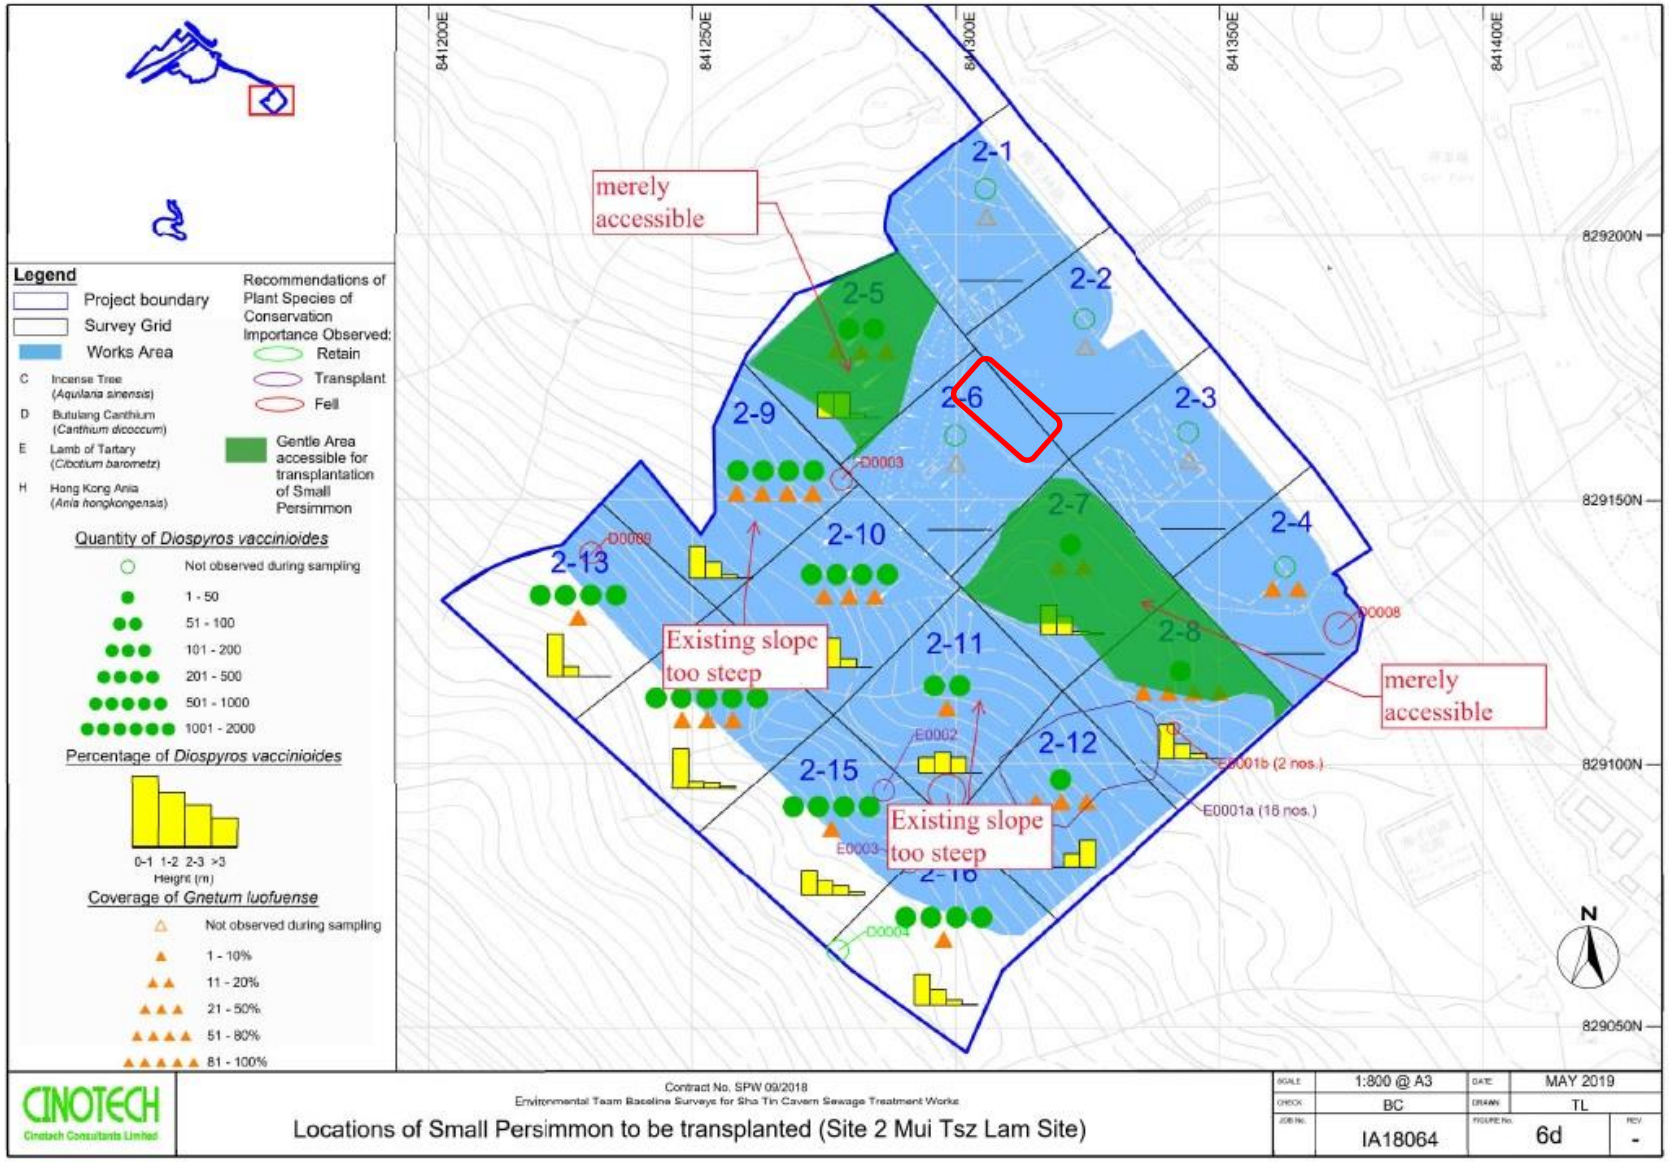
Figure 2. **Nursery site highlighted in red frame for DV0001-DV0040 at Site 2.**

The nursery is an open cleared wasteland within Site 2 (Figure 2), shelter was erected for the transplanted *Diospyros vaccinioides* against environmental stress. Each plant was tagged and lined up in rows. Water supply is ready for irrigation (Plate 1).

Nursery ground was found waterlogged and the drainage nearby was blocked by soil and debris; due to the same reason of recent rains (Plate 1). The transplanted *Diospyros vaccinioides* seedlings were probably stressed under saturated soil. Next few monitoring will be importance to assess their progress in plant condition.

In contrast, the Landscape Contractor was recommended to check all transplanted plants after heavy rains/ typhoon under safe condition, in order to carry out any stabilization/ maintenance work. Blocked drainage shall be cleared; excessive water shall be pumped or diverged from nursery ground; saturated soil shall be aerated.

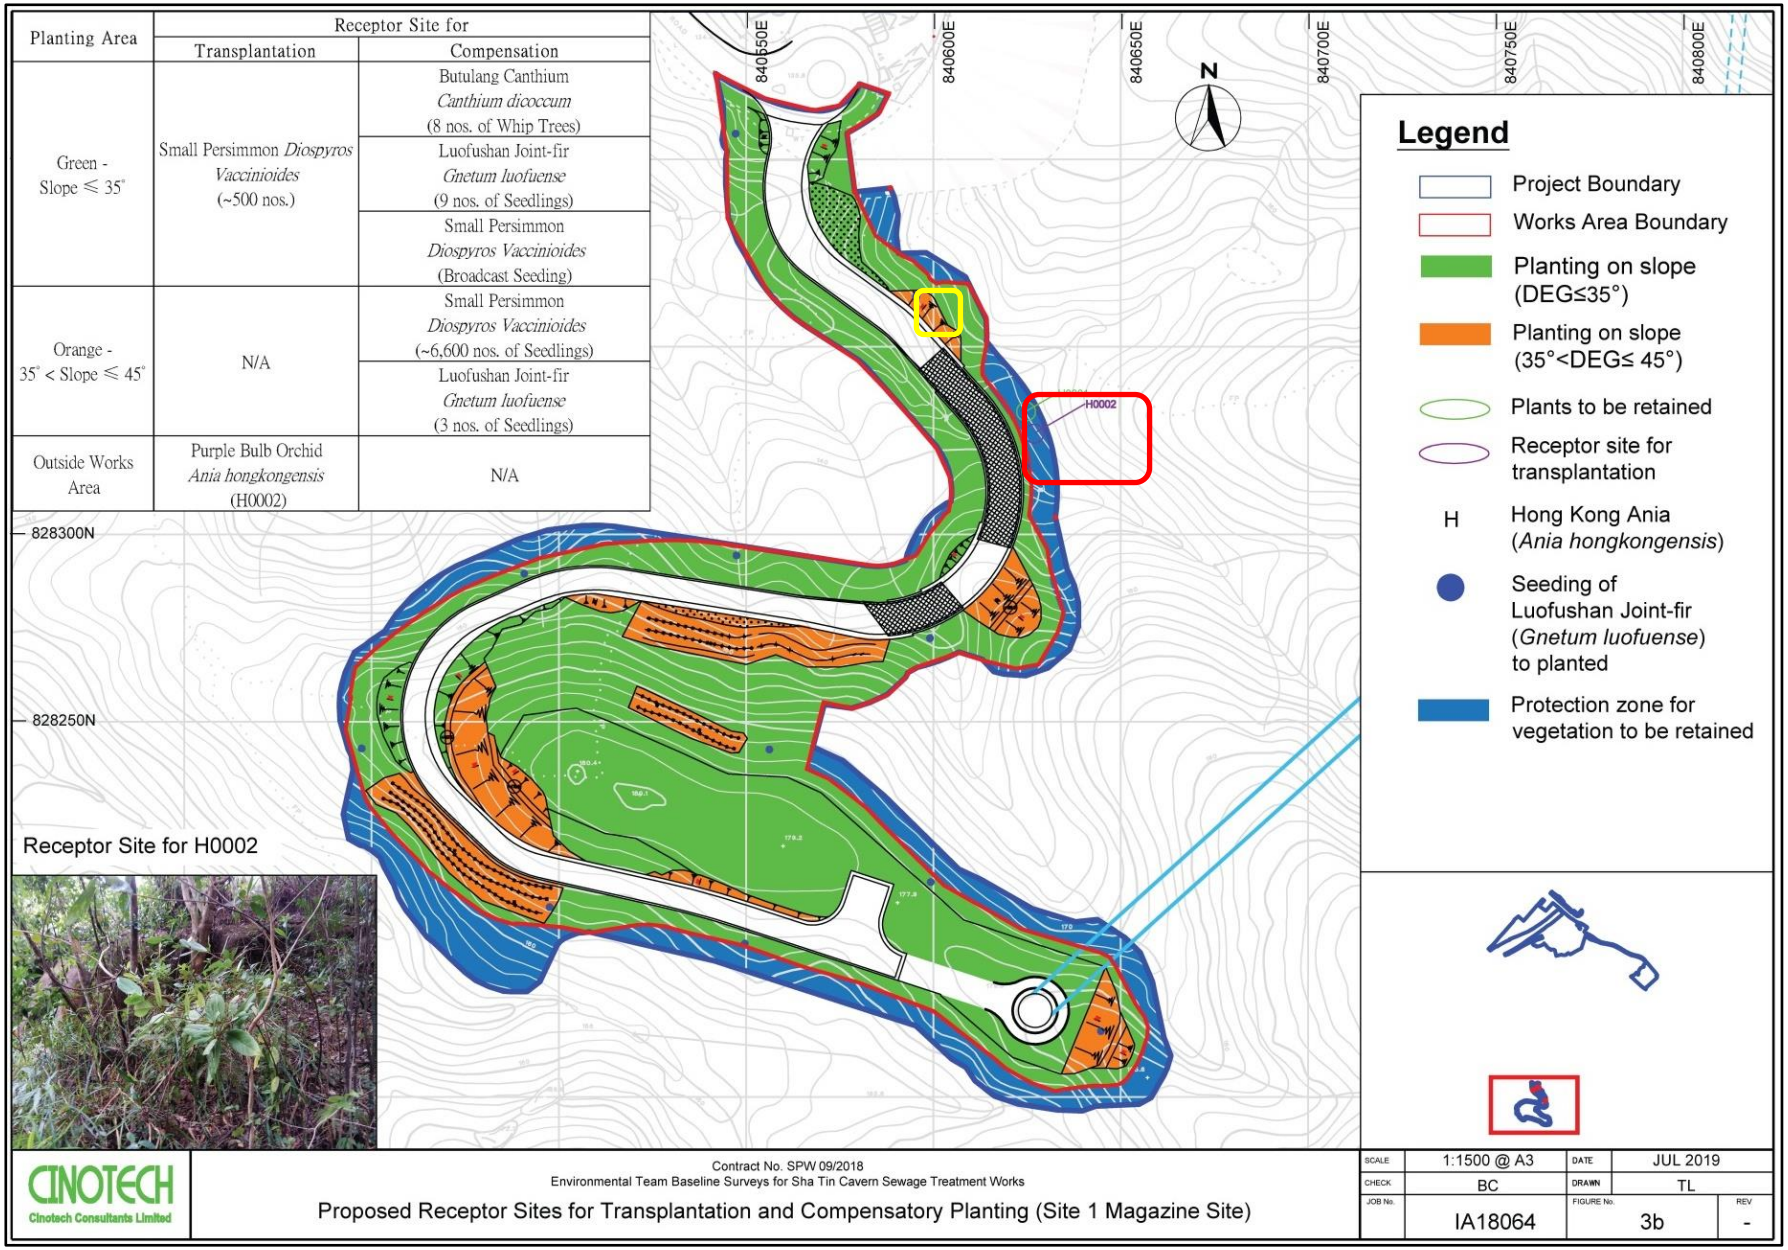
***Figure 3*. Original location of H0002 highlighted in yellow frame and its receptor site highlighted in red frame.**

Post-transplantation monitoring for 1 no. of *Aquilaria sinensis* seedling (named as C0001), 7 nos. of *Cibotium barometz* (grouped as E0004) and 1 no. of *Ania hongkongensis* (named as H0002) was conducted on 20 September 2019 at their corresponding receptor sites/ nursery (Figure 2, 3 and 4); while the 40 nos. of *Diospyros vaccinioides* (DV0001-DV0040) was monitored with extra effort made on 5 and 20 September 2019.

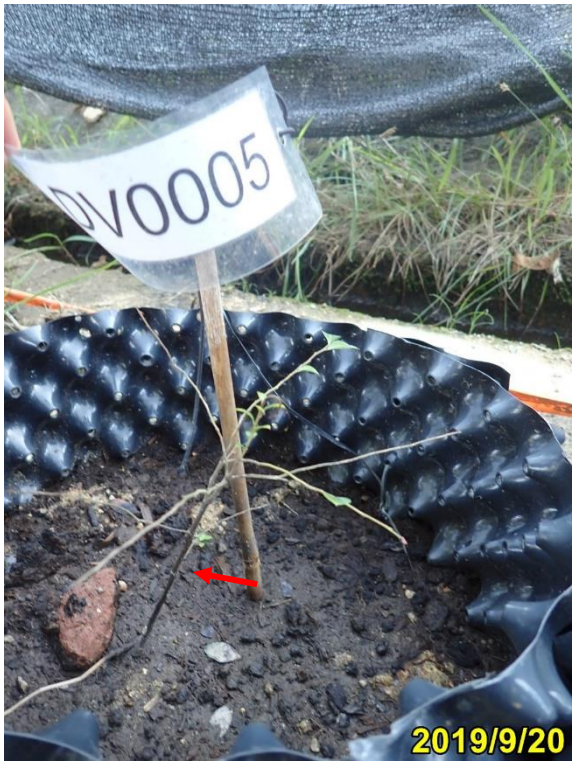
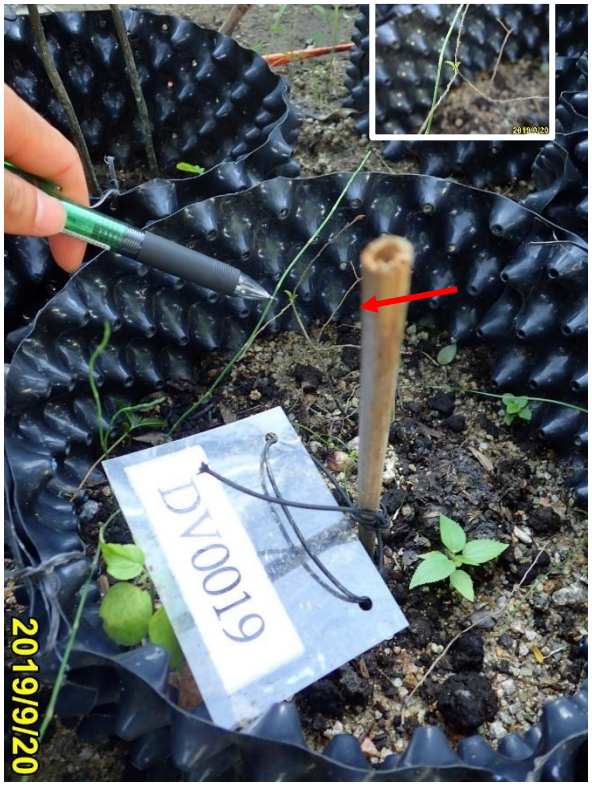
Post-transplantation monitoring at temporary nursery on 20 September 2019

Most seedlings were generally tiny (about 10cm in height) aiming at smaller root zone and better survival. However, some of them have yet developed sufficient leaves. Sign of leaf drop and dehydration has been observed (Plate 1), despite provision of shelter and irrigation. Although tiny new branch or leaf buds were observed, seedlings may struggle for survival against environmental stress.

In about 2-week time, about 32.5% (13 out of 40 individuals) of transplanted seedlings has died or turned in poor condition, as illustrated in Appendix 1.

<u>Recommendation on post-transplantation monitoring maintenance</u>
According to environmental condition and location of the receptor sites/ nursery, watering frequency was recommended in a daily practice for at least the first 3 months as the transplant time is in summer months with strong sunlight and high temperature; except the days with fog and rain. Water frequency may be reduced based on the plant condition after monitoring in the first 3 months.
