ENVIRONMENTAL TEAM FOR RELOCATION OF SHA TIN SEWAGE TREATMENT WORKS TO CAVERNS – SITE PREPARATION AND ACCESS TUNNEL CONSTRUCTION

MONTHLY ENVIRONMENTAL MONITORING & AUDIT REPORT

JUNE 2020

Lam Environmental Services Limited

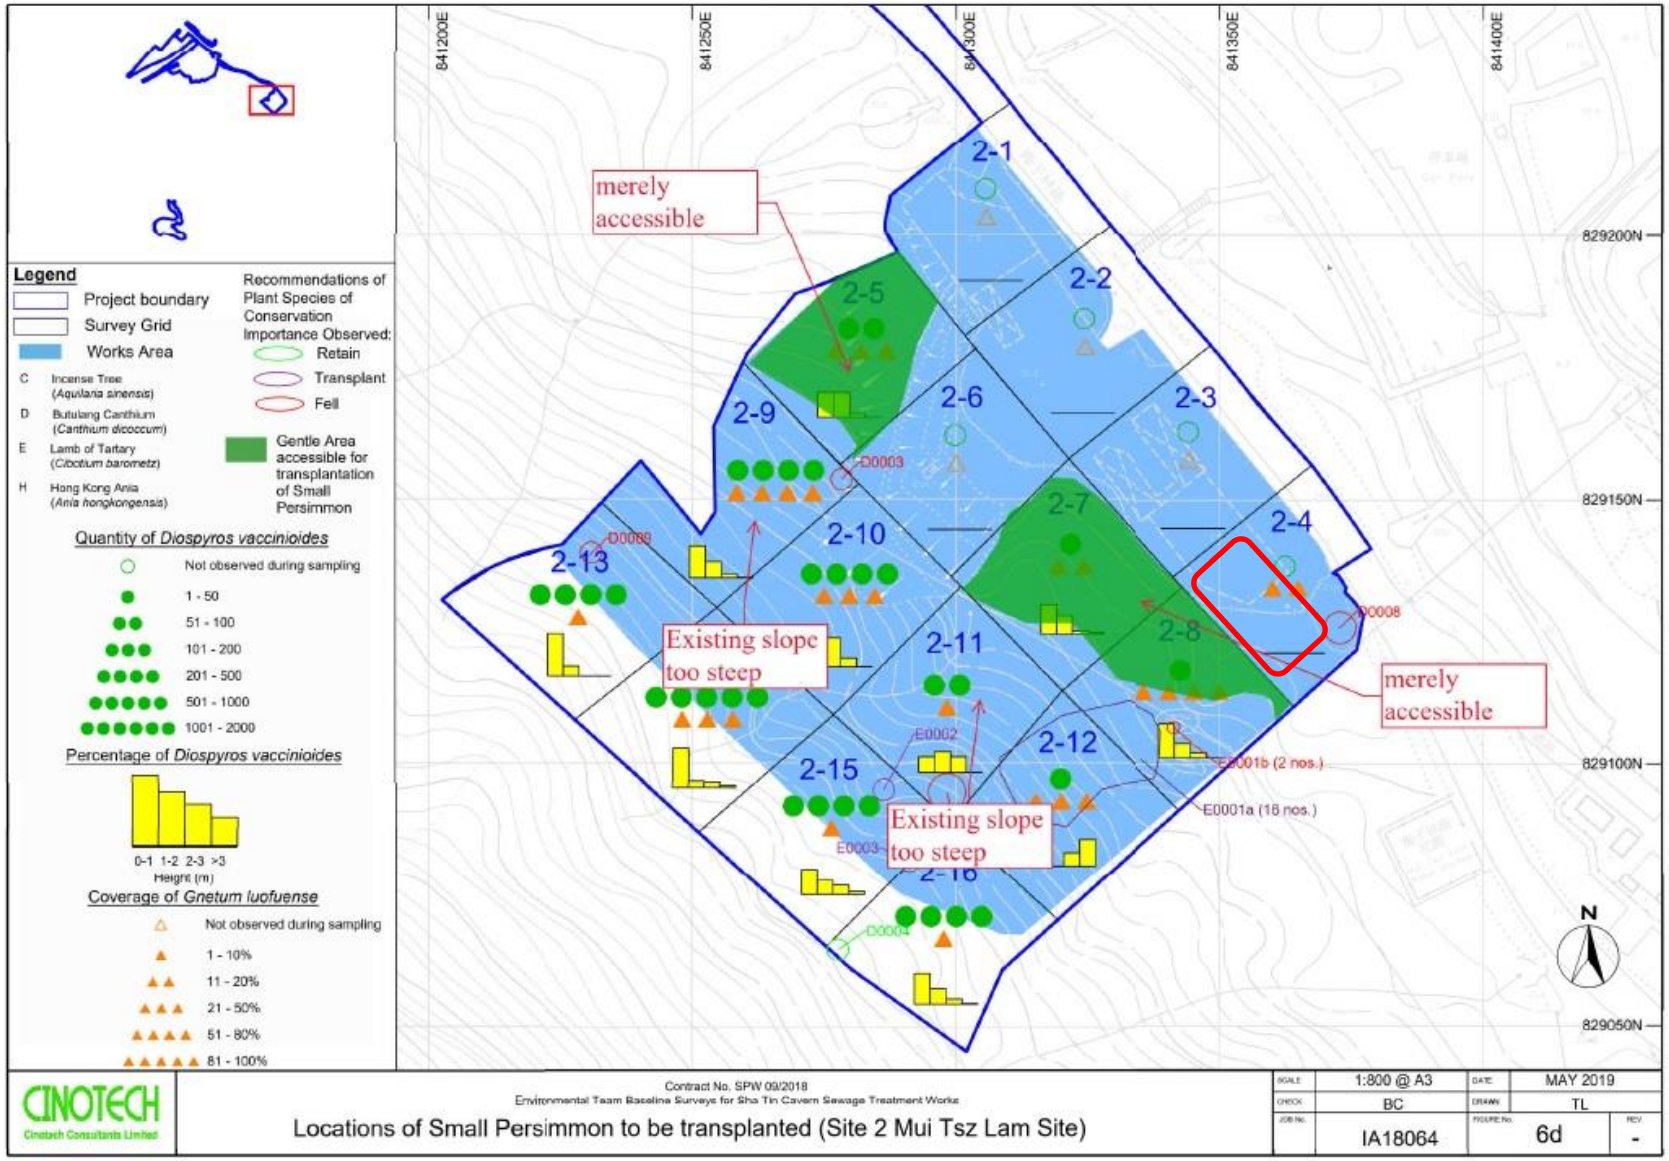
Figure 2. Nursery site highlighted in red frame for DV0001-DV0040 (1st batch) and DV0001-DV0228 (2nd batch) at Site 2.

The nursery is an open cleared wasteland within Site 2 (**Figure 2**), a shelter was erected for the transplanted *Diospyros vaccinioides* against environmental stress. Each plant was tagged and lined up in rows (**Plate 1**). Water supply is ready for irrigation.

Plant conditions of 1st batch DV0001-DV0040 and 2nd batch DV0001-DV0228 were listed in **Table 2a, 2b** and illustrated in **Appendix 1**. Some seedlings were generally tiny (about 10cm in height) aiming at smaller root zone and better survival. However, some of them have yet developed sufficient leaves. Sign of leaf drop and dehydration has been observed, despite provision of shelter and irrigation (**Plate 1**). Although tiny new branch or leaf buds were observed, seedlings may struggle for survival against environmental stress.

According to environmental condition and location of the receptor sites/ nursery, watering frequency was recommended in daily practice for at least the first 3 months as the transplant time is in summer months with strong sunlight and high temperature; except the days with fog and rain. Water frequency may be reduced based on the plant condition after monitoring in the first 3 months.

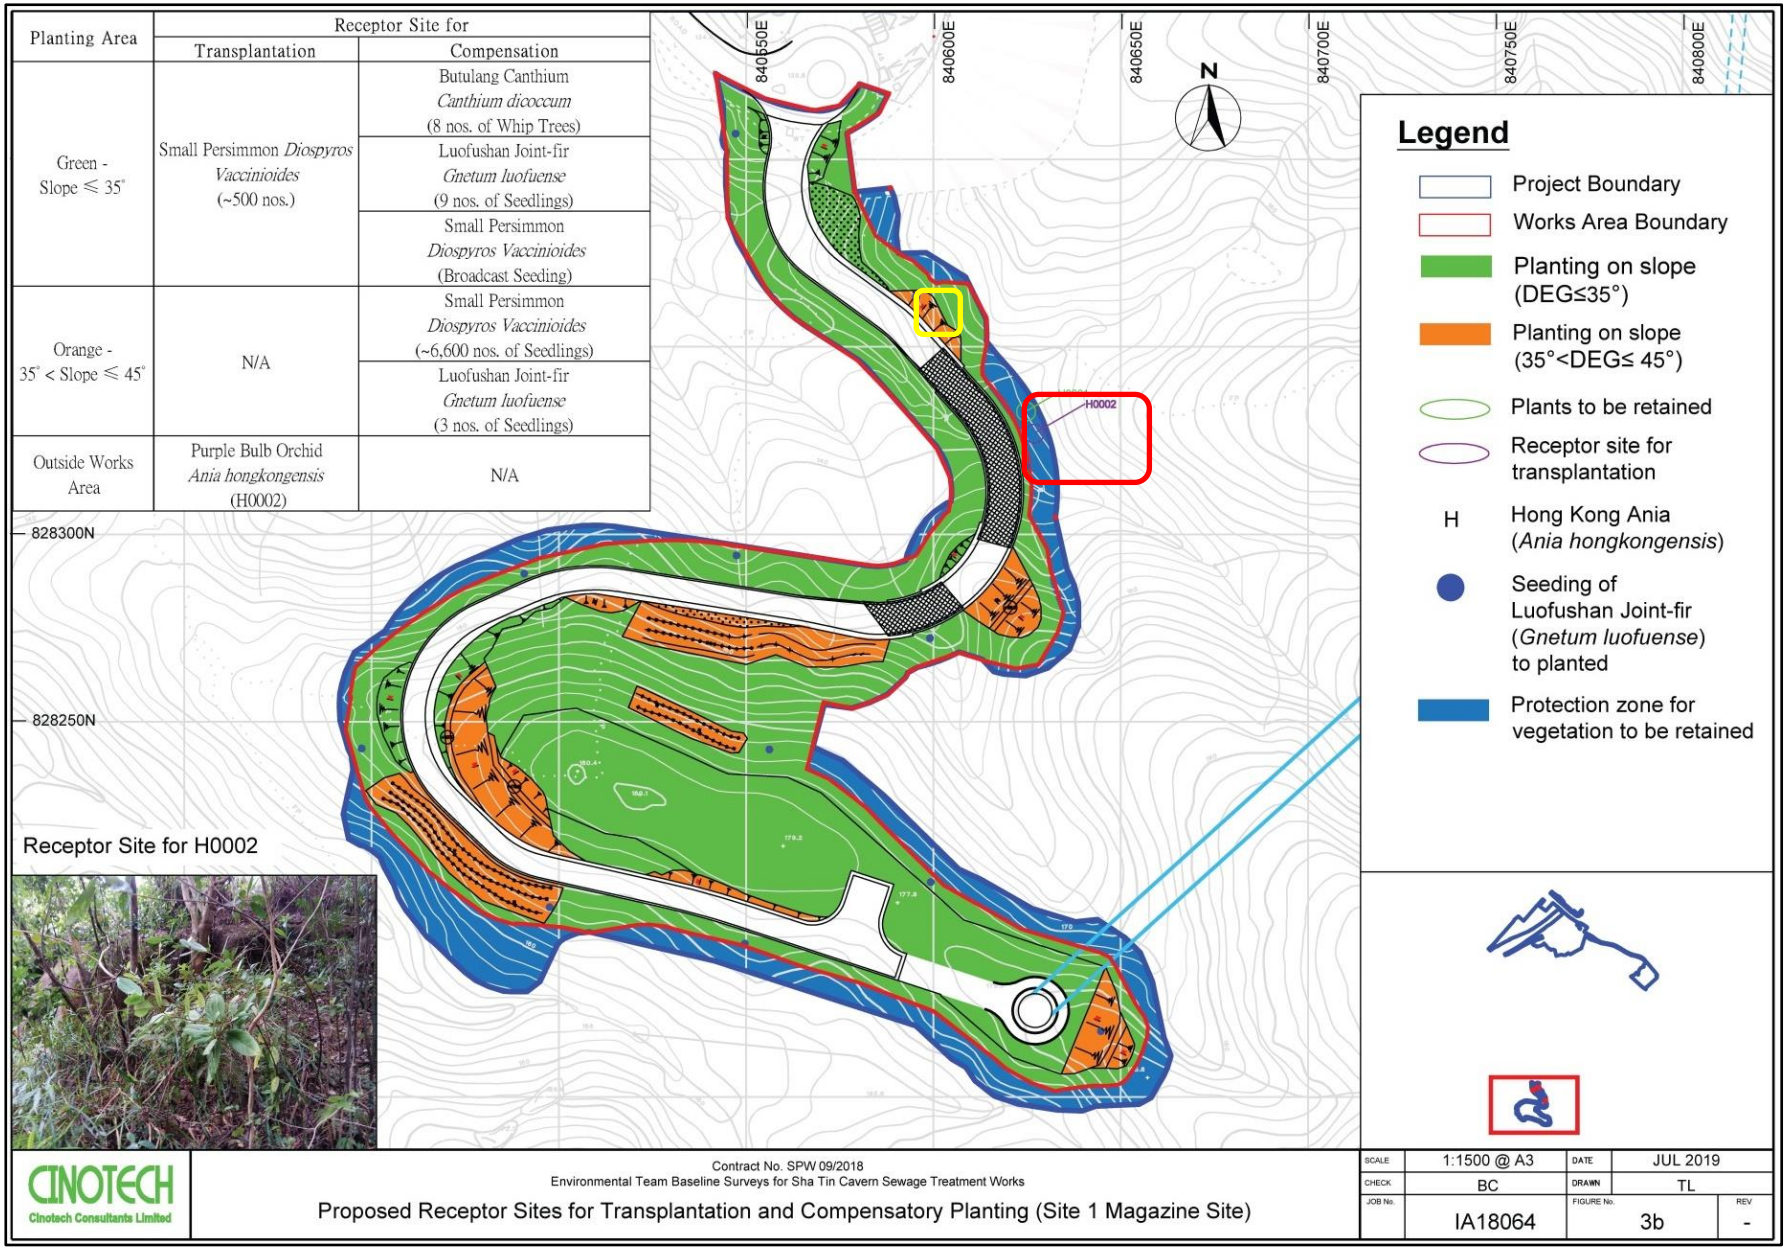
Figure 3. Original location of H0002 highlighted in yellow frame and its receptor site highlighted in red frame.

Post-transplantation monitoring for 2 batches of *Diospyros vaccinioides* and *Ania hongkongensis* (named as H0002) were conducted on 23 June 2020 at their corresponding receptor sites/ nursery (**Figure 2 and Figure 3**).

For C0001, E0004 and H0002, plant conditions were listed in **Table 3**, and corresponding photographic records were shown in **Appendix 2**. Despite root balls were maintained intact as far as possible, transplanted plants need time to grow into new soil of the receptor site. Therefore, sign of dehydration, leaf yellowing/ wilting, or even die-off were expected. Meanwhile, it is observed that site clearance was carried out in the continue patch of woodland surrounding receptor sites of H0002. A shelter has been set up for the transplanted plants to provide similar shading against adverse environmental condition (e.g. strong sunlight, rainstorm and construction dust). It is observed that organic soil conditioner was applied by the Contractor to H0002 in order to retain water moisture in the soil. On the other hand, sign of

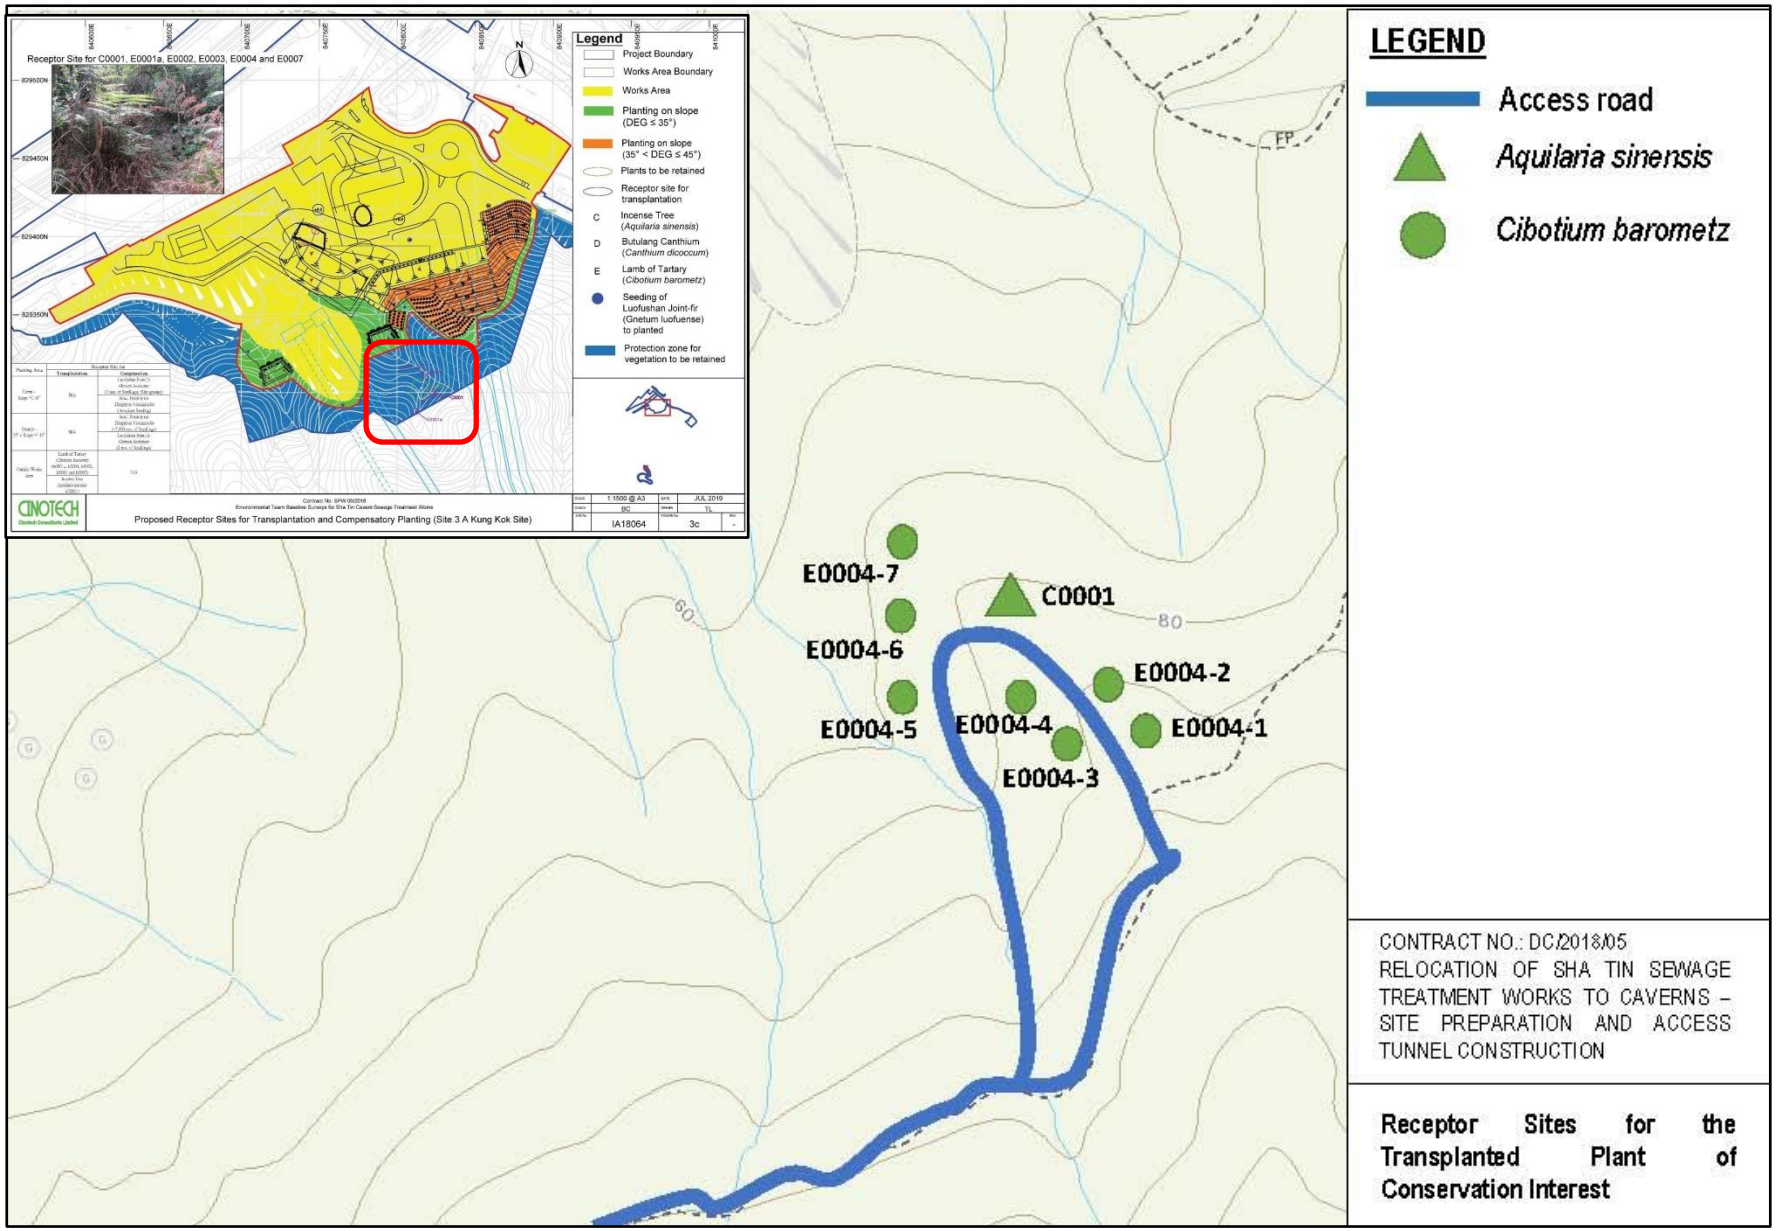
Figure 4. Receptor site for C0001 and E0004, the area highlighted in red frame is enlarged.

Monitoring for 1 no. of *Aquilaria sinensis* seedling (named as C0001) and 7 nos. of *Cibotium barometz* (grouped as E0004) were conducted on 23 June 2020 at a quarterly basis (**Figure 4**).

damage by insect was observed on E0004.

In response to the observed insect damage observed on E0004, appropriate horticultural treatment of spraying soap water (bio-degradable soap mixed with hot water in 1:60-70 ratio and cool down before spraying) once per week for 3-4 cycles with weekly monitoring is suggested to carry out. This help to access if the insect damage stop spreading to other *Cibotium barometz* individuals in vicinity.

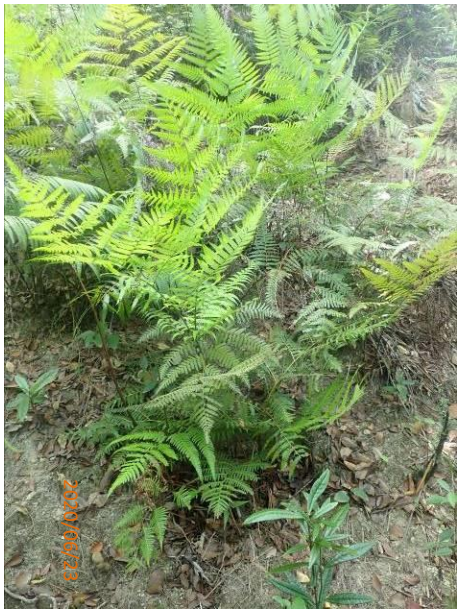
C0001	E0004-1

Date of monitoring	No.	Form	Health condition	Structural condition	Amenity value	Remarks	
23 Jun 2020	C0001	Fair	Fair	Fair	Poor	Young leaves kept growing; sign of yellow foliage	Quarterly monitoring (next monitoring will be scheduled in Sept 2020); weekly monitoring is suggested during the treatment of soap water spraying (3-4 weeks)
	E0004-1	Fair	Fair	Fair	Fair		
	E0004-2	Fair	Fair	Fair	Fair		
	E0004-3	Fair	Fair	Fair	Fair		
	E0004-4	Fair	Fair	Fair	Fair		
	E0004-5	Fair	Fair	Fair	Fair		
	E0004-6	Fair	Fair	Fair	Fair	Some leaves drop	
	E0004-7	Fair	Fair	Fair	Fair	Sign of insect chewing on fronds observed	
27 Apr 2020	H0002	Fair	Fair	Fair	Fair		Quarterly monitoring (next monitoring will be scheduled in July 2020)
