Agreement No. CE 30/2018 (EP) Environmental Team for Kai Tak Sports Park – Design and Construction

Monthly EM&A Report for July 2023

Environmental Permit No. EP-544/2017

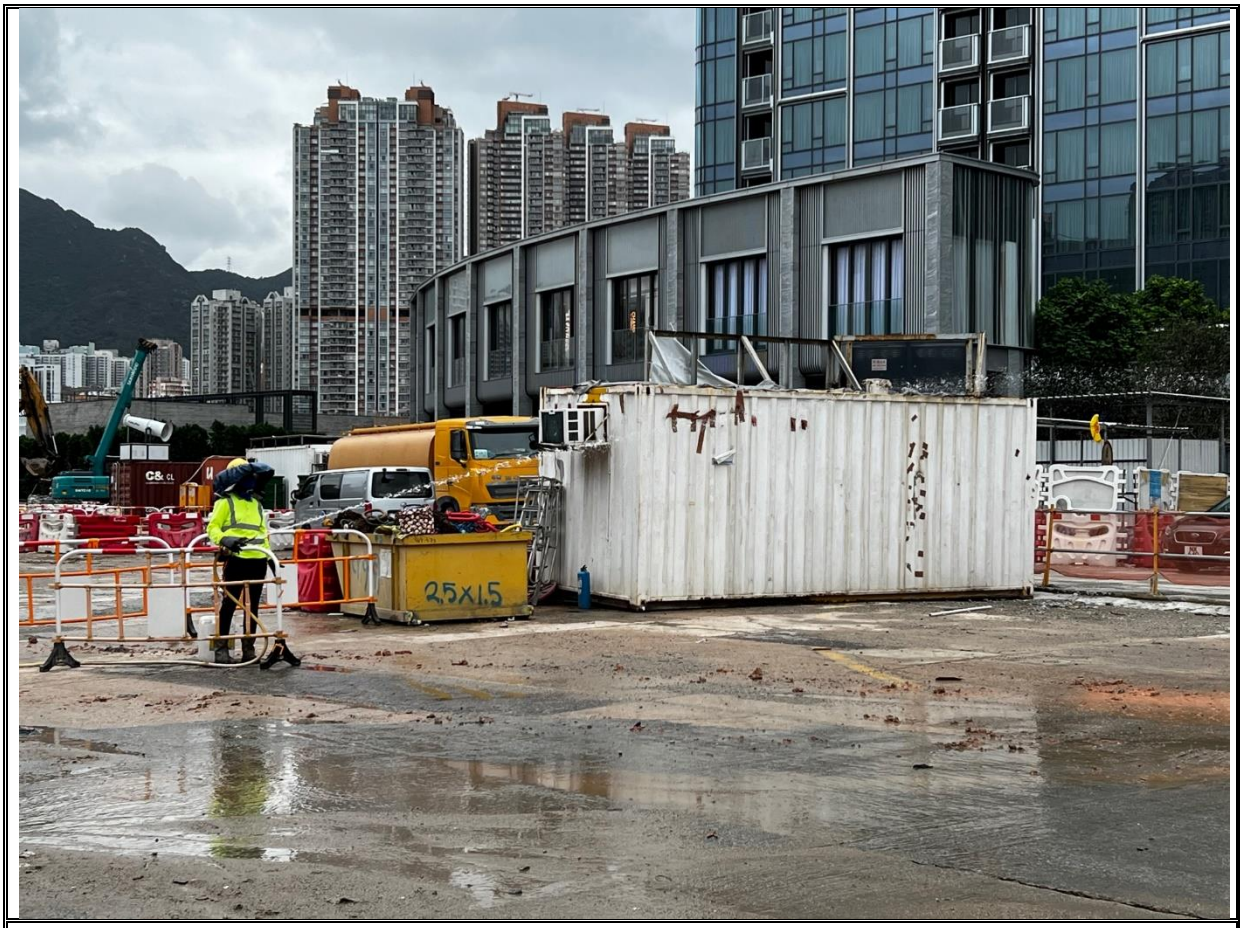
Photo 4: Water spraying was observed during regular site inspection on 19 July 2023. (site area at POS N(E))

RECOMMENDATIONS / MITIGATION MEASURES / ACTIONS			
Environmental mitigation measures have been maintained as follow: 1. Dust suppression measures (i.e. Water spraying) had been implemented during ground breaking works (Photo 1). 2. Water truck had been working continuously around all haul road within the site (Photo 2). 3. Water misting cannon had been installed to wet the area which water trucks cannot reach (Photo 3). 4. Implementation of construction dust mitigation measures recommended in EIA's Environmental Mitigation Implementation Schedule.			
Prepared by:	Sunny Chan	Title:	Environmental Team Leader
Signature:
