PROJECT NO.: TCS00409/08

DSD CONTRACT NO. DC/2007/08
DRAINAGE IMPROVEMENTS WORKS IN TAI PO TIN, PING CHE, MAN UK PIN AND LIN MA HANG

19TH MONTHLY ENVIRONMENTAL MONITORING & AUDIT REPORT FOR THE DESIGNATED WORKS UNDER THE PROJECT – SEPTEMBER 2010
CHANNELS MUP03A&B, MUP04A&B, MUP05 AND LMH01

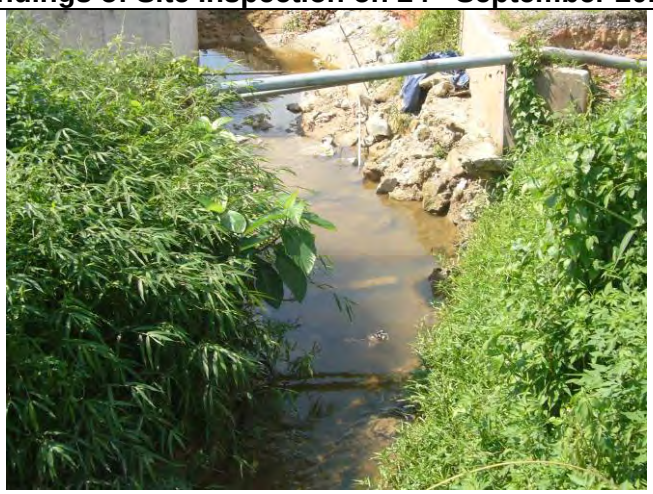
Photo 1	 Photo 2
C&D waste observed at the bottom of the stream, the contractor was reminded to clean. (TKL02)	Soil and mud tail was observed at the site exit, the contractor was reminded to clean. The contractor should maintain the public area near the site area clean and tidy.(MUP05)

Heavy smoke emitted from the backhoe was observed, the contractor was reminded to maintain the plant properly to prevent dark smoke emitted. (MUP05)
