Contract No. EP/SP/58/08

Sludge Treatment Facilities

Environmental Monitoring and Audit Report

October 2011

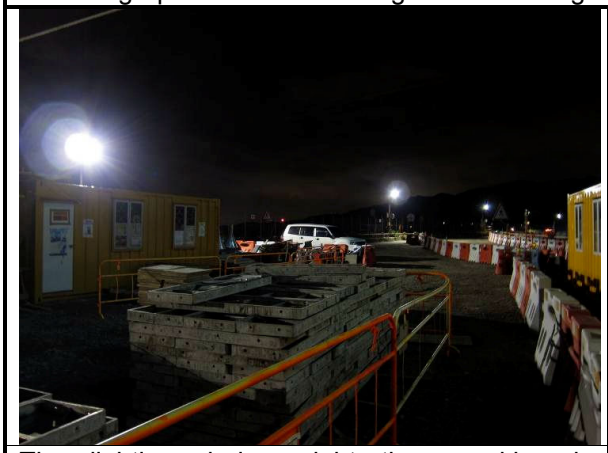
T758 transplant work has not commenced yet, crown pruning has been commenced to avoid further damaged to the tree during construction.	T758 transplant work has not commenced yet.
4. Photographic record of the night time working

The lighting during night time working is confined within the working area within the site boundary. Periphery area and the sensitive receivers are not affected by the lighting during night time working.	The floodlights mounted on the boundary fence is directed inside the site boundary.

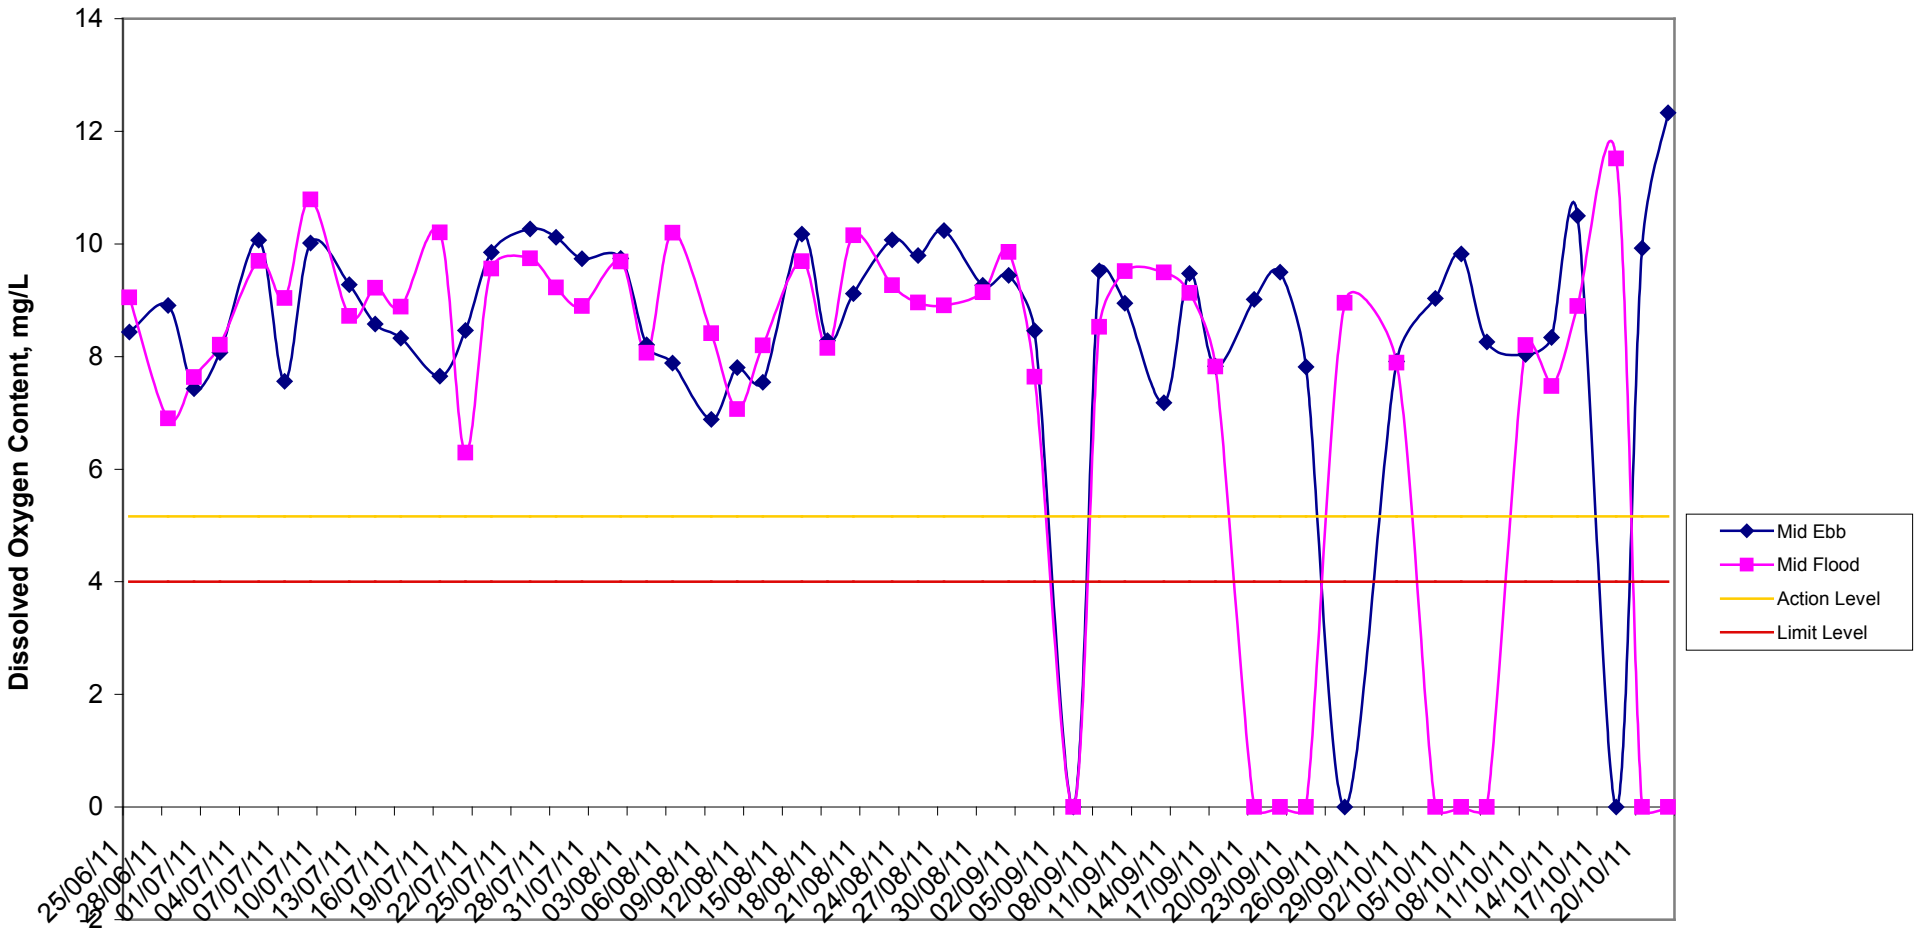
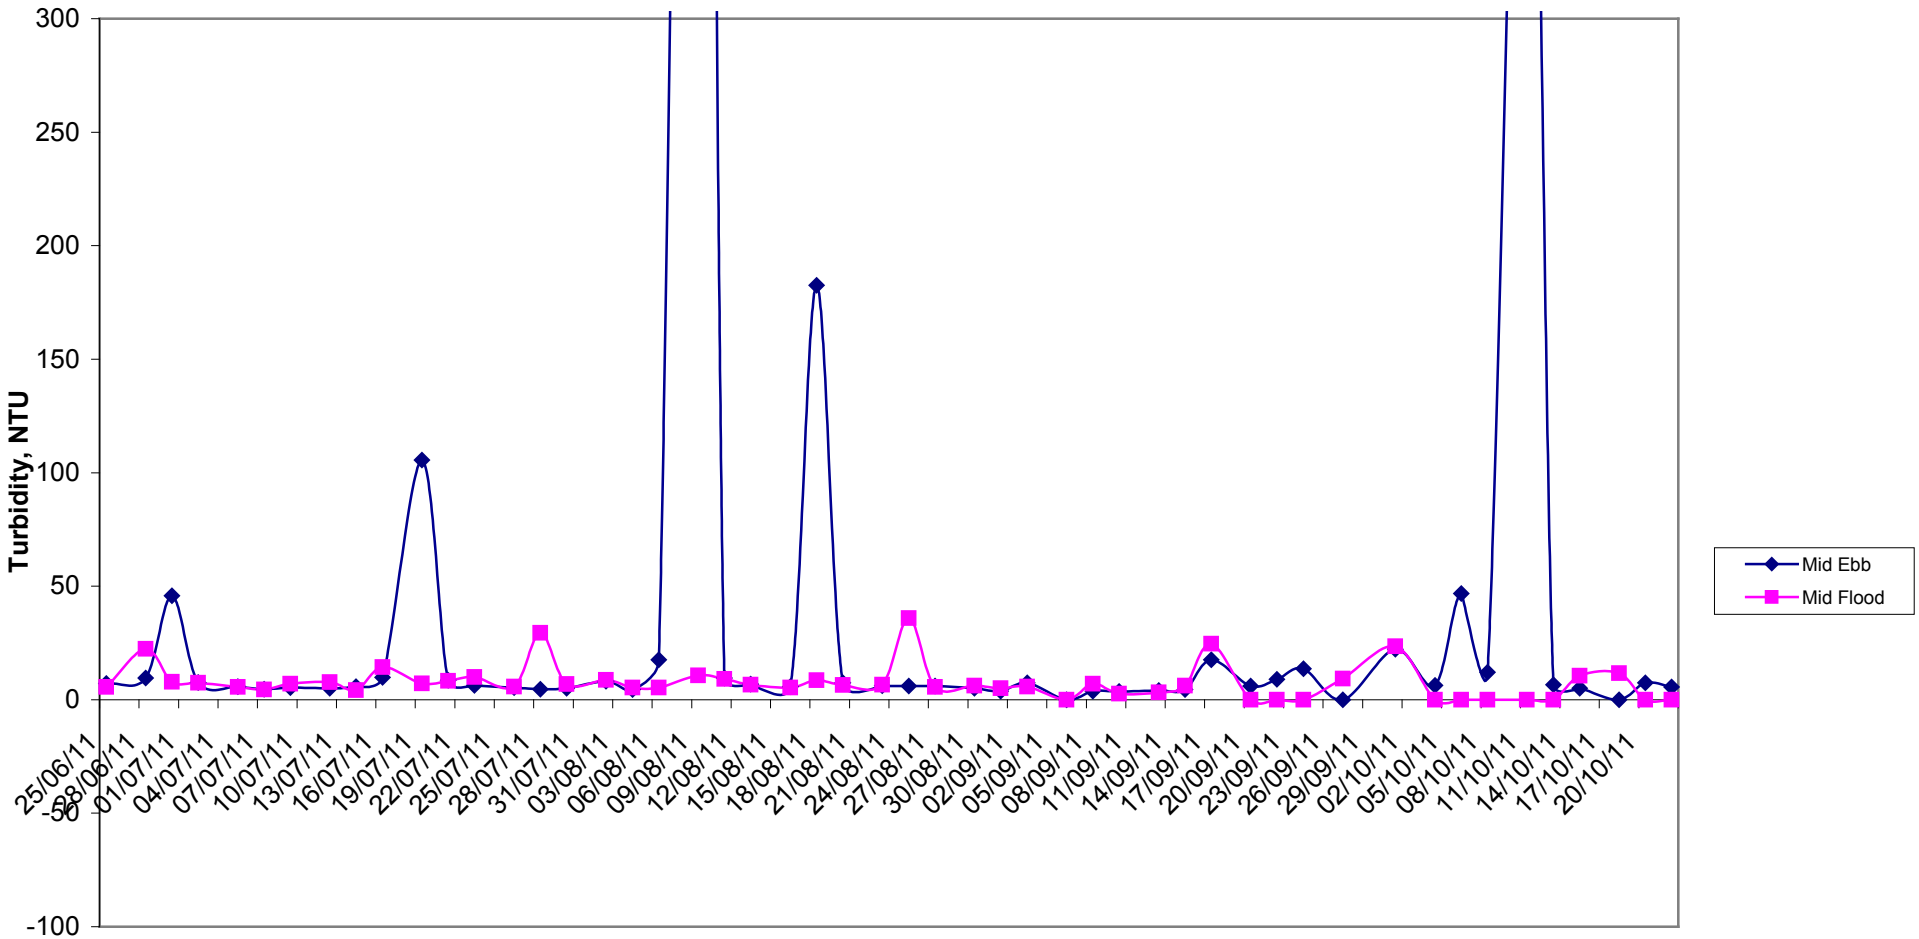
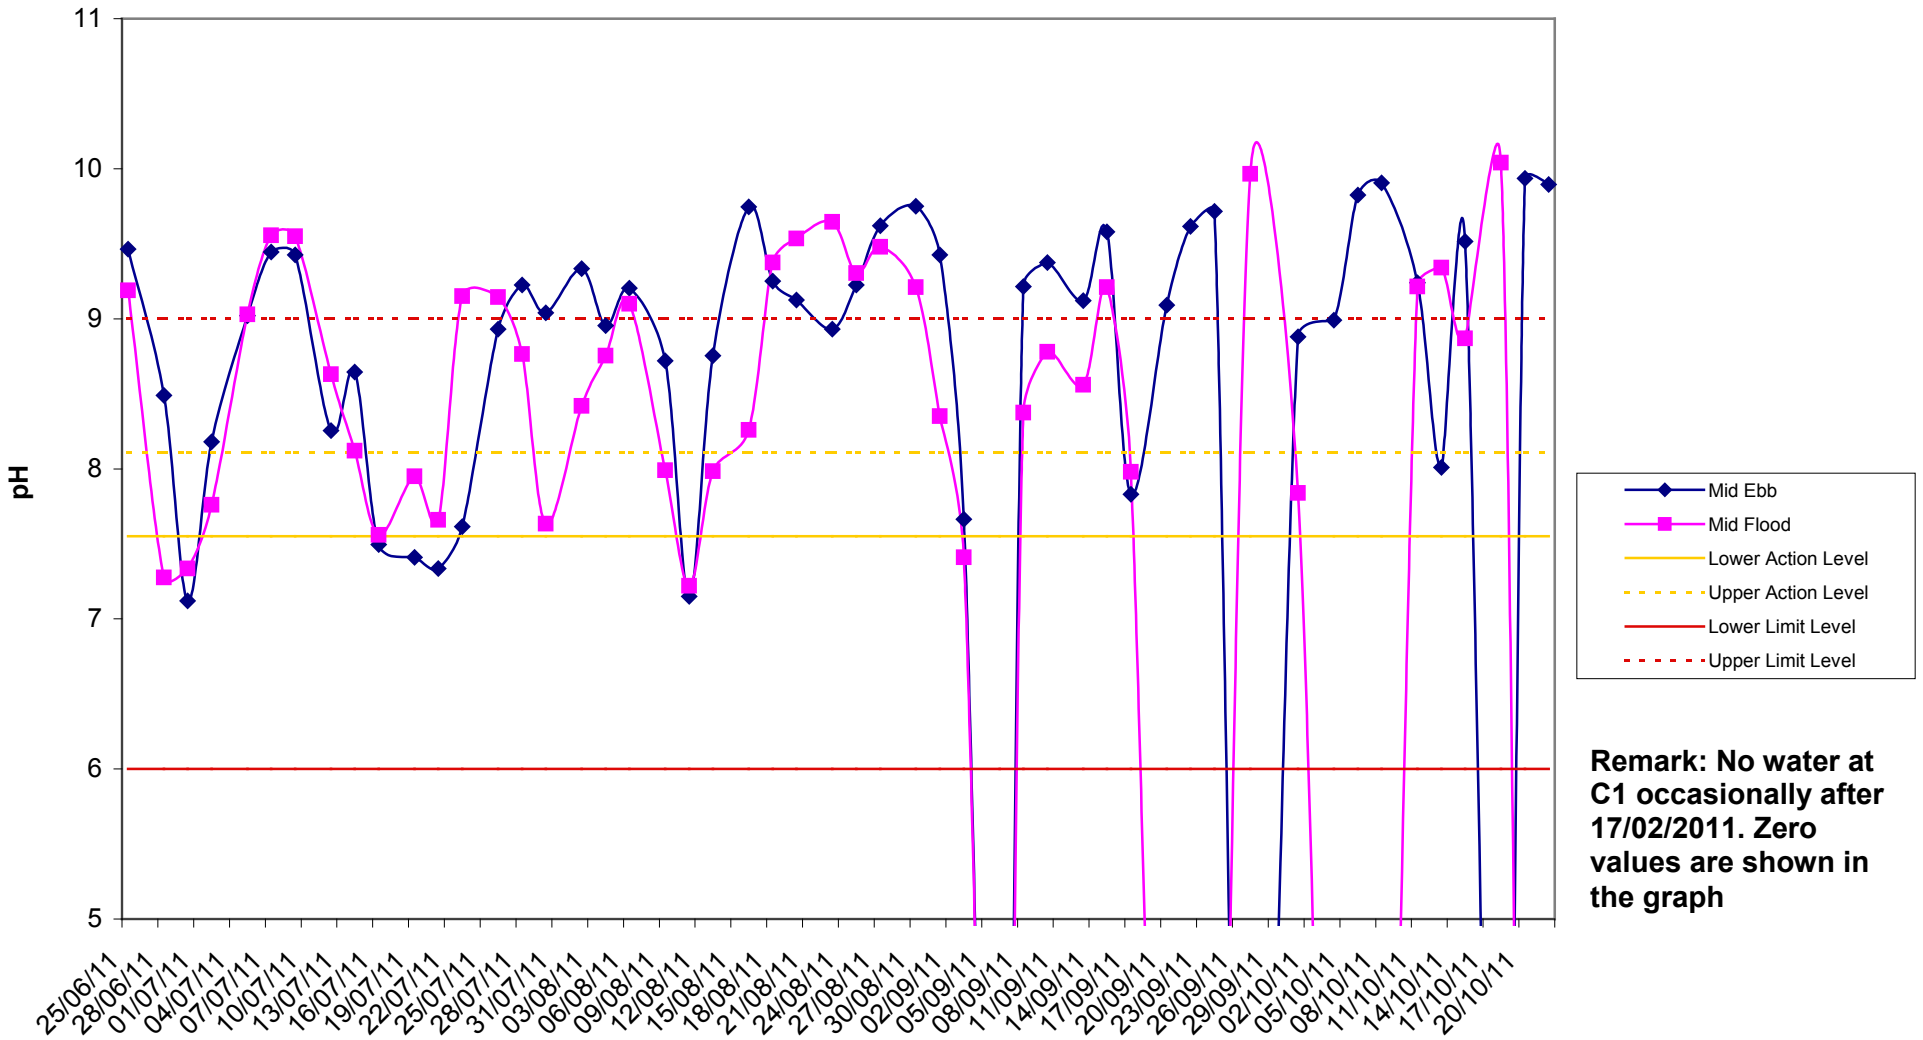
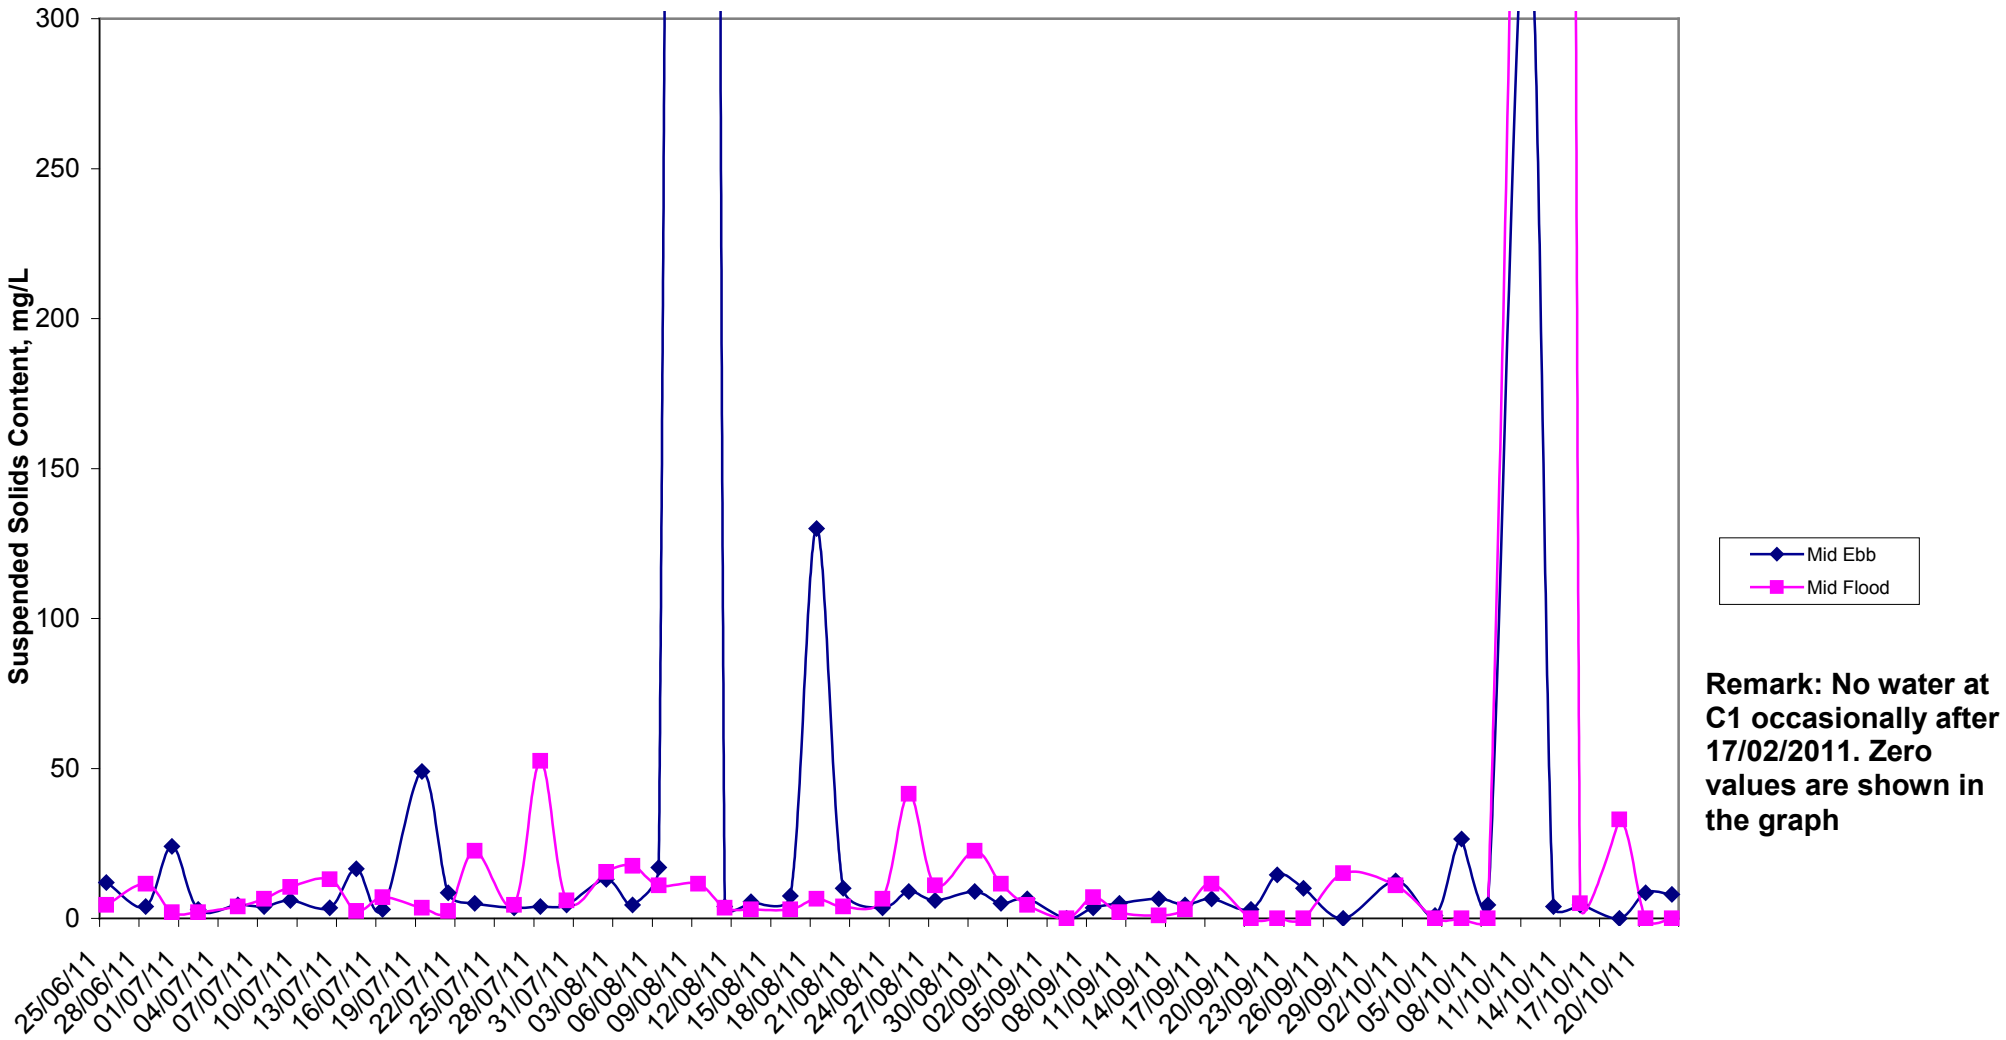
Remark: No water at C1 occasionally after 17/02/2011. Zero values are shown in the graph
