Contract No. EP/SP/58/08

Sludge Treatment Facilities

Environmental Monitoring and Audit Report

November 2011

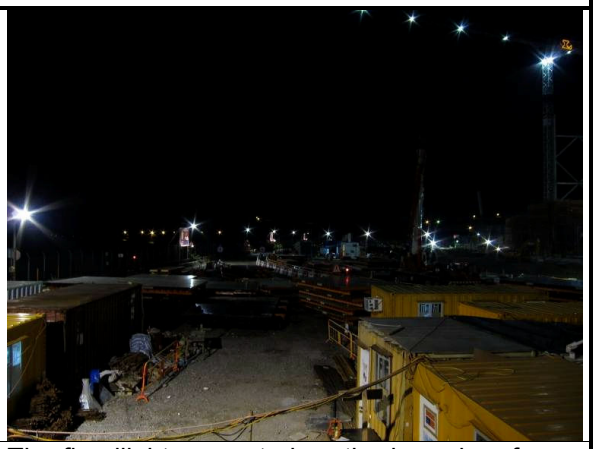
T758 transplant work has not commenced yet, crown pruning has been commenced to avoid further damaged to the tree during construction.	T758 transplant work has not commenced yet.
4. Photographic record of the night time working

The lighting during night time working is confined within the working area within the site boundary. Periphery area and the sensitive receivers are not affected by the lighting during night time working.	The floodlights mounted on the boundary fence is directed inside the site boundary.

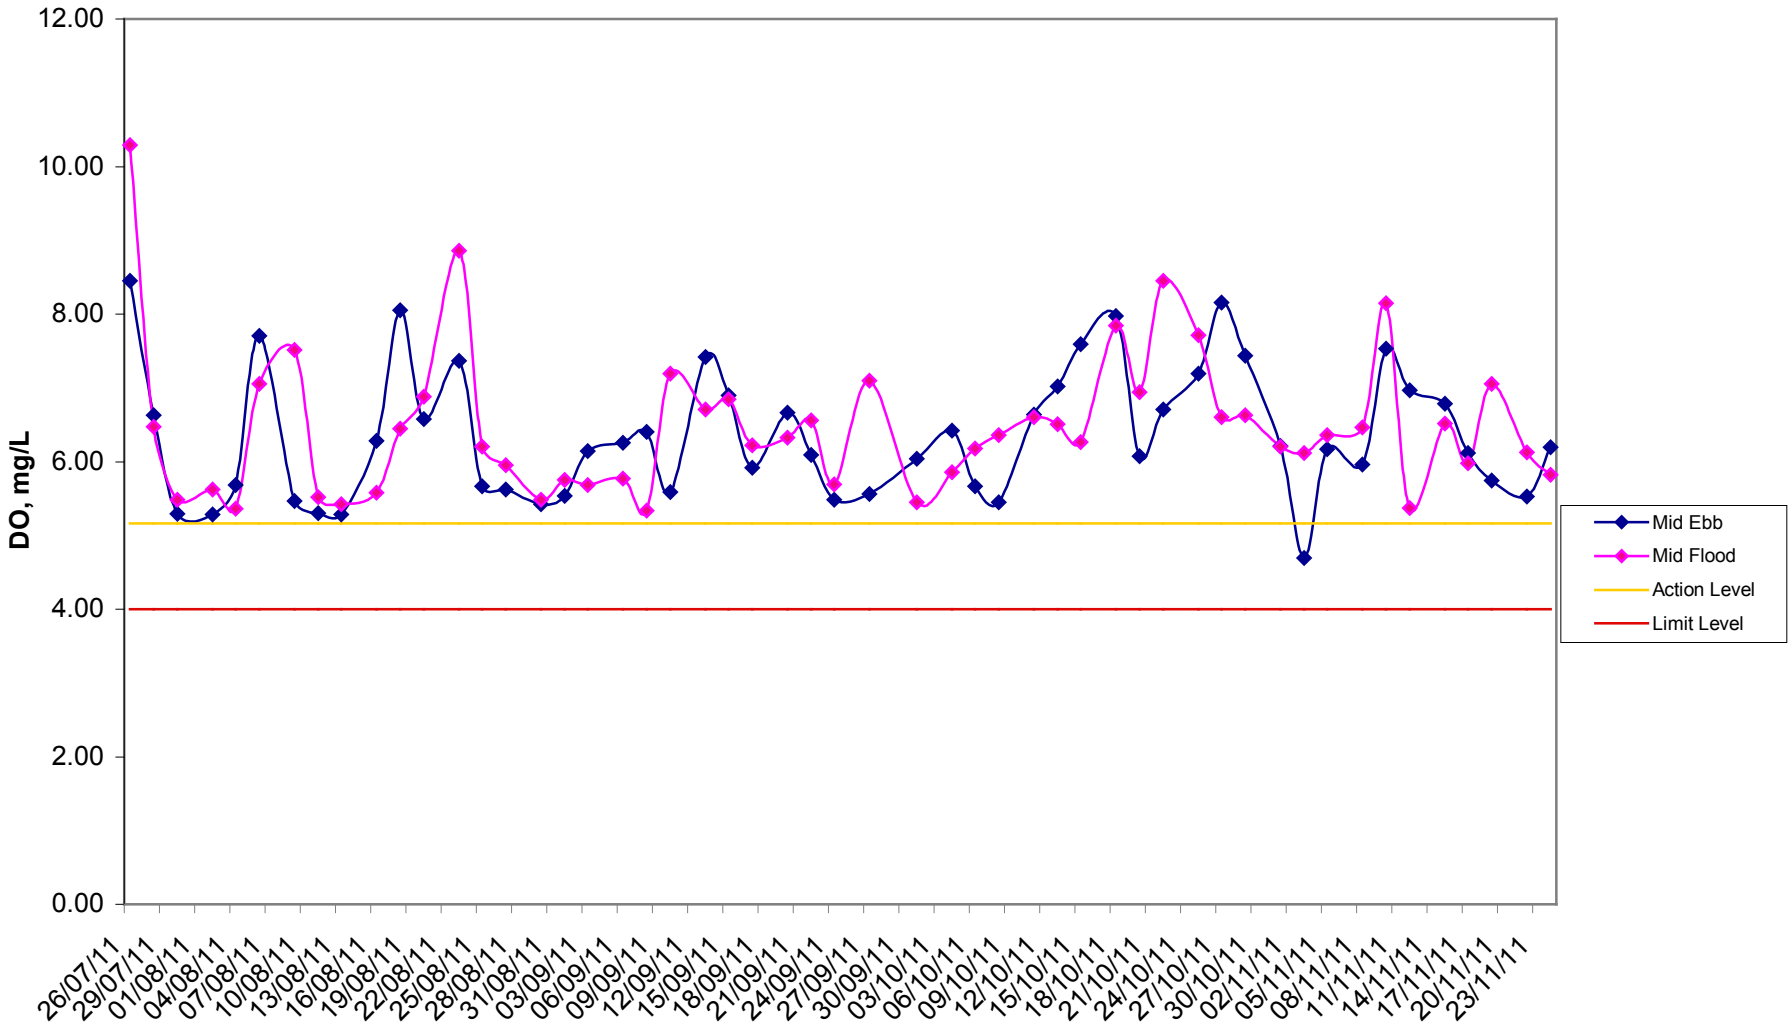
W1 - Dissolved Oxygen Content

2 events of exceedance of dissolved oxygen were recorded at mid-ebb on 03 November at W1 and W2. The event was recorded at W1 and W2 due to occasional stagnancy of stream water. The stream water quality monitoring conducted in the afternoon of 03 November 2011 indicated that DO level restored to normal condition. Thus, the exceedance should not be related to the Project.

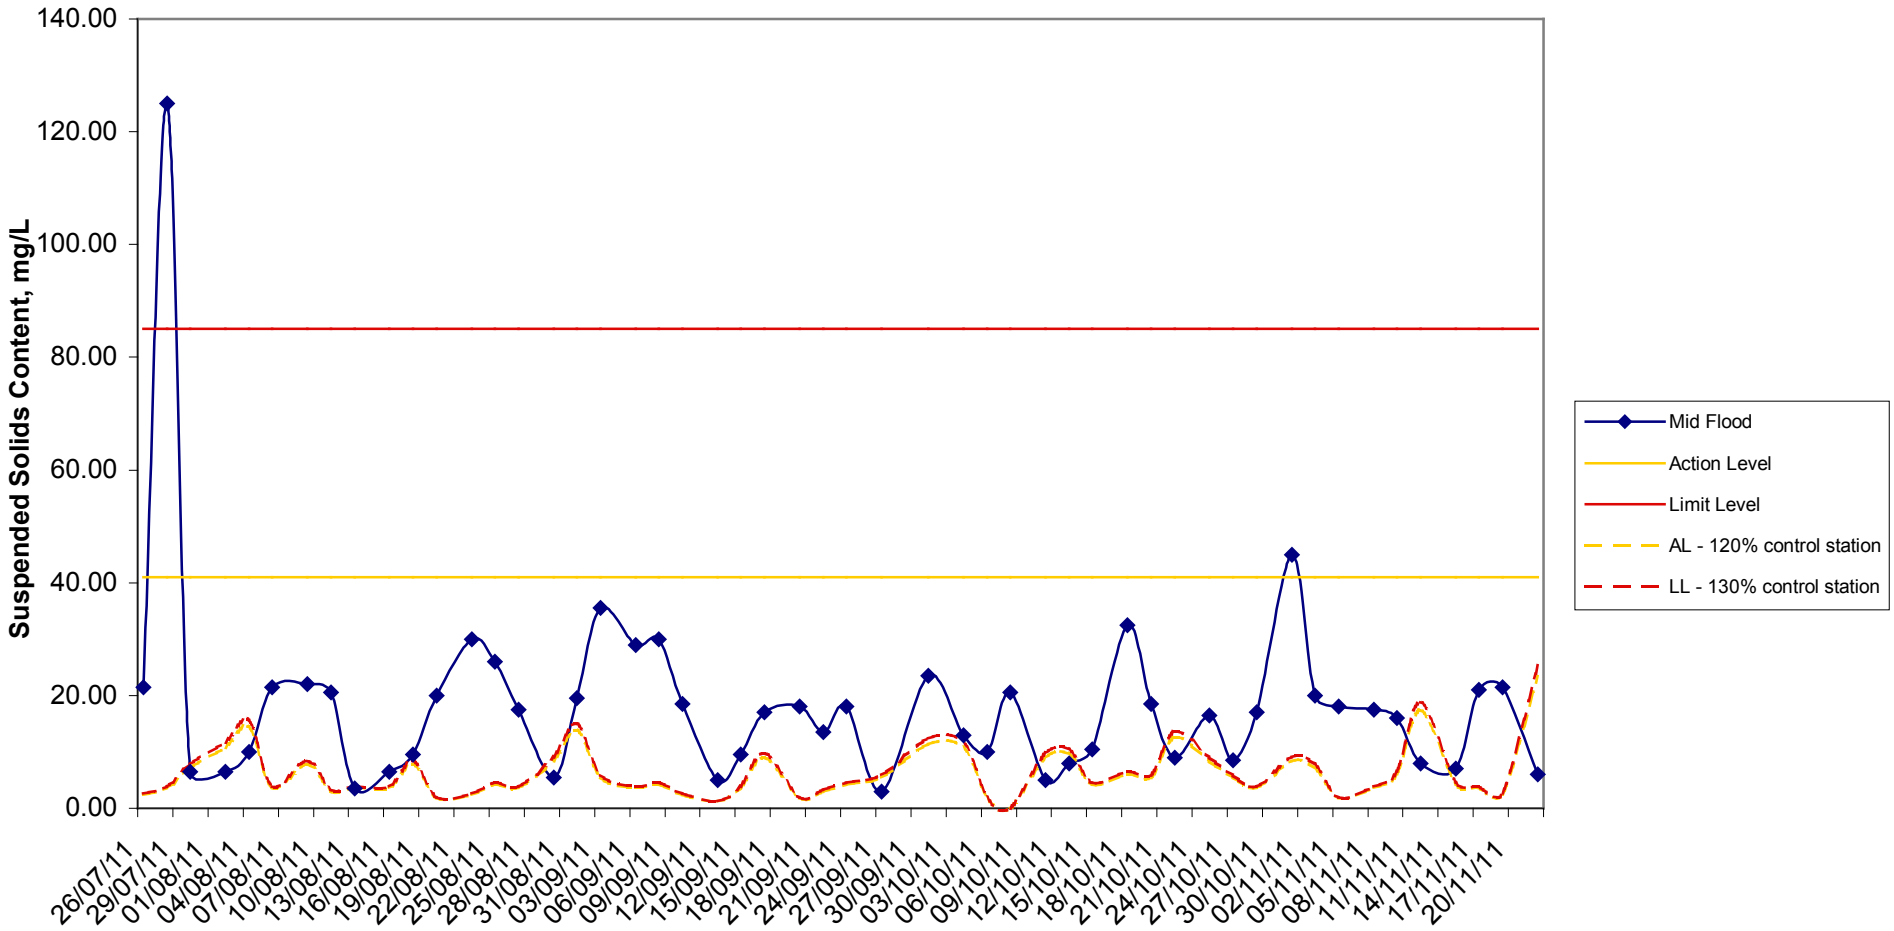
W1 - Suspended Solids Content (Mid-Flood)

1 event of exceedance of SS was recorded at mid-flood on 01 November at W1. The event was caused by tidal wave and the stirring up of riverbed sediment. Hence, the exceedance should not be related to the Project.
