Phase III Redevelopment of The Hong Kong Federation of Youth Groups Jockey Club Sai Kung Outdoor Training Camp

Environmental Monitoring and Audit Report for November 2012

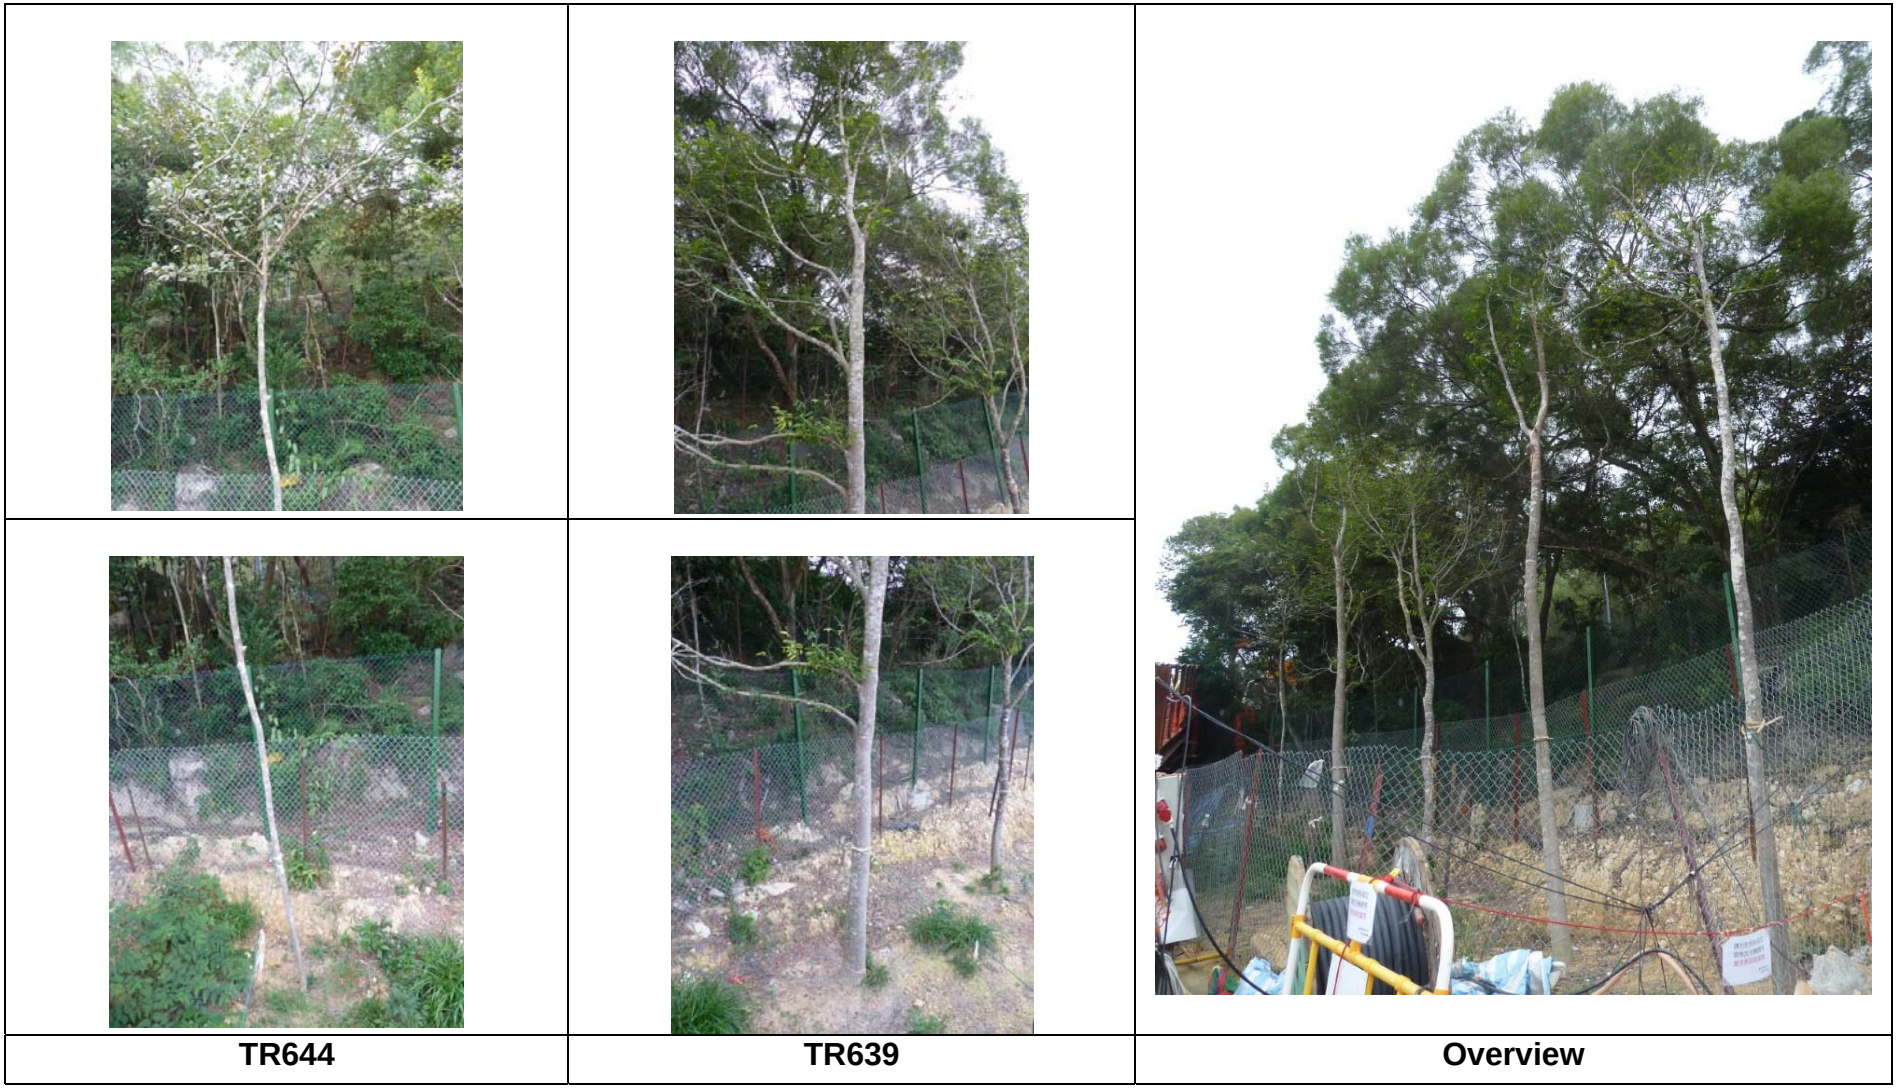
Figure 4.3 Photo Records of the Transplanted Trees, November 2012

11.1.1 Tree protection measures were implemented and some rectified. Transplantation of the Incense Trees was completed on March 2012. Monitoring results in November 2012 showed that the transplanted trees were in fair conditions. Monitoring will continue in February 2013 as scheduled.

TR643	**TR775**	**TR766**
