Contract No. EP/SP/66/12
Integrated Waste Management Facilities, Phase 1
Monthly EM&A Report No.50

Monthly EM&A Report No.50
(Period from 1 August to 31 August 2022)

(Clause 3.3, Further Environmental Permit FEP-01/429/2012/A)

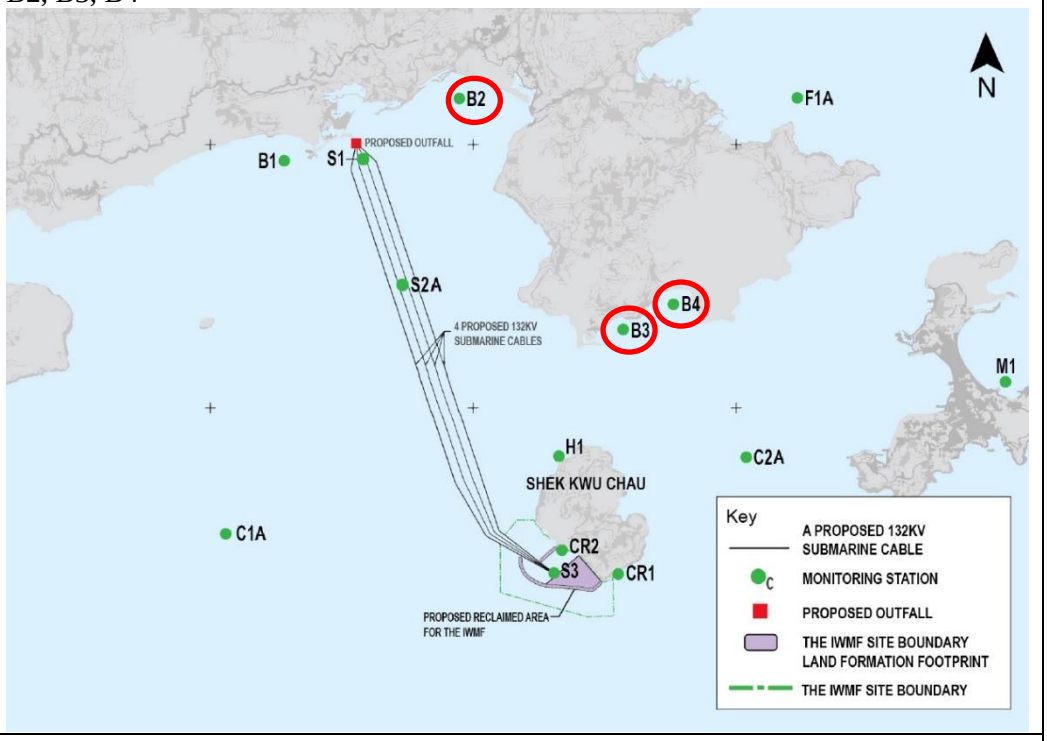
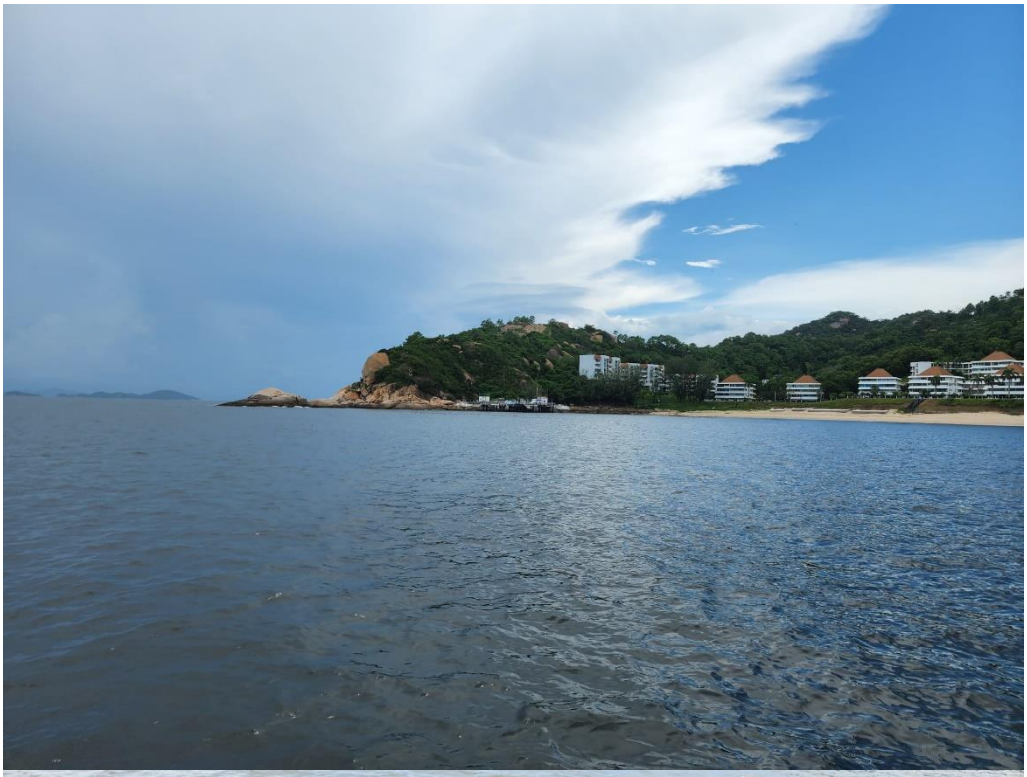
B3:

Project	Integrated Waste Management Facilities, Phase 1		
Date	08 August 2022 (Lab result received on 16 August 2022)		
Time	14:45 – 18:15 (Mid-Flood)		
Mid-Flood			
Monitoring Location	B2, B3, B4

Parameter	Suspended Solid (SS)		
Action & Limit Levels	Action Level	Limit Level	
	≥ 12.0 mg/L	≥ 14.0 mg/L	
Measurement Level	Impact Station(s) of Exceedance	Control Stations	Impact Station(s) without Exceedance

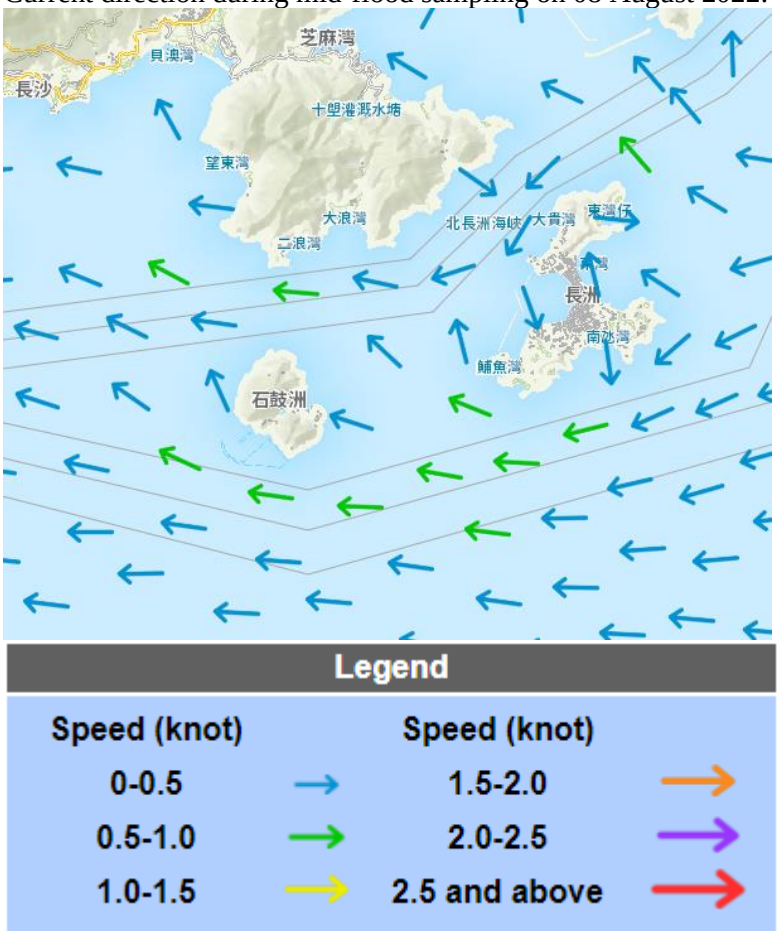
Remarks	Current direction during mid-flood sampling on 08 August 2022:

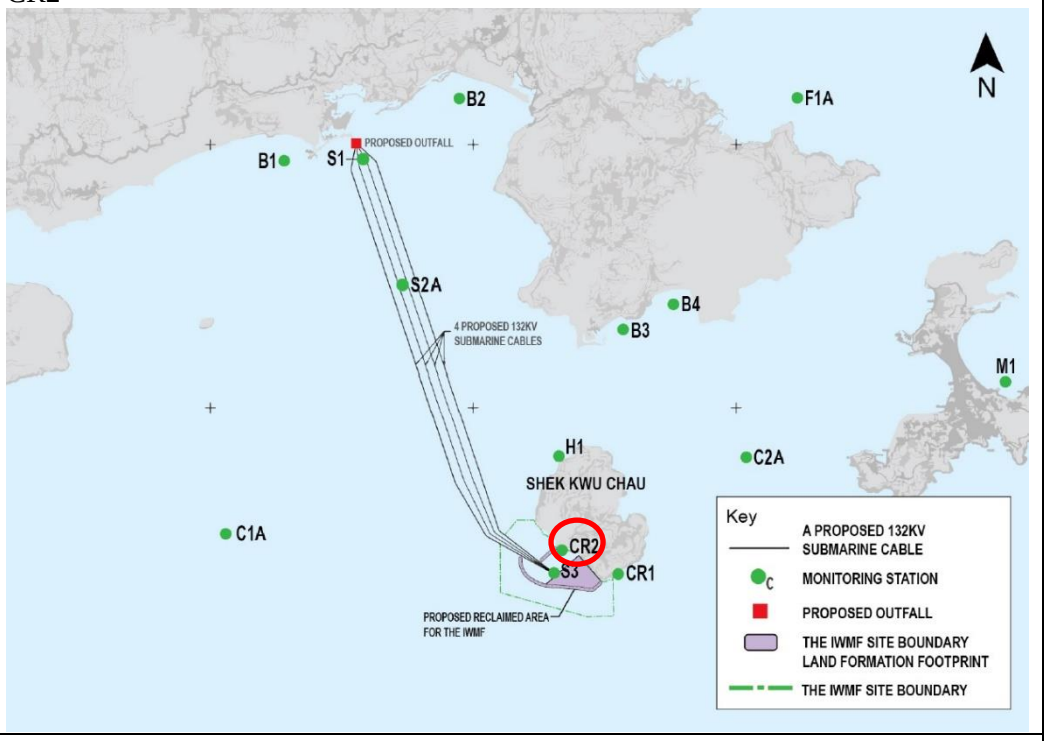
Project	Integrated Waste Management Facilities, Phase 1		
Date	16 August 2022 (Lab result received on 23 August 2022)		
Time	12:04 – 18:27 (Mid-Ebb)		
Mid-Ebb			
Monitoring Location	CR2

Parameter	Suspended Solid (SS)		
Action & Limit Levels	Action Level	Limit Level	
	≥ 12.0 mg/L	≥ 14.0 mg/L	
Measurement Level	Impact Station(s) of Exceedance	Control Stations	Impact Station(s) without Exceedance

17.8 mg/L (CR2)	4.3 mg/L (C1A) 5.4 mg/L (C2A)	4.8 mg/L (B1) 5.0 mg/L (B2) 5.0 mg/L (B3) 4.3 mg/L (B4) 8.8 mg/L (F1A) 4.5 mg/L (H1) 11.3 mg/L (M1) 9.0 mg/L (CR1)
Possible reason for Action or Limit Level Non-compliance	Works scheduled on site on 16 Aug 2022 include infilling of caisson, infilling of 1.85T armour at Caisson 57 - 60, infilling of G200 Rock fill at Caisson 62 - 63, installation of Stoppers at Breakwater A CH670 - CH720, installation of Stopper, landfilling works for below +6.00mPD, landfilling works for above +6.00mPD, installation of instrumentation, piling pre-drilling works, piling works, piling works for driven pile, piling works for pre-bored socketed H-pile, piling works for bored pile, pile cap construction, blockwork seawall and existing caisson extension. Dominant sea current direction was found to be from Northeast to Southwest at waters around Shek Kwu Chau. An exceedance of SS limit level was found at CR2.

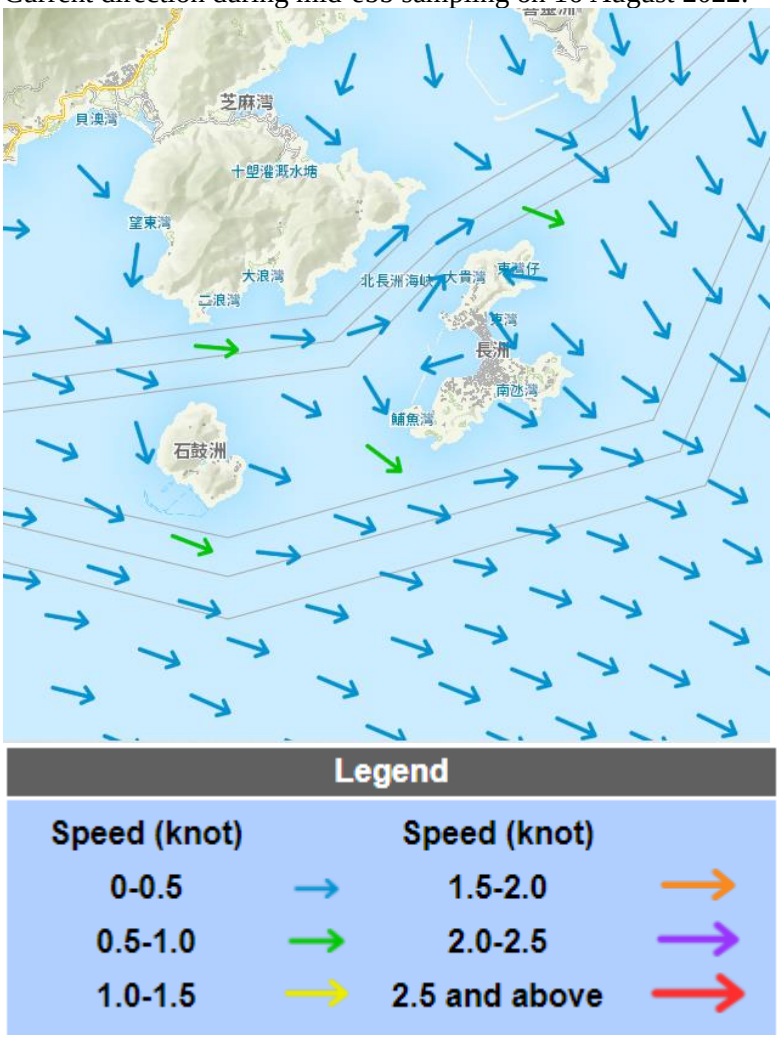
Remarks	Current direction during mid-ebb sampling on 16 August 2022:
