Contract No. EP/SP/66/12
Integrated Waste Management Facilities, Phase 1
Monthly EM&A Report No.51

Monthly EM&A Report No.51
(Period from 1 September to 30 September 2022)

(Clause 3.3, Further Environmental Permit FEP-01/429/2012/A)

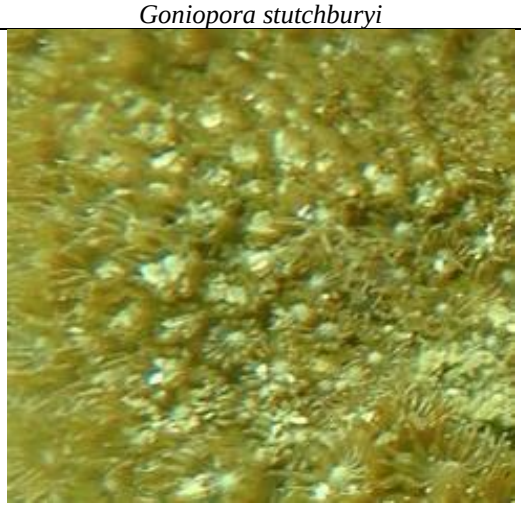
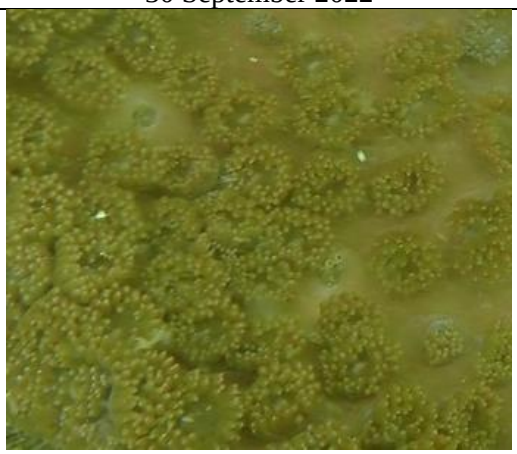
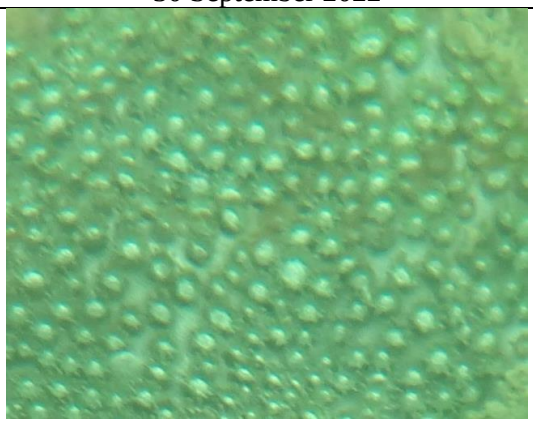
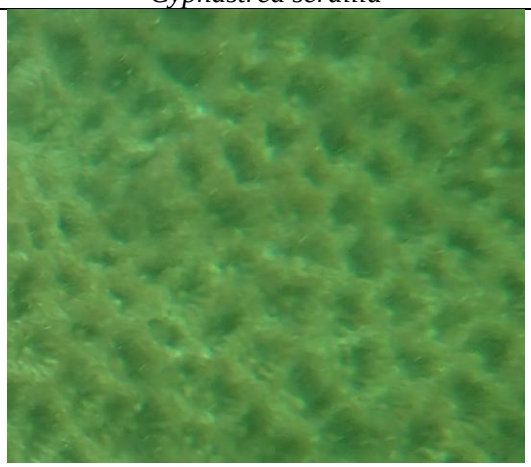
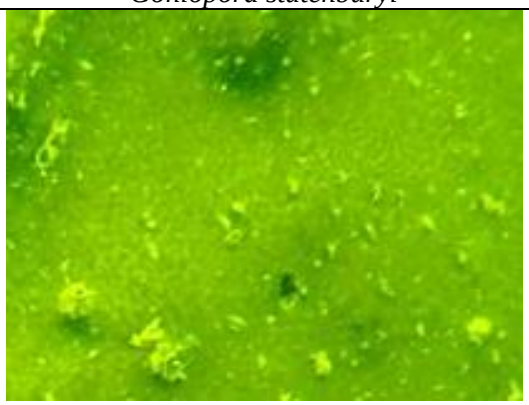
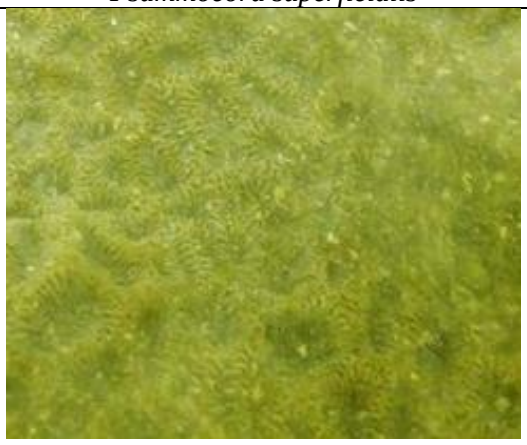
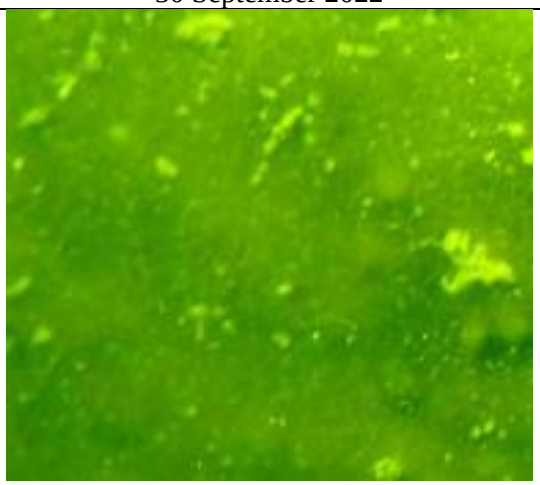
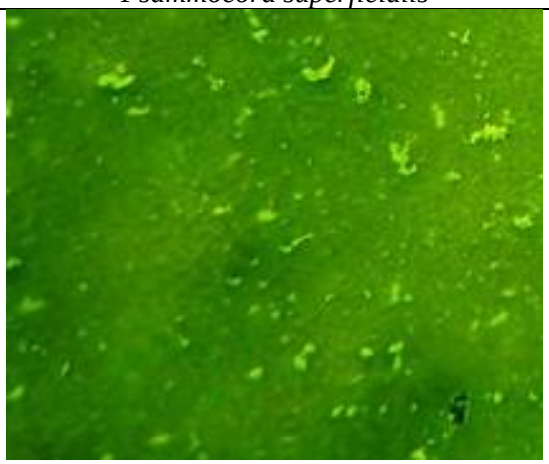
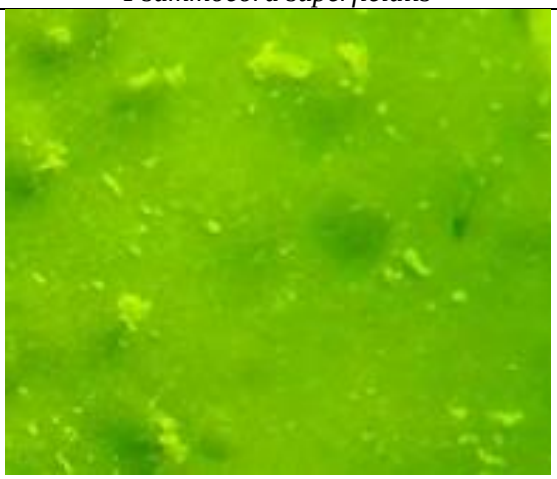
5.6.4 All tagged and re-tagged coral colonies showed good health condition during the 15th Quarterly Construction Phase Monitoring. There was no increased level of mortality, bleaching and sediment when compared with the baseline results.
