Contract No. EP/SP/66/12
Integrated Waste Management Facilities, Phase 1
Monthly EM&A Report No.12

Monthly EM&A Report No.12
(Period from 1 June to 30 June 2019)

(Clause 3.3, Further Environmental Permit FEP-01/429/2012/A)

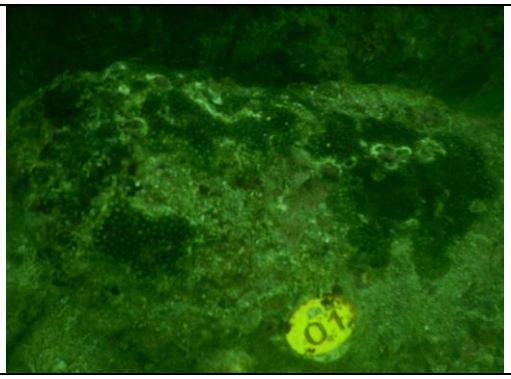
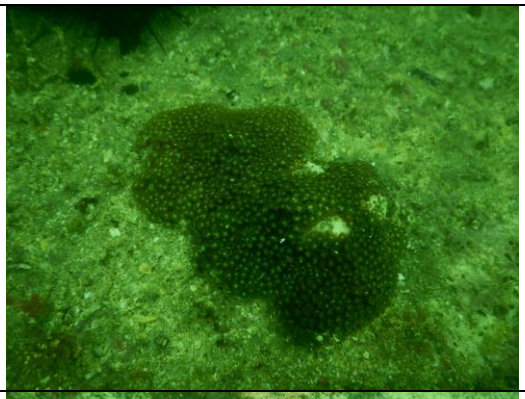
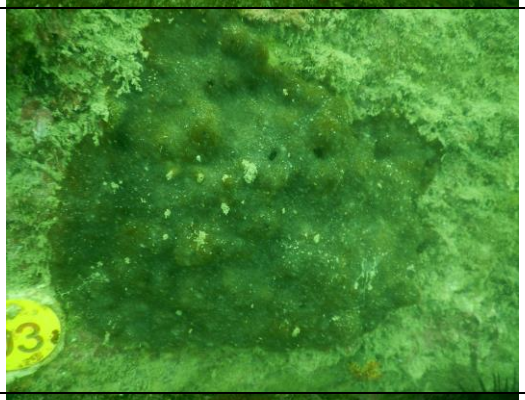
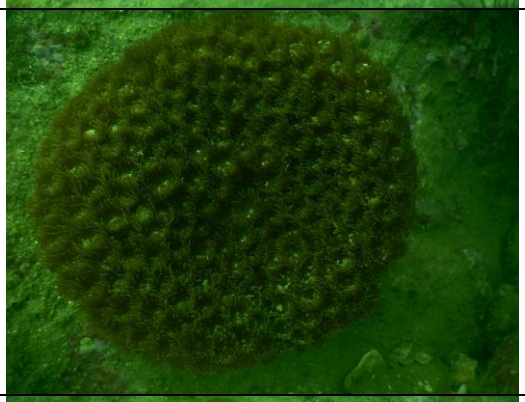
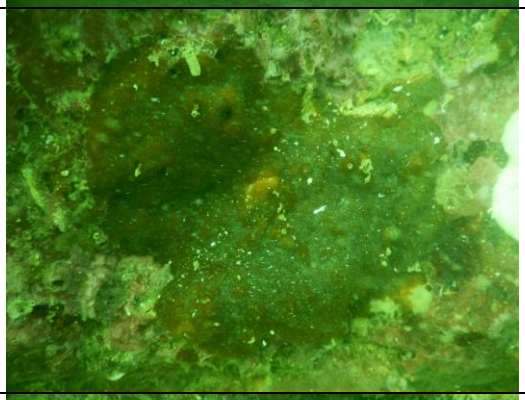
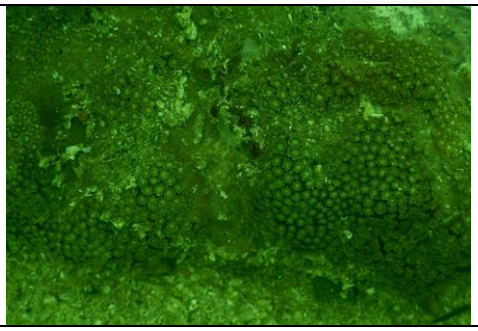
Photo Plate 5.1 Ten (10) Monitored Corals at Control Site

5.6.4 All tagged and re-tagged coral colonies showed good health condition during the 2nd Quarterly Construction Phase Monitoring. There was no increased level of mortality, bleaching and sediment when compared with the baseline results.
