South East New Territories (SENT) Landfill Extension

Monthly Environmental Monitoring & Audit Report No.5 for May 2019

August 2019

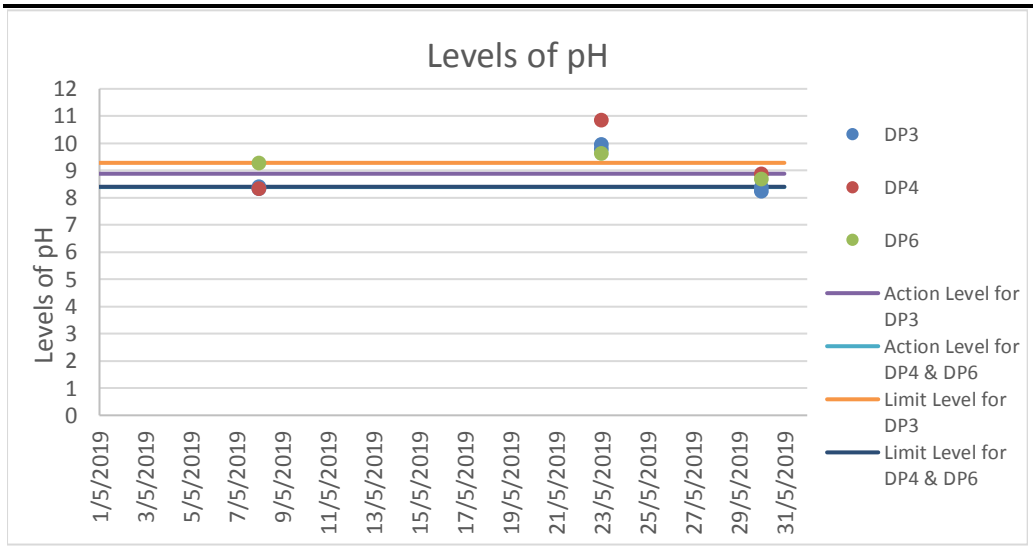
Figure F2.2 Graphical Presentation for Surface Water Quality Monitoring (pH)

6 Limit Level of pH exceedances and 6 Limit Level of Suspended Solids (SS) exceedances were recorded for surface water quality impact monitoring in the reporting period. The pH and SS exceedances at DP6 on 8 May 2019, pH and SS exceedances at DP3, pH exceedance at DP6 on 23 May 2019 and pH and SS exceedances at DP4 (Future, temporary) and DP6 on 30 May 2019 were considered not Project-related upon further investigation. The pH and SS exceedances at DP4 (Future, temporary) and SS exceedance at DP6 on 23 May 2019 were found deemed to Project-related activities.

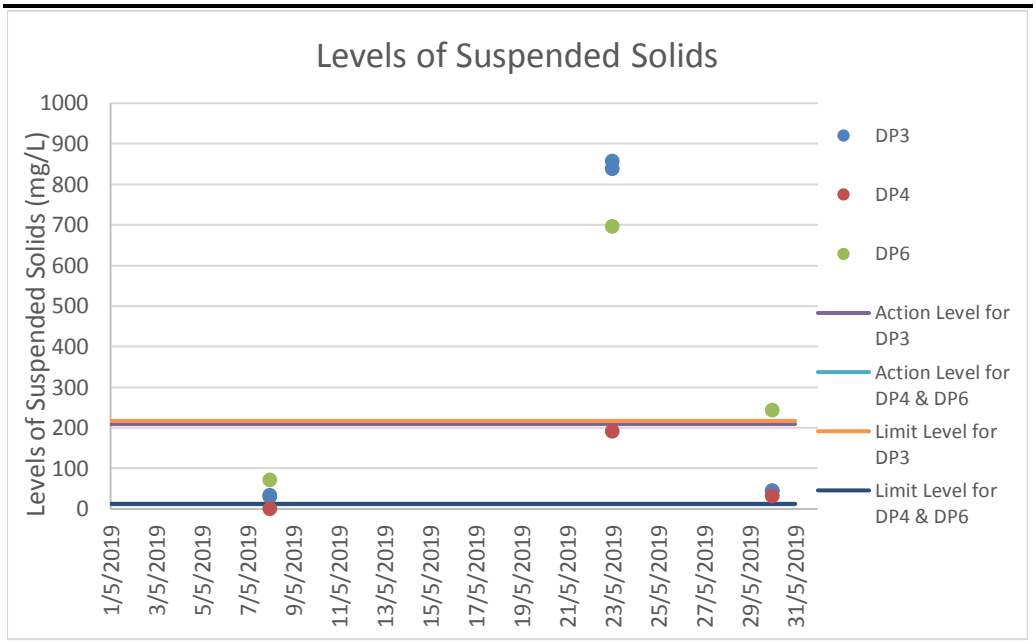
Figure F2.3 Graphical Presentation for Surface Water Quality Monitoring (SS)

Based on the investigation conducted for each of the monitoring event with potential Action and Limit Levels exceedances with the Contractor, and the IEC, the pH and SS exceedances at DP6 on 8 May 2019, pH and SS exceedances at DP3, pH exceedance at DP6 on 23 May 2019 and pH and SS exceedances at DP4 (Future, temporary) and DP6 on 30 May 2019 were considered not Project-related. However, upon further investigation, the pH and SS exceedances at DP4 (Future, temporary) and SS exceedance at DP6 on 23 May 2019 were found deemed to Project-related activities. The Contractor was reminded to implement all relevant mitigation measures for the construction works and maintain good site practice. The ET will keep track on the monitoring data and ensure Contractor's compliance of the environmental requirements.
