South East New Territories (SENT) Landfill Extension

Monthly Environmental Monitoring & Audit Report No.19 for July 2020

December 2020

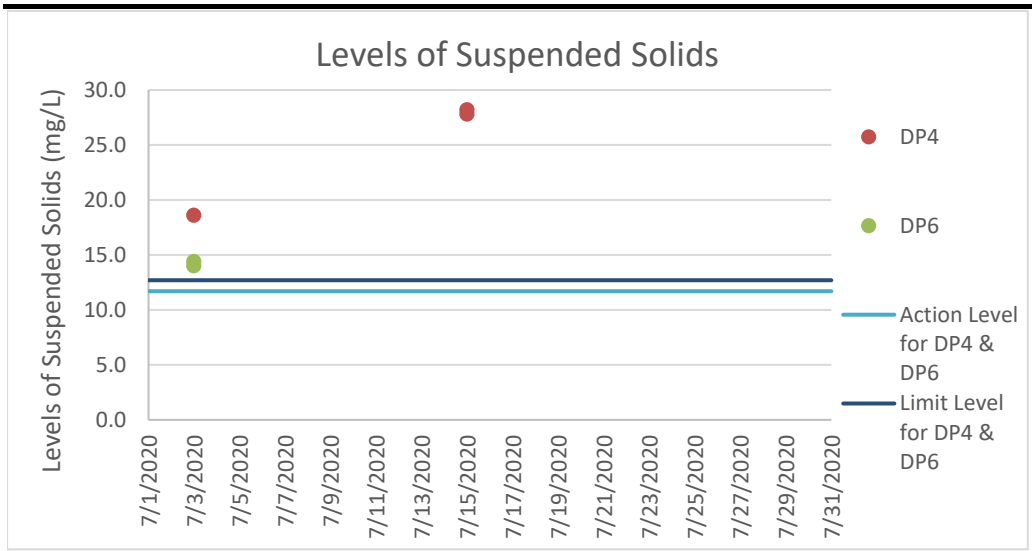
Figure F2.3 Graphical Presentation for Surface Water Quality Monitoring (SS)

Three exceedances of the Limit Level for suspended solids (SS) were recorded for surface water quality impact monitoring in the reporting period. The SS exceedances at DP4 (Future, temporary) and DP6 on 3 July 2020 were considered non Project-related upon further investigation. The SS exceedance at DP4 (Future, temporary) on 15 July 2020 was found deemed to Project-related activities.

Based on the investigation conducted for the monitoring event with potential Action and Limit Levels exceedances with the Contractor, and the IEC, the SS exceedances at DP4 (Future, temporary) and DP6 on 3 July 2020 were considered non Project-related upon further investigation. The SS exceedance at DP4 (Future, temporary) on 15 July 2020 was found deemed to Project-related activities. The Contractor was reminded to implement all relevant mitigation measures for the construction works and maintain good site practice. The ET will keep track on the monitoring data and ensure Contractor's compliance of the environmental requirements.
