South East New Territories (SENT) Landfill Extension

Quarterly Environmental Monitoring & Audit Report No.9

May 2021

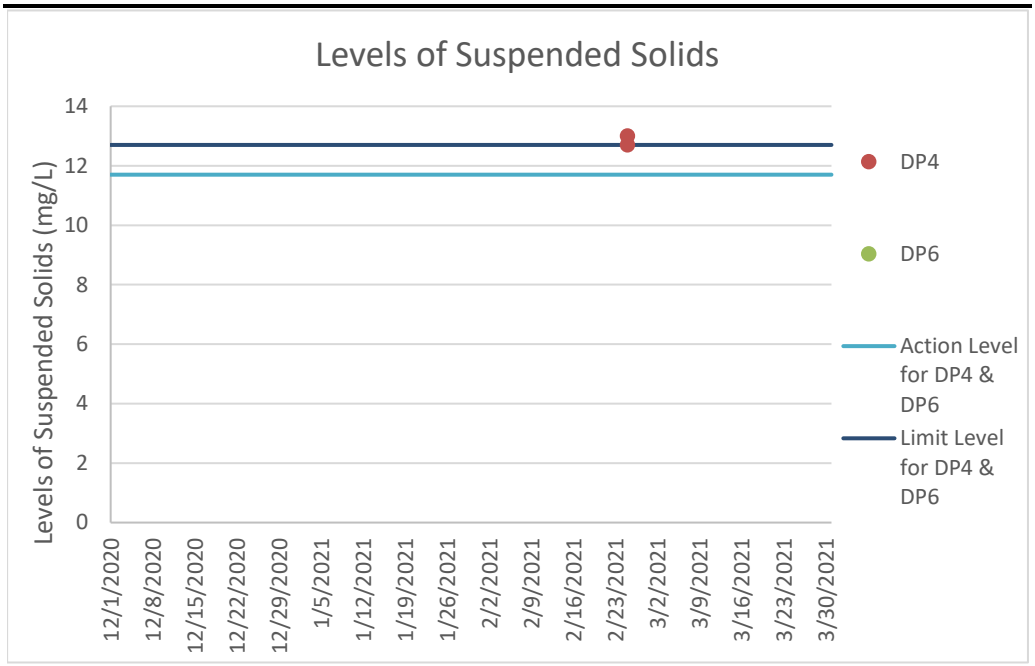
Figure F1.3 Graphical Presentation for Surface Water Quality Monitoring (SS)

Based on the investigation conducted for the monitoring event with potential Action and Limit Levels exceedance with the Contractor, and the IEC, the SS exceedance at DP4 (Future, temporary) on 25 February 2021 was found deemed to Project-related activities.
