Agreement No. CE 5/2019 (EP)
Independent Environmental Checker for First Stage of
Tseung Kwan O Desalination Plant – Investigation
Verification of Monthly EM&A Report No.13 (March 2021)

Design, Build and Operate First Stage of Tseung Kwan O Desalination Plant

Monthly EM&A Report No.13
(Period from 1 March to 31 March 2021)

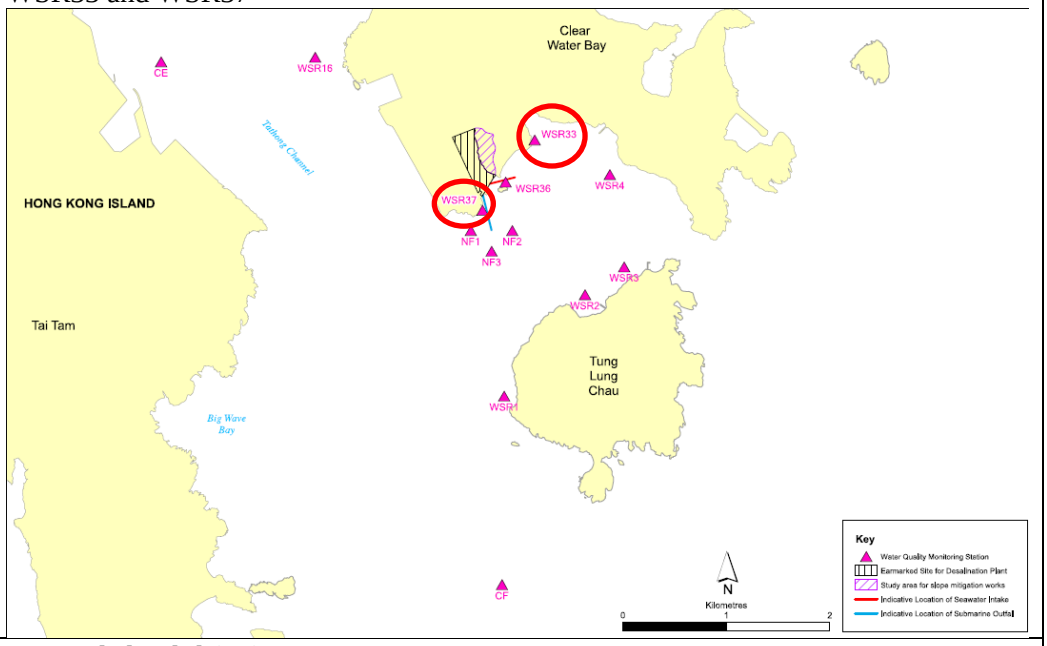
5.7 mg/L (WSR 33) 6.3 mg/L (WSR 37)	4.7 mg/L (CE)	3.6 mg/L (WSR1) 3.4 mg/L (WSR2) 3.6 mg/L (WSR3) 3.9 mg/L (WSR4) 5.0 mg/L (WSR16) 5.3 mg/L (WSR36)
Possible reason for Action or Limit Level Non-compliance	Marine construction activities, namely 1) Setting up silt curtains (~ 20m) by lighter and divers; 2) welding on temporary steel platform; and 3) setting up of vibratory hammer on barge, were conducted on-site at the Intake Shaft area (near to work station WSR36) on 25 Mar 2021. The conducted marine construction activities were noted to be with preparation nature, mostly without contact with the water and would not contribute to SS generation. No marine construction activity was conducted at the Outfall Shaft area (near to work station WSR37). Marine construction activities with contact with water: 1) Setting up silt curtains by lighter and divers. Marine vessels on 25th March 2021 • Derrick lighter x 2 • Flat-top barge x 1 • Passenger boat x 2 Dominating sea current direction was found to be from Northwest to Southeast at waters to the west side of Tit Cham Chau; and from West to East at waters to the east side of Tit Cham Chau.

<table><tr><td></td><td colspan="3">Work stations WSR33 and WSR37 are located at downstream and upstream direction during ebb tide respectively. The SS value at station WSR36 (5.3 mg/L), which is the closest station to the area with marine construction activities, was lower than that of WSR33 (5.7 mg/L) and WSR37 (6.3 mg/L) at the same tide. Considering the SS value at station WSR36 has not exceeded the action and limit level, there is no direct evidence indicating that the SS exceedance of WSR33 and WSR37 were related to the marine construction activities near the Intake Shaft area.
According to the field observation by sampling team during sampling event, no silt plume was observed in the Project site.
Conditions of the protective silt curtain at the inland water outfall was satisfactory on 25 Mar 2021.</td></tr></table>

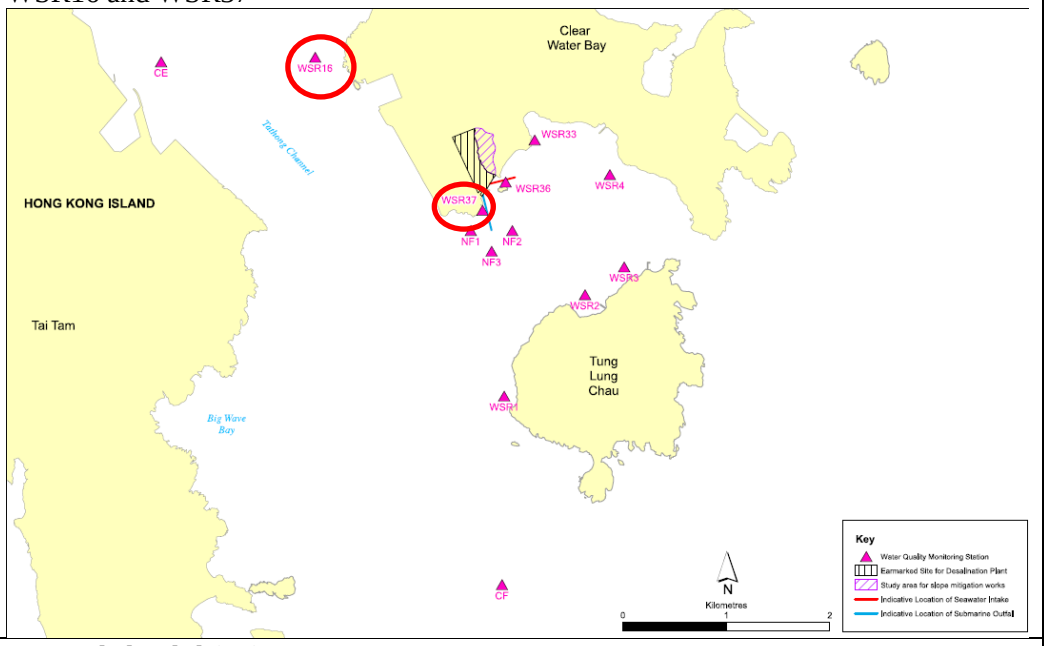
5.5 mg/L (WSR 16) 5.8 mg/L (WSR 37)	3.0 mg/L (CF)	3.0 mg/L (WSR1) 2.8 mg/L (WSR2) 3.4 mg/L (WSR3) 4.1 mg/L (WSR4) 4.8 mg/L (WSR33) 4.2 mg/L (WSR36)
Possible reason for Action or Limit Level Non-compliance	Marine construction activities, namely 1) Setting up silt curtains by divers (~20m); 2) materials loading/ unloading; and 3) welding on temp. steel platform, were conducted on-site at the Intake Shaft area (near to work station WSR36) on 25 Mar 2021. The conducted marine construction activities were noted to be with preparation nature, mostly without contact with the water and would not contribute to SS generation. No marine construction activity was conducted at the Outfall Shaft area (near to work station WSR37). Marine construction activities with contact with water: 1) Setting up silt curtains by divers Marine vessels on 27th March 2021 • Derrick lighter x 2 • Flat-top barge x 1 • Passenger boat x 2 Dominating sea current direction was found to be from Southeast to Northwest at waters to the west side of Tit Cham Chau; and from Northeast to Southwest at waters to the east side of Tit Cham Chau.

Work stations WSR16 and WSR 37 are located at downstream direction during flood tide. The SS value at station WSR36 (4.2 mg/L), which is the closest station to the area with marine construction activities, was lower than that of WSR16 (5.5 mg/L) and WSR37 (5.8 mg/L). Considering the SS value at station WSR36 has not exceeded the action and limit level, there is no direct evidence indicating that the SS exceedance of WSR16 and WSR37 were related to the Project activities near the Intake Shaft area. Comparing SS values during flood tide on 27/03/2021 with the identified activities on 30/03/2021 - 1) Setting up silt curtains by diver; 2) welding of pipe piles; 3) pipe piling by vibratory hammer, which may contribute to increase SS value, the SS values at WSR16 (2.5 mg/L), WSR37 (2.6 mg/L) and WSR36 (2.5 mg/L) were noticeably lower than that of 27/03/2021. Hence, the SS exceedance on 27/03/2021 may be suggested to be caused by factors other than marine construction activities of the Project. According to the field observation by sampling team during sampling event, no silt plume was observed in the Project site. Conditions of the protective silt curtain at the inland water outfall was satisfactory on 27 Mar 2021.
