Proposed Extension of Public Golf Course at Kau Sai Chau Island, Sai Kung

Monthly Environmental Monitoring & Audit (EM&A) Report for May 2007

(Report No. 382210/017)

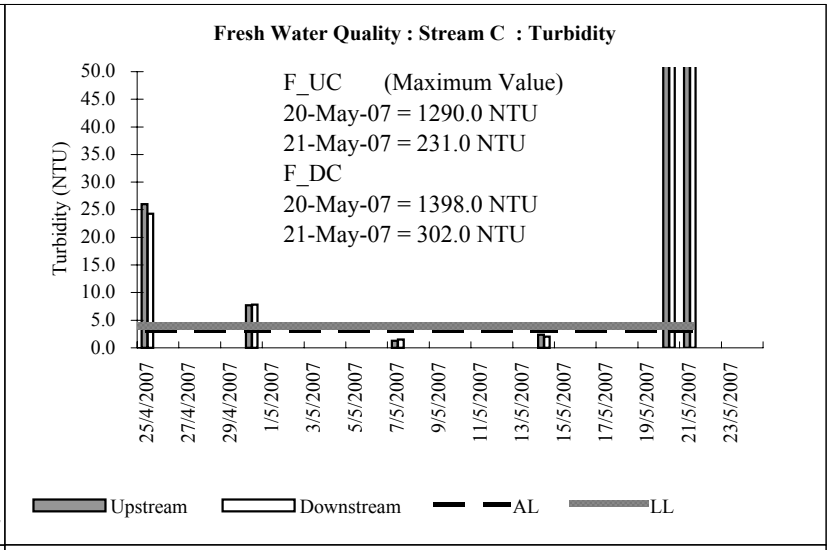
Rainstorm events occurred on 19 and 20 May 2007 with rainfall was ranging from 70-100 mm. An *ad hoc* site audit was carried out and heavy silty runoff was observed at all streams, fresh water inland marsh and marine water. Additional water sampling due to the heavy rainstorm was carried out on 20 May 2007 which indicated that high limit level exceedances on suspended solids (ranged from 631 mg/L to 3,970 mg/L) and turbidity (ranged from 704 NTU to 3,870 NTU) at fresh water monitoring stations. Low concentrations of suspended solids and turbidity were recorded at fresh water control station at 45 mg/L and 41 NTU respectively. For marine monitoring stations, high concentrations of suspended solids were also recorded at outlet of fresh water inland marsh (23.2 mg/L) and temporary barging point (24.7 mg/L) while the suspended solids concentrations at control monitoring station (M_A) was 2.5 mg/L only.

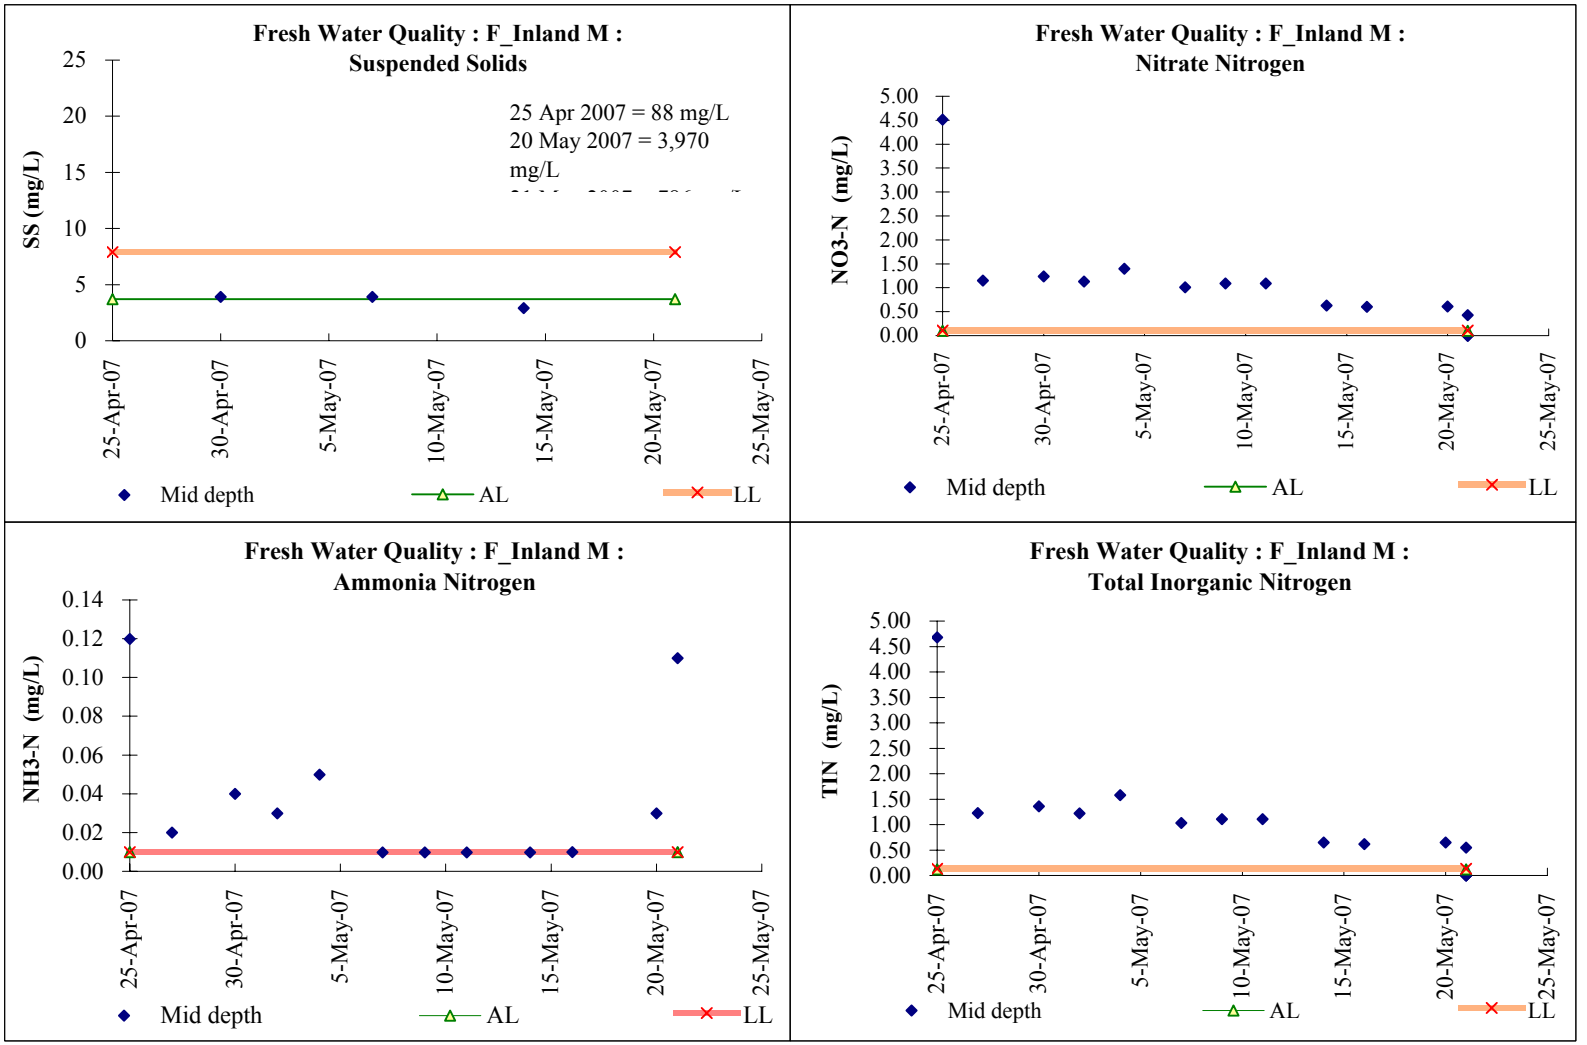
Long-term nutrient exceedances are recorded at the downstream of fresh water inland marsh since February 2007. Due to the poor water quality recorded on 16 April 2007 from the direct discharge of the Contractor's (CHEC) temporary sewage treatment plant, an additional sampling was taken on 12 May 2007 due to the overflow incident of the sewage discharge from the temporary storage tank which was installed on 5 May 2007 in order to prevent contamination of the fresh water inland marsh as the interim mitigation measure until CHEC repair and resume the sewage treatment plant.

No water was discharged from the sewage treatment plant since early May 2007. The ammonia nitrogen, nitrate nitrogen and total inorganic nitrogen was gently decreased during this reporting month. The water quality monitoring data during this reporting month confirmed that the cause of the nutrient exceedances at the downstream of fresh water inland marsh was due to the poor performance of the CHEC's temporary sewage treatment plant and not turf-related activities.
