Drainage Service Department

Monthly Environmental Monitoring & Auditing report for

Contract No.DC/2006/11
Drainage Improvement in Southern Lantau

March 2009

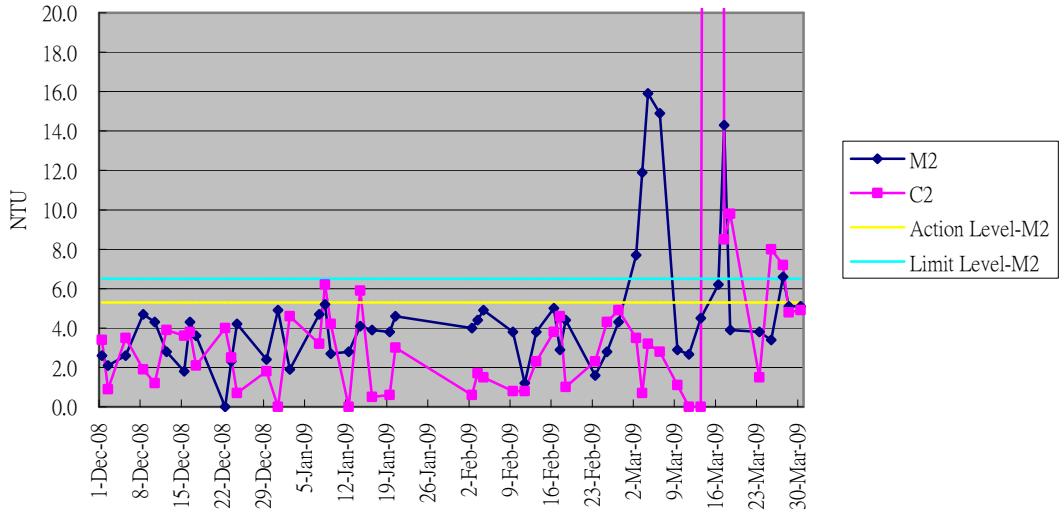
Graphical Plot of Turbidity Trend M2&C2 (Dec 08-Mar 09)

Remarks: The reading of C2 on Mar 16th 2009 is 329.6, which was over the range of the plot.

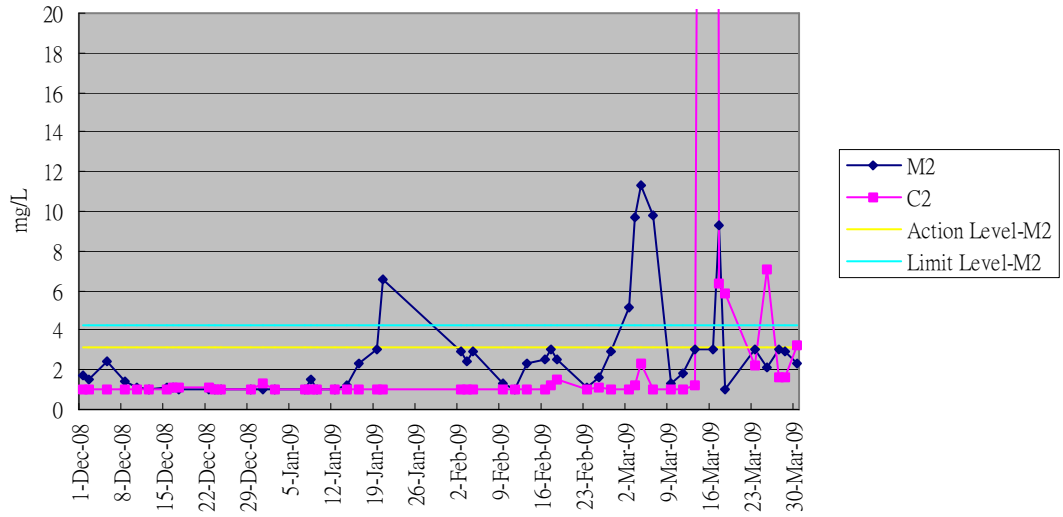
Graphical Plot of Suspended Soild M2&C2 (Dec 08 - Mar 09)

Remarks: The reading of C2 on Mar 16th 2009 is 215.4, which was over the range of the plot.
