Drainage Service Department

Monthly Environmental Monitoring & Auditing report for

Contract No.DC/2006/11
Drainage Improvement in Southern Lantau

April 2009

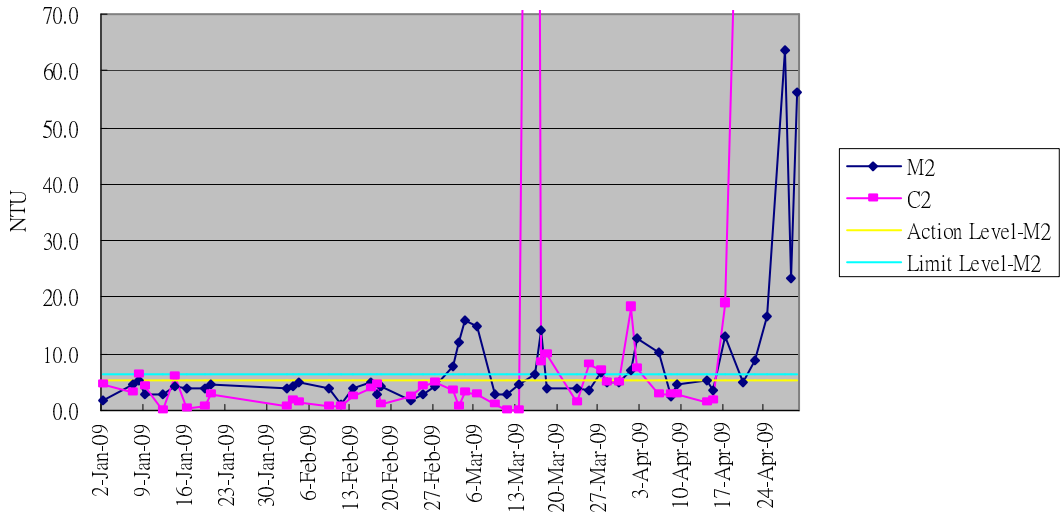
Graphical Plot of Turbidity Trend M2&C2 (Jan- Apr 09)

Remarks: The reading of C2 on 27th, 28th and 29th April 2009 is 732.1, 360.5, and 186.7, which was over the range of the plot.

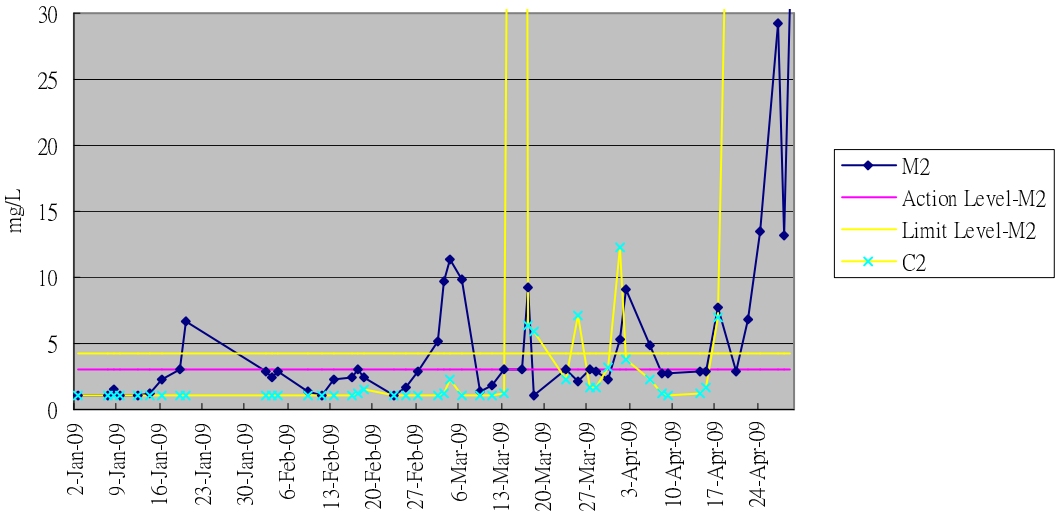
Graphical Plot of Suspended Soild M2&C2 (Jan-Apr 08)

Remarks: The reading of M2 on 30th April 2009 is 30.6 and C2 on 27th April 2009 is 490.5, which was over the range of the plot.
