CONTRACT NO: KL/2009/01

SITE FORMATION FOR KAI TAK CRUISE TERMINAL DEVELOPMENT

ENVIRONMENTAL MONITORING & AUDIT MONTHLY REPORT

- MAY 2011 -

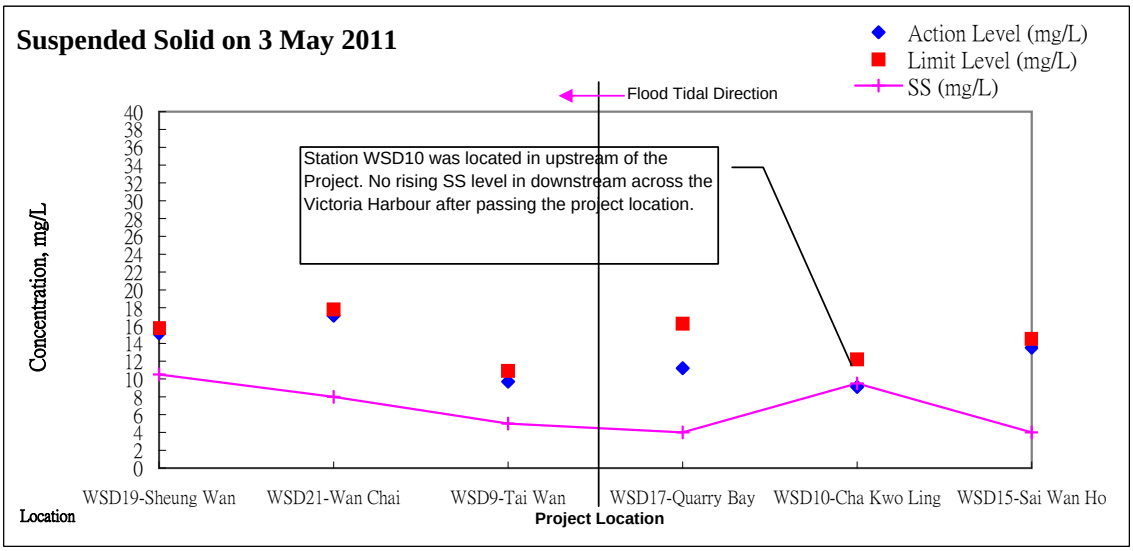
Suspended Solid on 3 May 2011
Action Level (mg/L)
Limit Level (mg/L)
SS (mg/L)
Flood Tidal Direction
Station WSD10 was located in upstream of the Project. No rising SS level in downstream across the Victoria Harbour after passing the project location.
Concentration, mg/L
WSD19-Sheung Wan
WSD21-Wan Chai
WSD9-Tai Wan
WSD17-Quarry Bay
WSD10-Cha Kwo Ling
WSD15-Sai Wan Ho
Location
Project Location

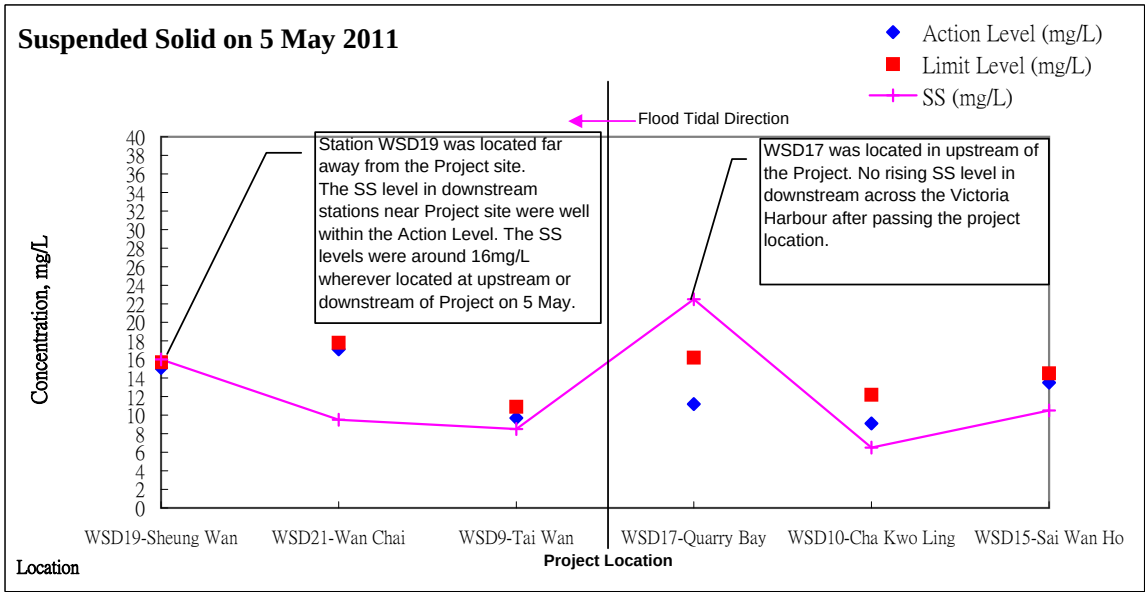
Suspended Solid on 5 May 2011
Action Level (mg/L)
Limit Level (mg/L)
SS (mg/L)
Flood Tidal Direction
Station WSD19 was located far away from the Project site. The SS level in downstream stations near Project site were well within the Action Level. The SS levels were around 16mg/L wherever located at upstream or downstream of Project on 5 May.
WSD17 was located in upstream of the Project. No rising SS level in downstream across the Victoria Harbour after passing the project location.
Concentration, mg/L
WSD19-Sheung Wan
WSD21-Wan Chai
WSD9-Tai Wan
WSD17-Quarry Bay
WSD10-Cha Kwo Ling
WSD15-Sai Wan Ho
Location
Project Location

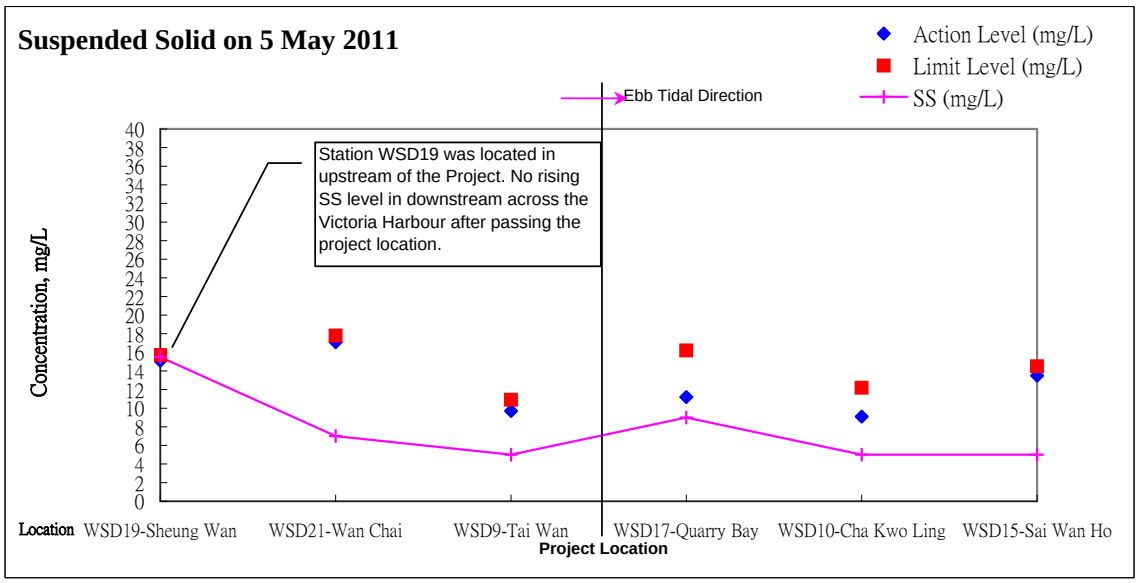
Suspended Solid on 5 May 2011
Action Level (mg/L)
Limit Level (mg/L)
SS (mg/L)
Ebb Tidal Direction
Station WSD19 was located in upstream of the Project. No rising SS level in downstream across the Victoria Harbour after passing the project location.
Concentration, mg/L
Location
WSD19-Sheung Wan
WSD21-Wan Chai
WSD9-Tai Wan
WSD17-Quarry Bay
WSD10-Cha Kwo Ling
WSD15-Sai Wan Ho
Project Location

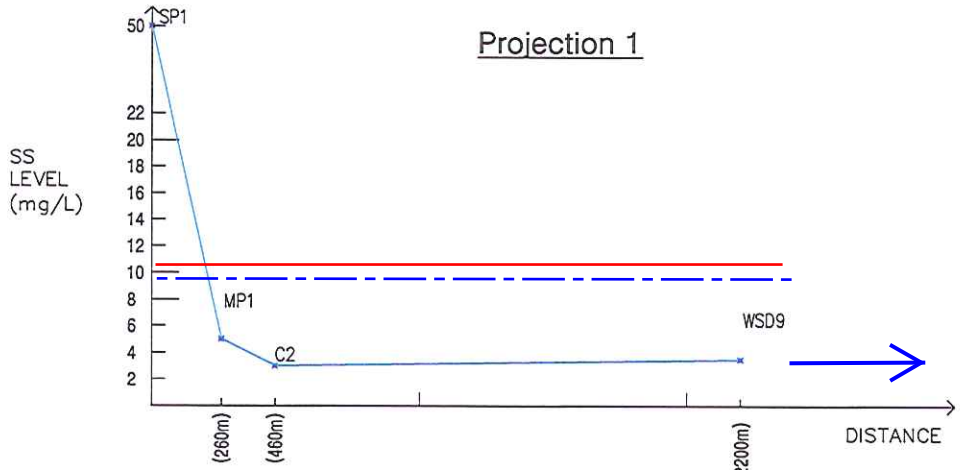
Projection 1

Description: WSD9 was located at downstream which had a SS level below SP1 and MP1. The SS value was similar to Control Point - C2 and well within the Action Level.

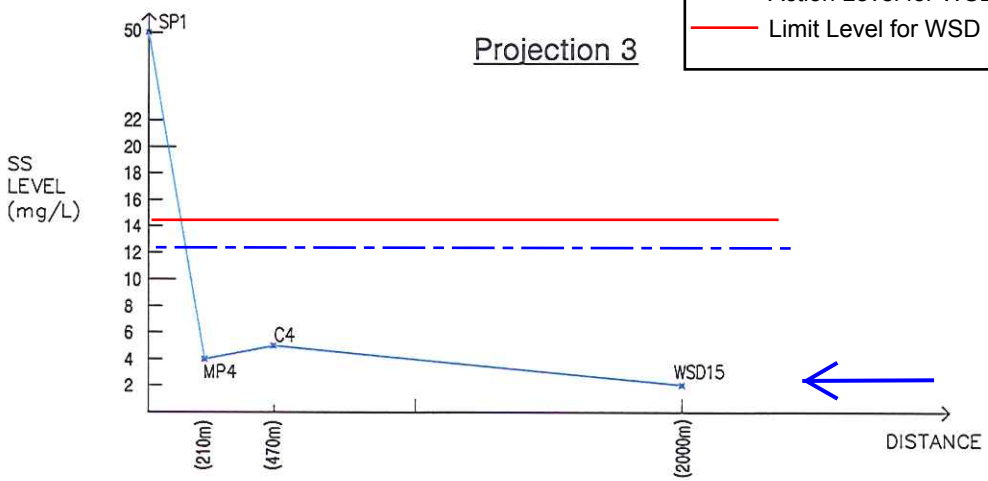
Projection 3

Description: WSD15 was located at upstream which was well within the Action Level.

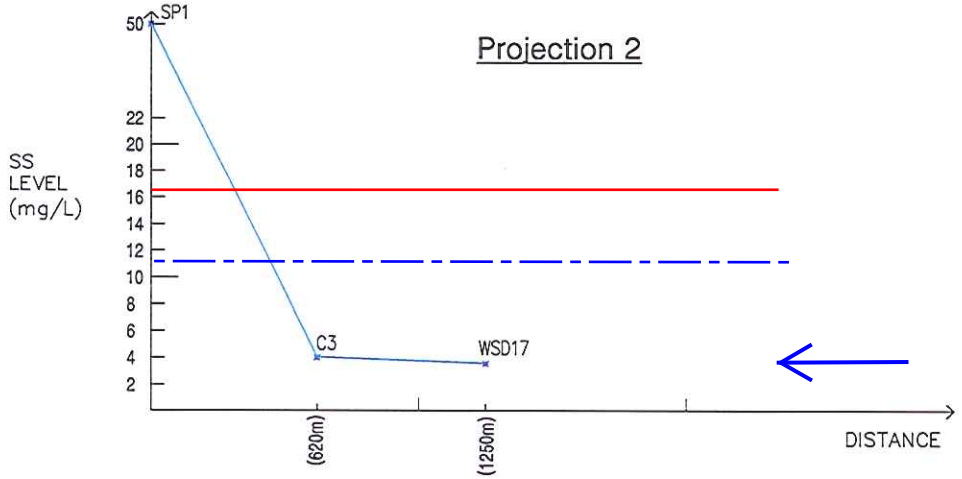
Projection 2

Description: WSD17 was located at upstream which was well within the Action Level.

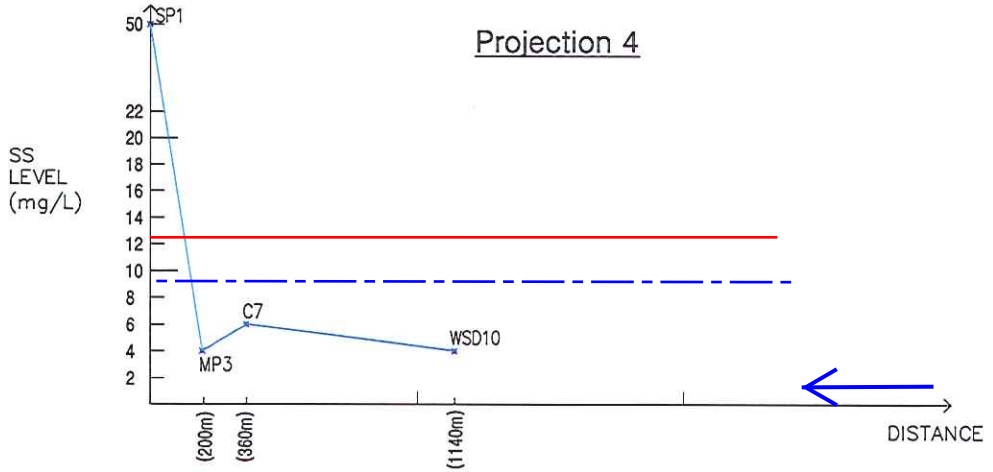
Projection 4

Description: WSD10 was located at upstream which was well within the Action Level.

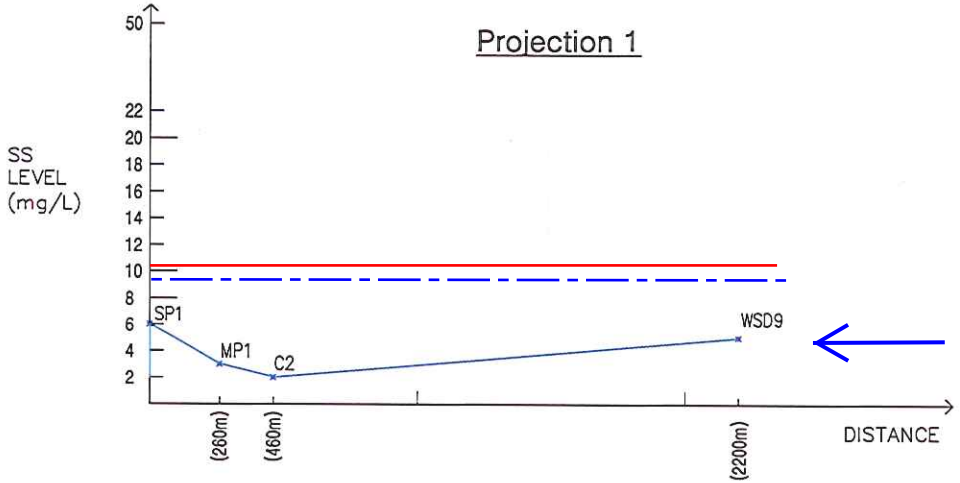
Projection 1

Description: WSD9 was located at upstream which was well within the Action Level.

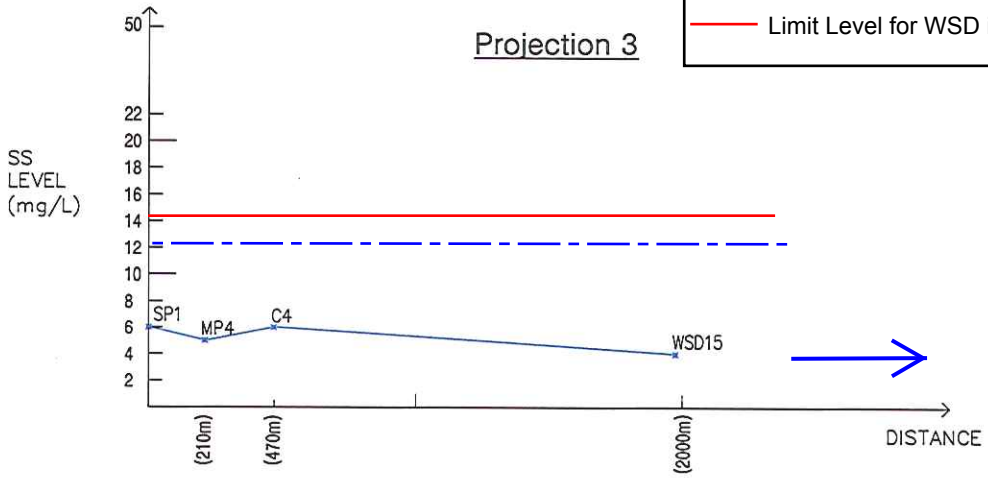
Projection 3

Description: WSD15 was located at downstream which had a SS level below SP1 and MP4. The SS value was similar to Control Point - C4 and well within the Action Level.

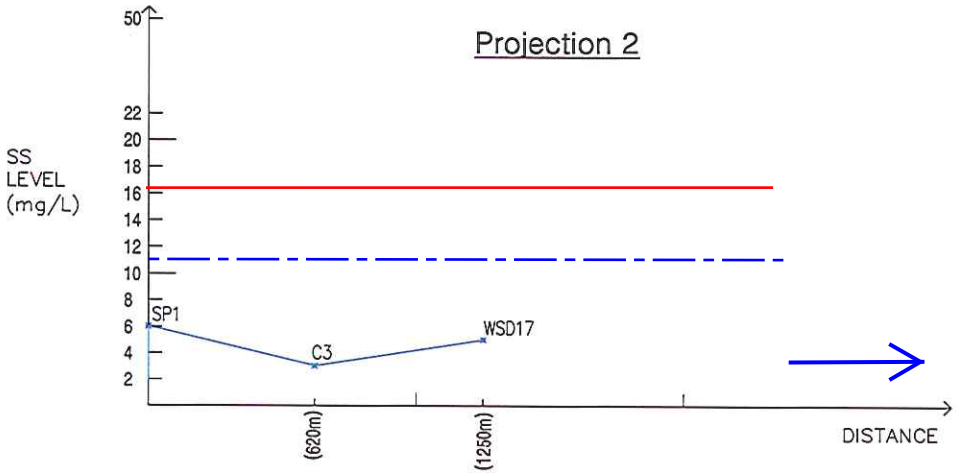
Projection 2

Description: WSD17 was located at downstream which had a SS level higher than the SP1 and control point. It can concluded there is existing variation in the vicinity of

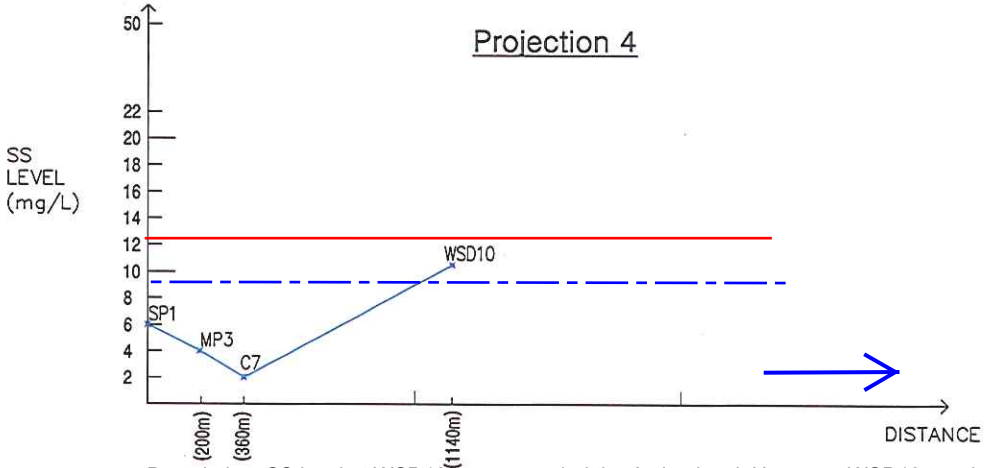
Projection 4

Description: SS level at WSD10 was exceeded the Action level. However, WSD10 was located at downstream which had a SS level higher than the MP3, control point and even SP1. It can concluded there was definitely existing variation in the vicinity of WSD10.
