CONTRACT NO: KL/2009/01

SITE FORMATION FOR KAI TAK CRUISE TERMINAL DEVELOPMENT

ENVIRONMENTAL MONITORING & AUDIT MONTHLY REPORT

- MARCH 2012 -

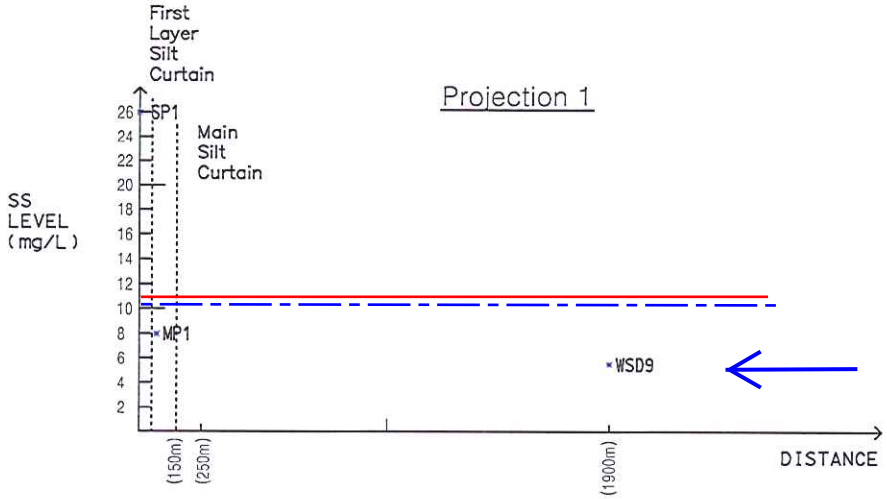
Description: WSD9 was located at upstream which was well within the Action Level.

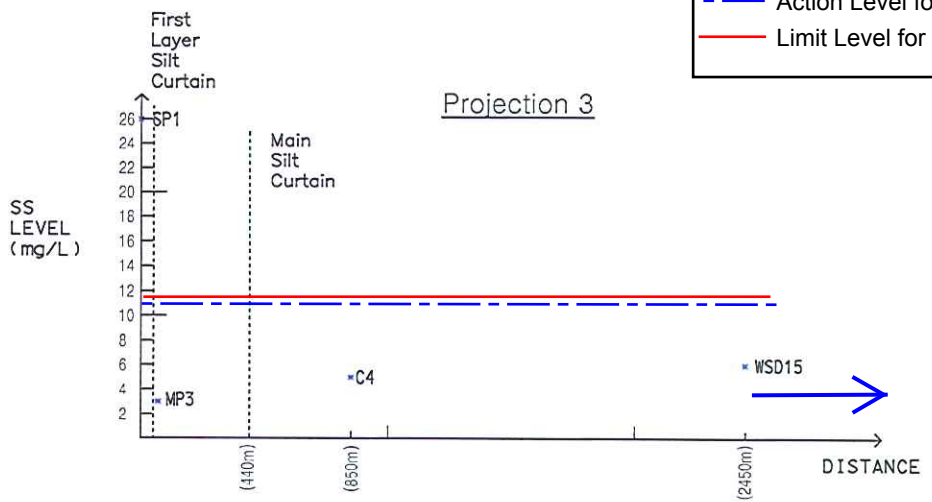
Description: WSD15 was located at downstream which was well within the Action Level.

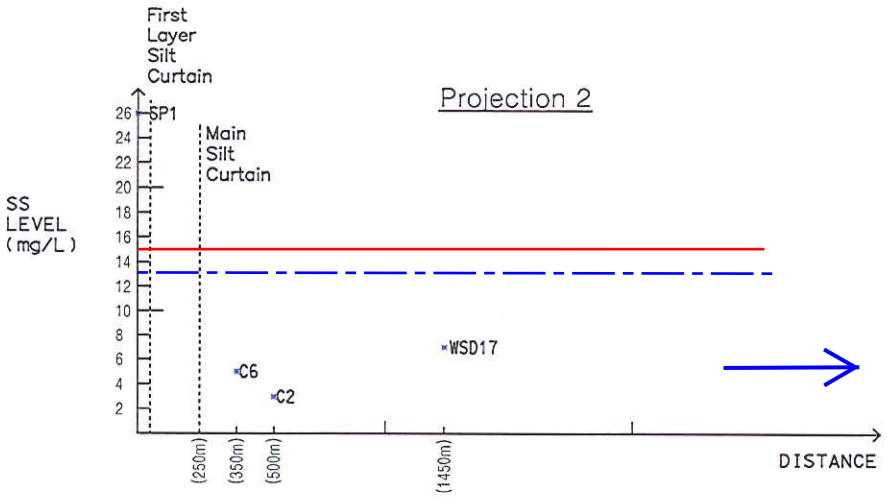
Description: WSD17 was located at downstream which was well within the Action Level.

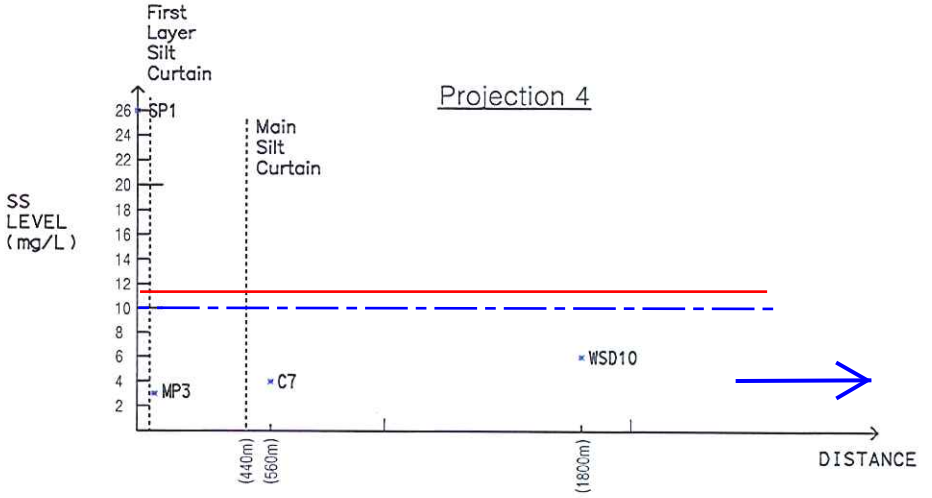
Description: WSD10 was located at downstream which was well within the Action Level.

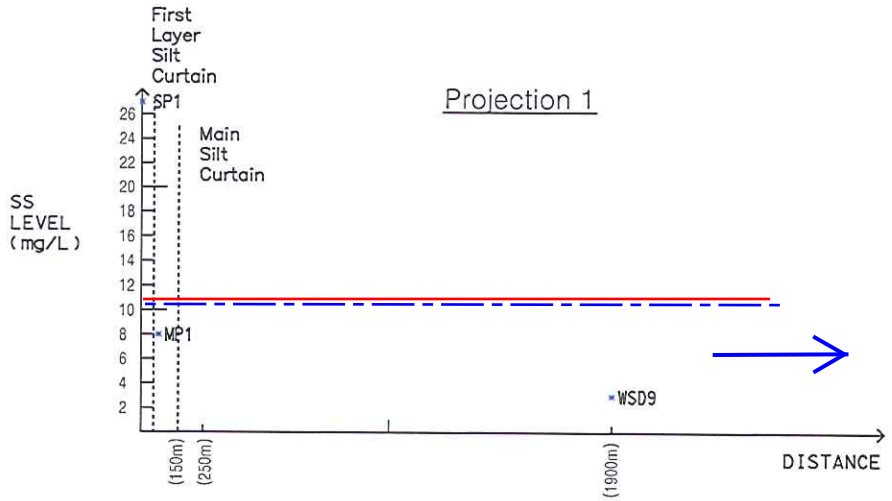
Description: WSD9 was located at downstream and well within the Action Level.

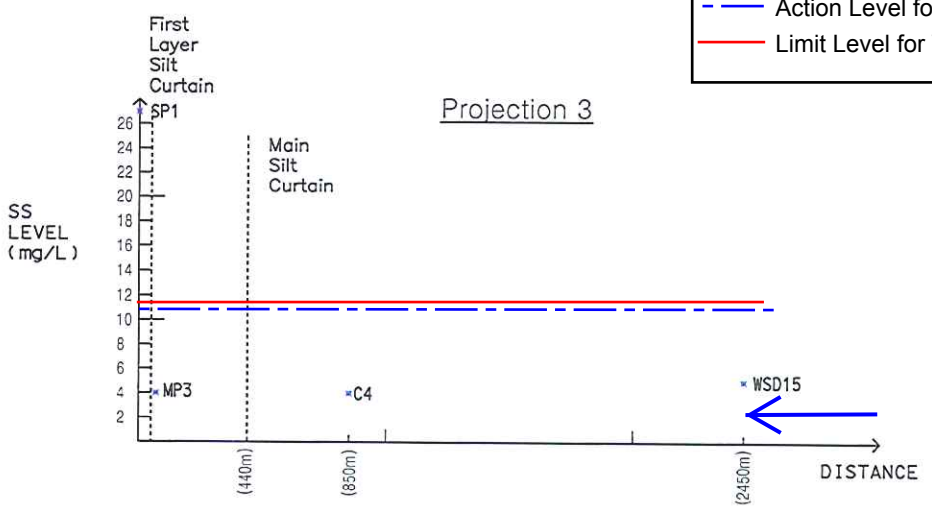
Description: WSD15 was located at upstream and well within the Action Level.

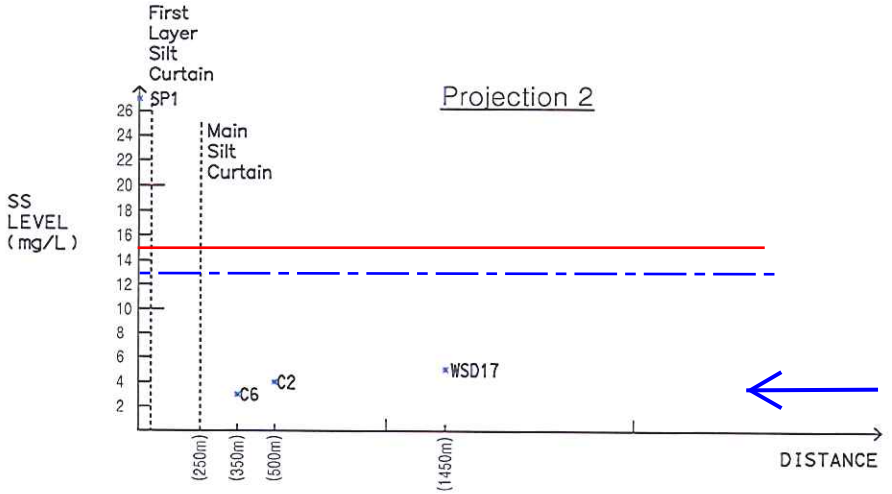
Description: WSD17 was located at upstream which was well within the Action Level.

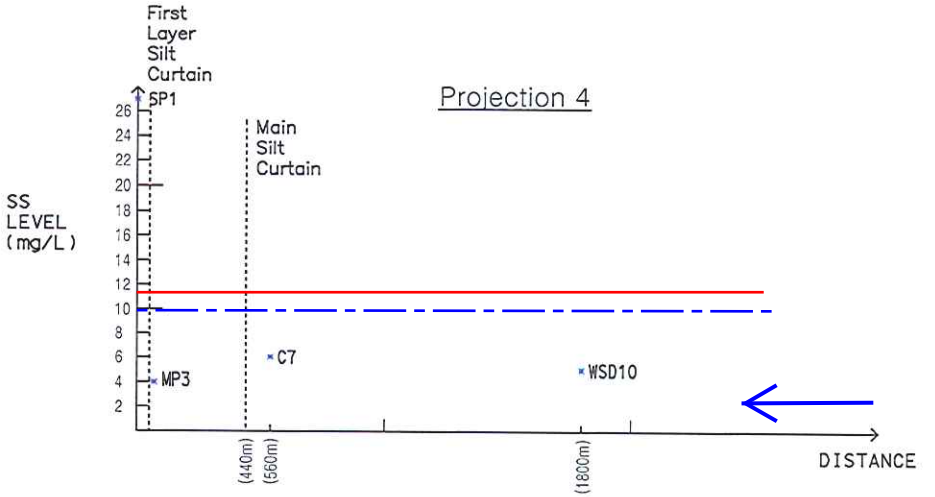
Description: WSD10 was located at upstream which was well within the Action Level.
