CONTRACT NO: KL/2009/01

SITE FORMATION FOR KAI TAK CRUISE TERMINAL DEVELOPMENT

ENVIRONMENTAL MONITORING & AUDIT MONTHLY REPORT

- SEPTEMBER 2012 -

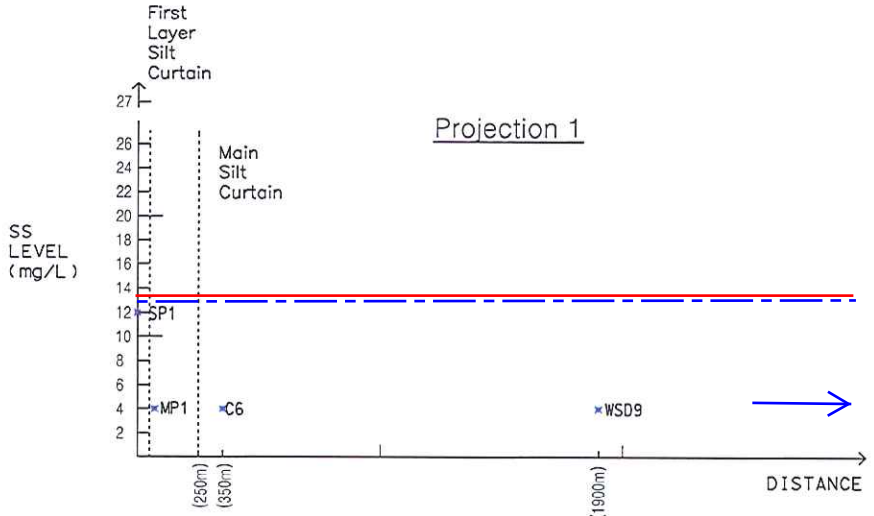
Description: WSD9 was located at upstream which was well within the Action Level.

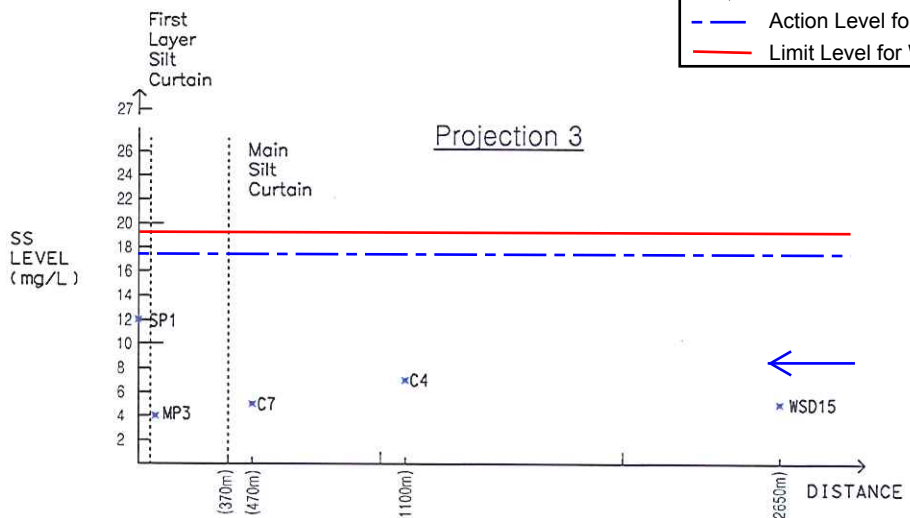
Description: WSD15 was located at downstream which was well within the Action Level.

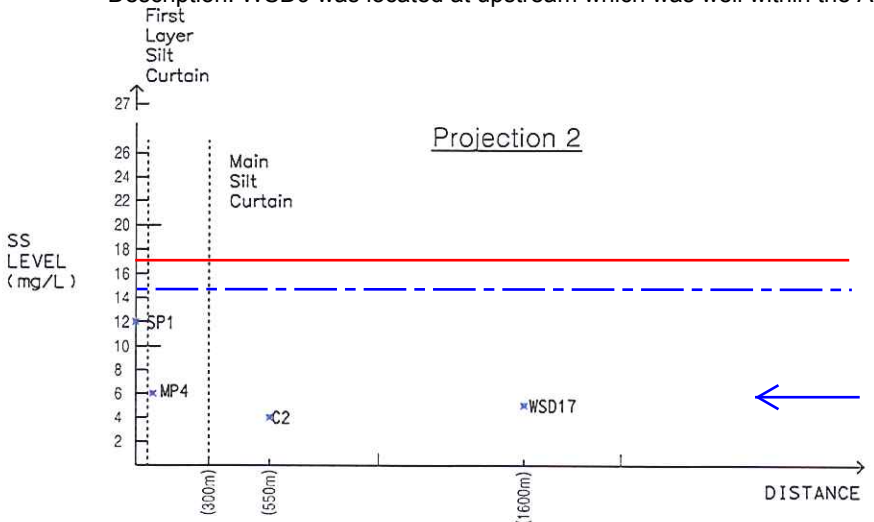
Description: WSD17 was located at downstream which was well within the Action Level.

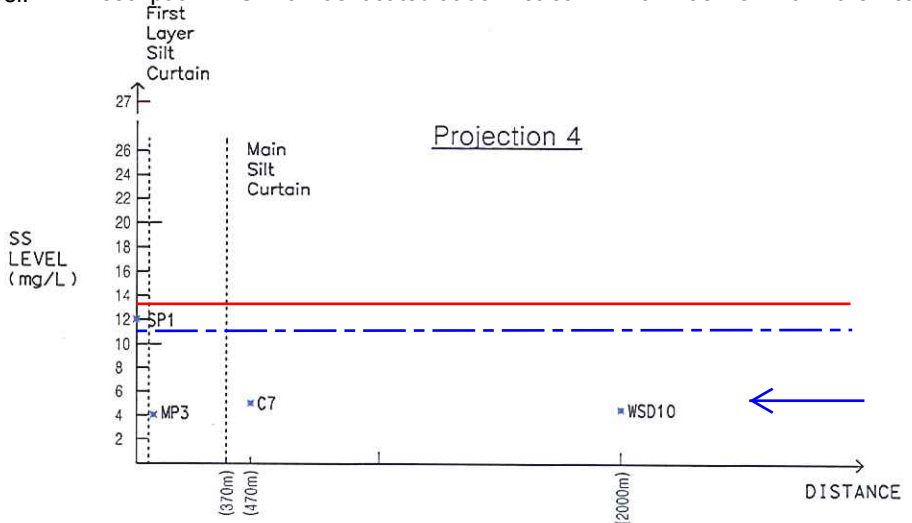
Description: WSD10 was located at downstream which was well within the Action Level.

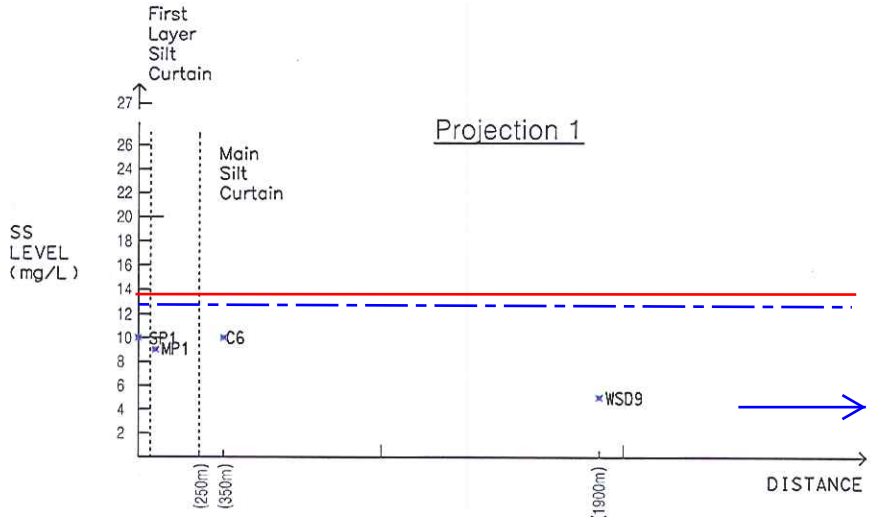
Description: WSD9 was located at downstream which was well within the Action Level.

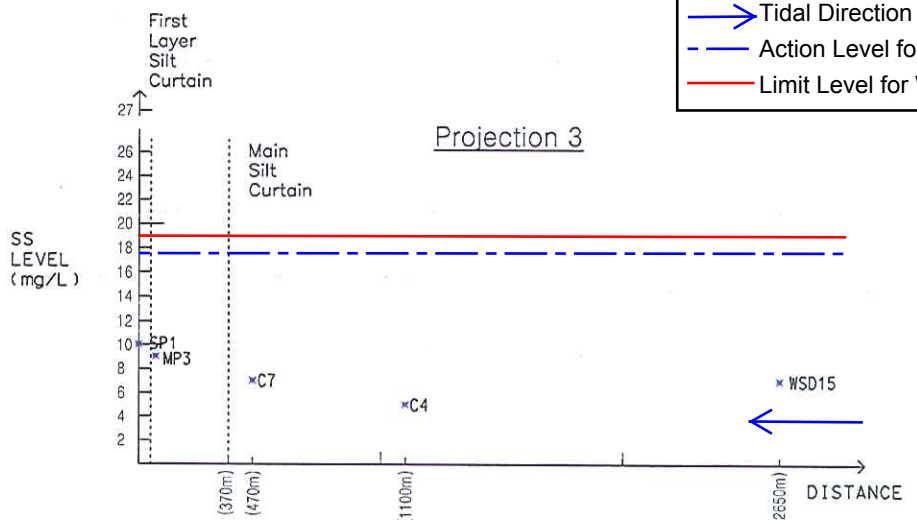
Description: WSD15 was located at upstream which was well within the Action Level.

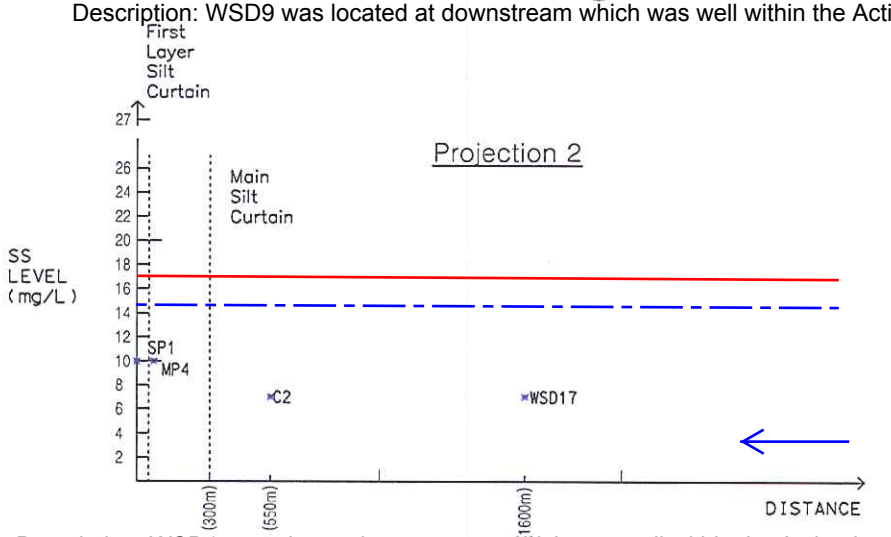
Description: WSD17 was located at upstream which was well within the Action Level.

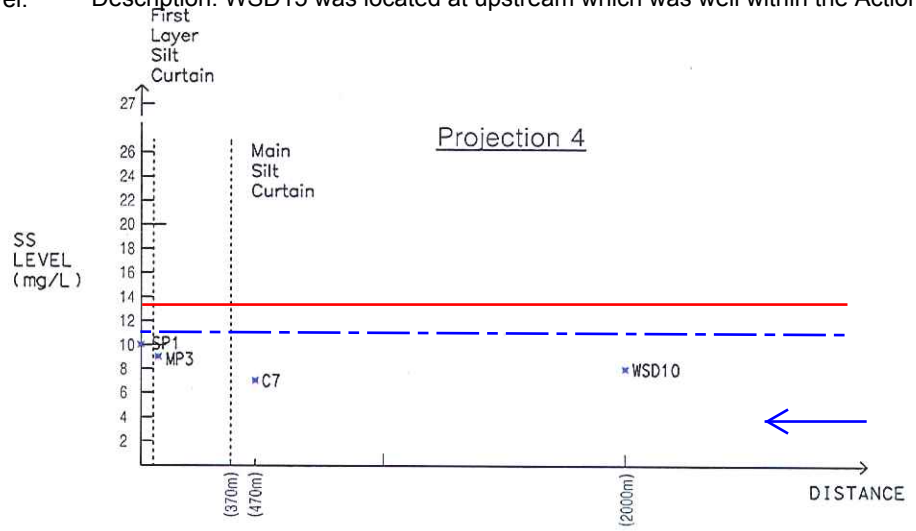
Description: WSD10 was located at upstream which was well within the Action Level.
