PROJECT NO.: TCS/00512/09

DSD CONTRACT NO. DC/2009/13
CONSTRUCTION OF SEWAGE TREATMENT WORKS AT YUNG SHUE WAN AND SOK KWU WAN

SOK KWU WAN PORTION AREA
MONTHLY ENVIRONMENTAL MONITORING AND AUDIT (EM&A) REPORT (NO.33) – APRIL 2013

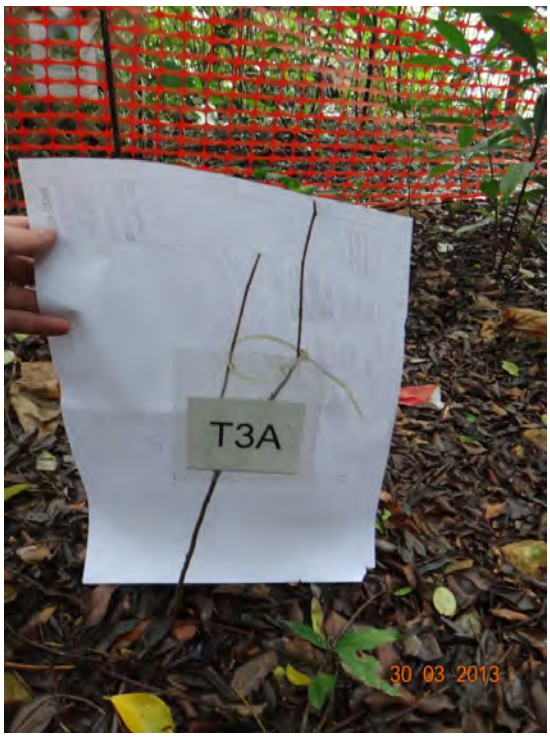
Tree ID: CT_3A

**Current Status: Poor** **Justification: Leaves were dry. The bark was also dry. No significant improvement in health. The plant was very weak.**
