PROJECT NO.: TCS/00512/09

DSD CONTRACT NO. DC/2009/13
CONSTRUCTION OF SEWAGE TREATMENT WORKS AT YUNG SHUE WAN AND SOK KWU WAN

SOK KWU WAN PORTION AREA
MONTHLY ENVIRONMENTAL MONITORING AND AUDIT (EM&A) REPORT (NO.38) – SEPTEMBER 2013

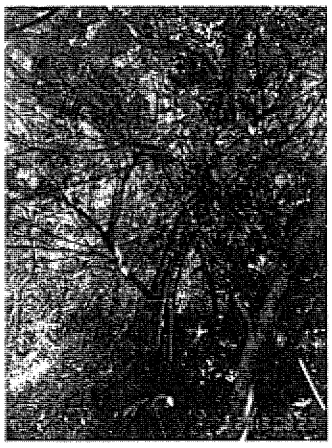
Findings of Site Inspection: (27 Aug 2013)

Electricity cable hang on the tree trunk was observed at Sok Kwu Wan, the contractor was reminded no construction material can be hang on the tree.

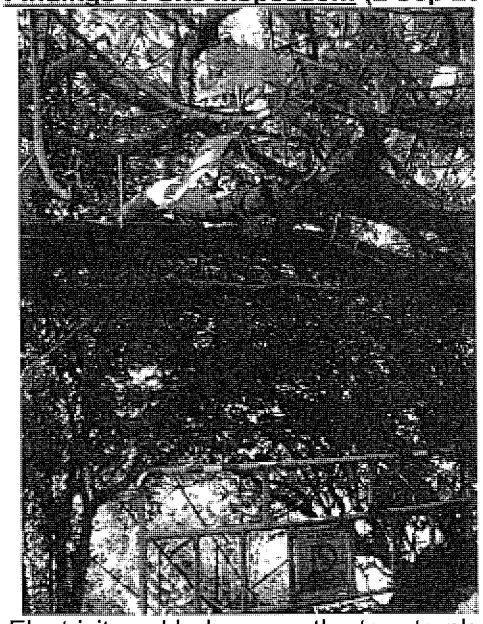
Findings of Site Inspection: (2 Sep 2013)

Electricity cable hang on the tree trunk was observed at Sok Kwu Wan, the contractor was reminded no construction material can be hang on the tree.

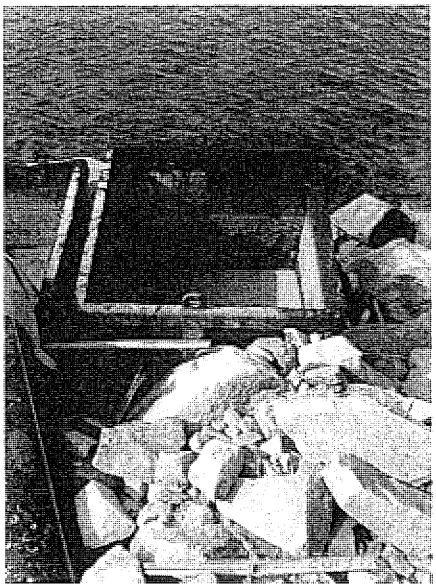
Sedimentation tank at Sok Kwu Wan was observed full of sediment, the contractor was reminded to clean.
