PROJECT NO.: TCS/00512/09

DSD CONTRACT NO. DC/2009/13
CONSTRUCTION OF SEWAGE TREATMENT WORKS AT YUNG SHUE WAN AND SOK KWU WAN

YUNG SHUE WAN PORTION AREA
MONTHLY ENVIRONMENTAL MONITORING AND AUDIT (EM&A) REPORT (NO.40) – DECEMBER 2013

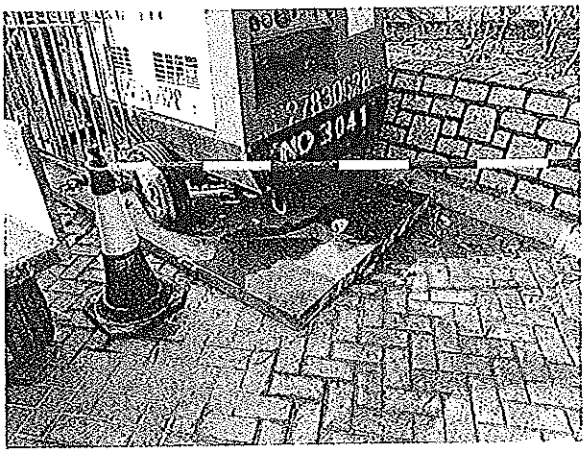
Follow up (17 December 2013):

Stagnant water at drip tray was observed, the Contractor was reminded to remove the stagnant water for mosquito breeding prevention.

Stagnant water was removed.
