PROJECT NO.: TCS/00512/09

DSD CONTRACT NO. DC/2009/13
CONSTRUCTION OF SEWAGE TREATMENT WORKS AT
YUNG SHUE WAN AND SOK KWU WAN

SOK KWU WAN PORTION AREA
MONTHLY ENVIRONMENTAL MONITORING AND AUDIT
(EM&A) REPORT (NO.43) – FEBRUARY 2014

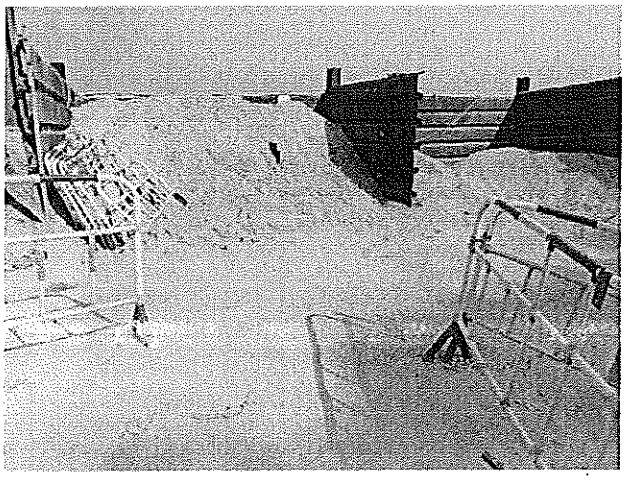
Findings of Site Inspection: (28 January 2014)

Stockpile of dusty materials without cover was observed, the Contractor was reminded to cover it with tarpaulin sheet to prevent dust disperse into air.

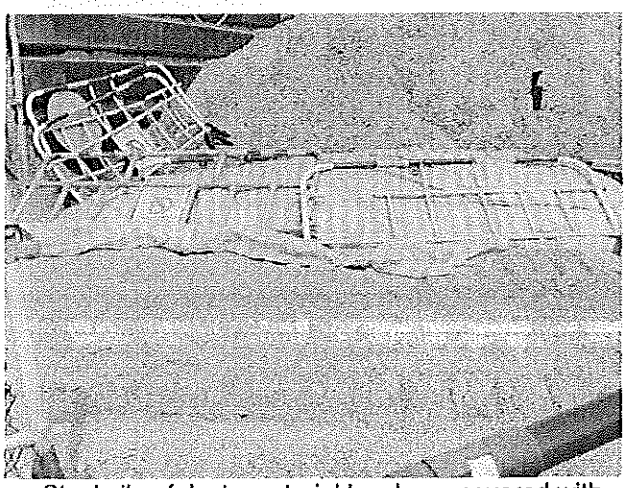
Follow up (28 January 2014)

Stockpile of dusty material has been covered with tarpaulin sheet.

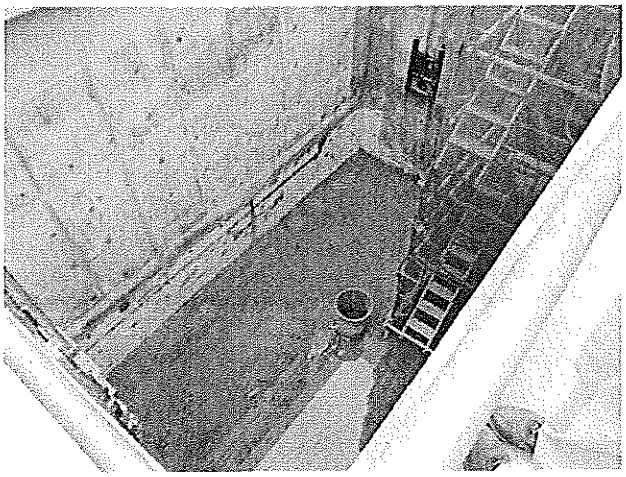
Findings of Site Inspection: (18 February 2014)

Stagnant water was observed, the Contractor was reminded to spray larvicidal oil for mosquito breeding prevention.

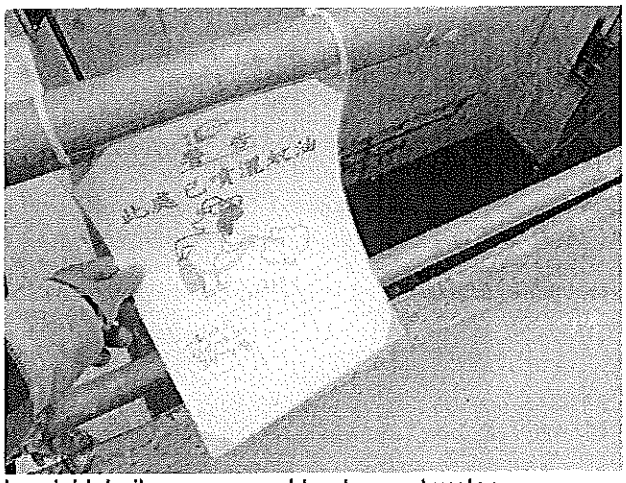
Follow up (18 February 2014)

Larvicidal oil was sprayed to stagnant water.

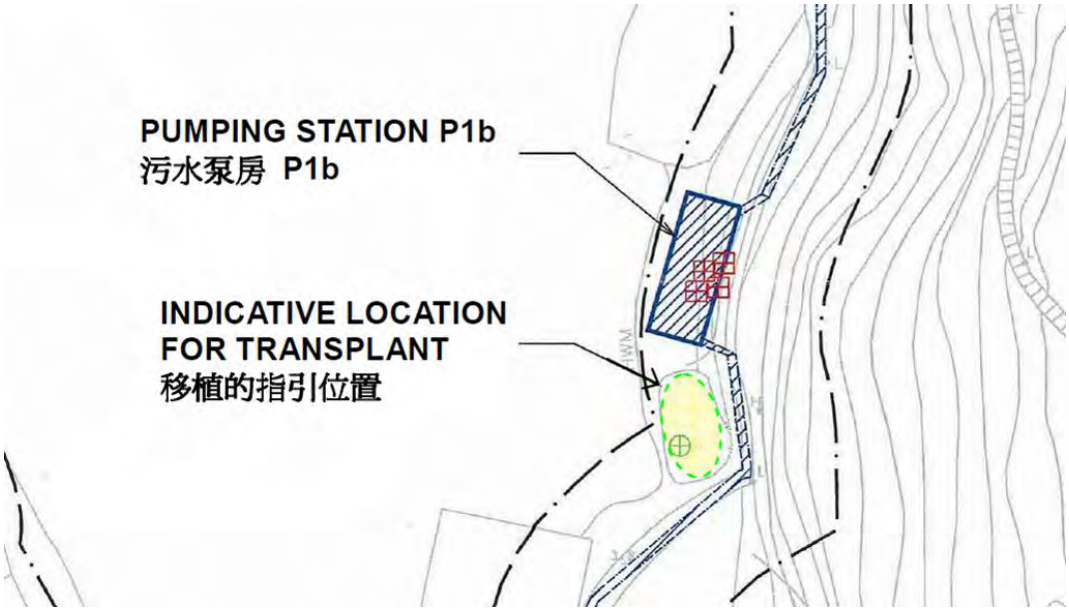
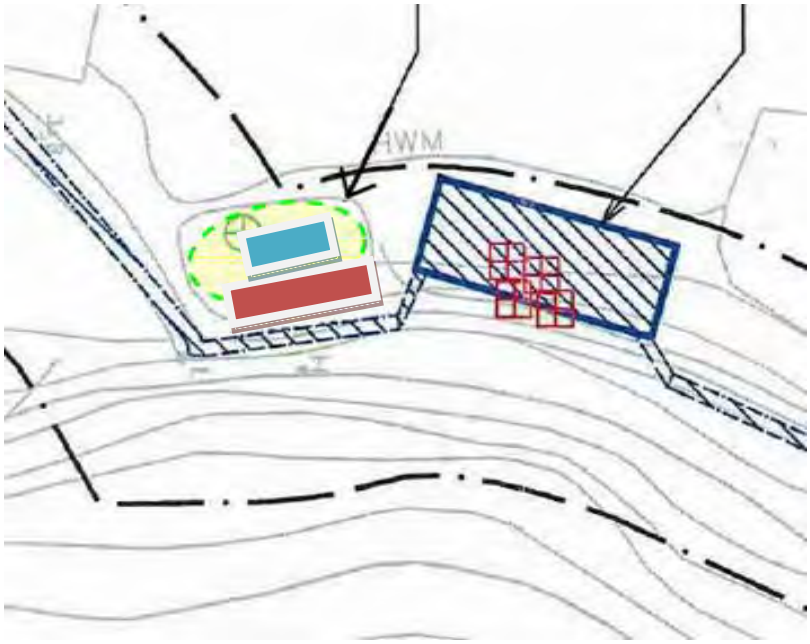
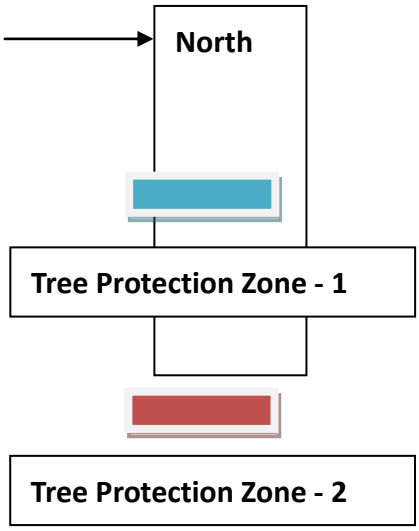
According to the requirement in the Environmental Permit EP-281/2007/A, the uncommon tree species, *Celtis timorensis*, found in the pumping station P1b area as shown in figure below shall be properly transplanted to the area immediately south of the Pumping Station P1b before commencement of construction of the Pumping Station P1b

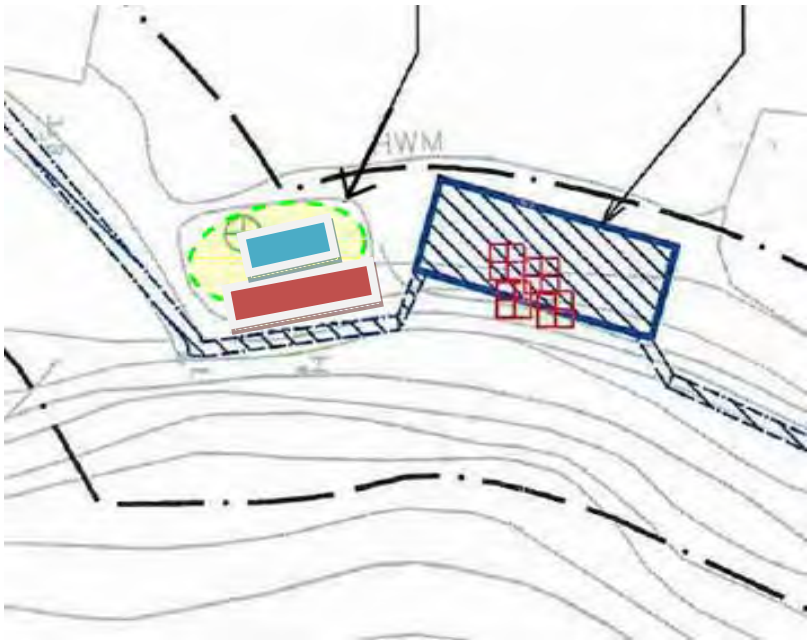
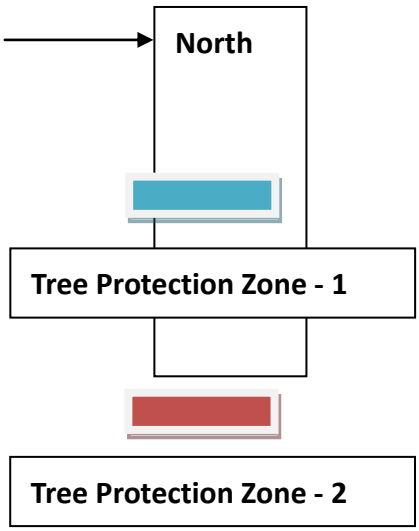
According to the requirement in the Environmental Permit EP-281/2007/A, the uncommon tree species, *Celtis timorensis*, found in the pumping station P1b area as shown in figure below shall be properly transplanted to the area immediately south of the Pumping Station P1b before commencement of construction of the Pumping Station P1b
