PROJECT NO.: TCS/00512/09

DSD CONTRACT NO. DC/2009/13
CONSTRUCTION OF SEWAGE TREATMENT WORKS AT
YUNG SHUE WAN AND SOK KWU WAN

SOK KWU WAN PORTION AREA
MONTHLY ENVIRONMENTAL MONITORING AND AUDIT
(EM&A) REPORT (NO.45) – APRIL 2014

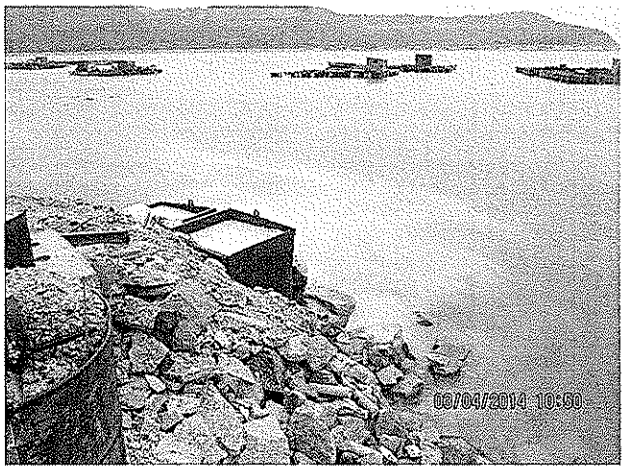
Findings of Site Inspection: (8 April 2014)

Refer from ER on 3 Apr 2014, there is an observation that turbid water has been released from the sedimentation tank after heavy rain at night of 2 Apr 2014.

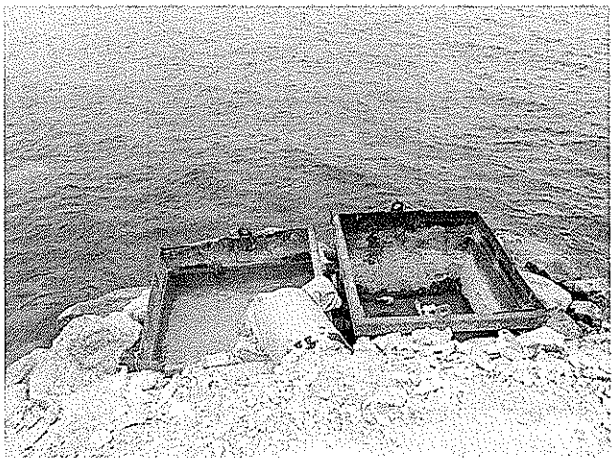
Follow up (8 April 2014)

The sedimentation tank has been cleaned up and no turbid water release to the sea. The contractor was reminded to clean up the sedimentation tank regularly.
