PROJECT NO.: TCS/00512/09

DSD CONTRACT NO. DC/2009/13
CONSTRUCTION OF SEWAGE TREATMENT WORKS AT YUNG SHUE WAN AND SOK KWU WAN

SOK KWU WAN PORTION AREA
MONTHLY ENVIRONMENTAL MONITORING AND AUDIT (EM&A) REPORT (NO.47) – JUNE 2014

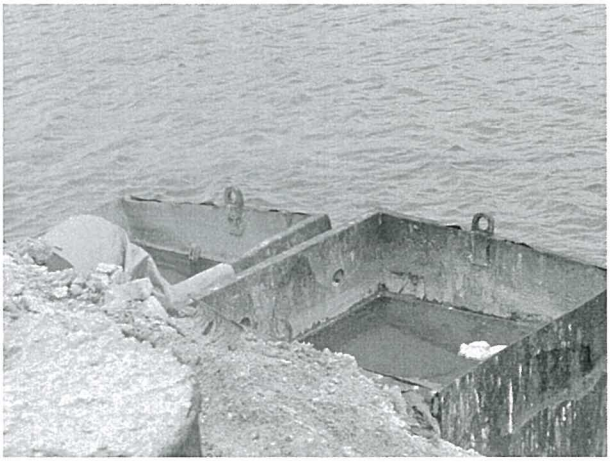
Follow up (4 June 2014)

Date	Findings / Deficiencies	Follow-Up Status
27 May 2014	• No environmental issue was observed during the site inspection	NA
4 June 2014	• The Contractor was reminded to clean the sedimentation tank regularly to prevent turbid water discharge into sea when raining.	The sedimentation tank was cleaned.
10 June 2014	• The Contractor was reminded to clean the stagnant water for mosquito breeding prevention.	The stagnant water was removed.
17 June 2014	• No environmental issue was observed during the site inspection	NA

The sedimentation tank was cleaned.

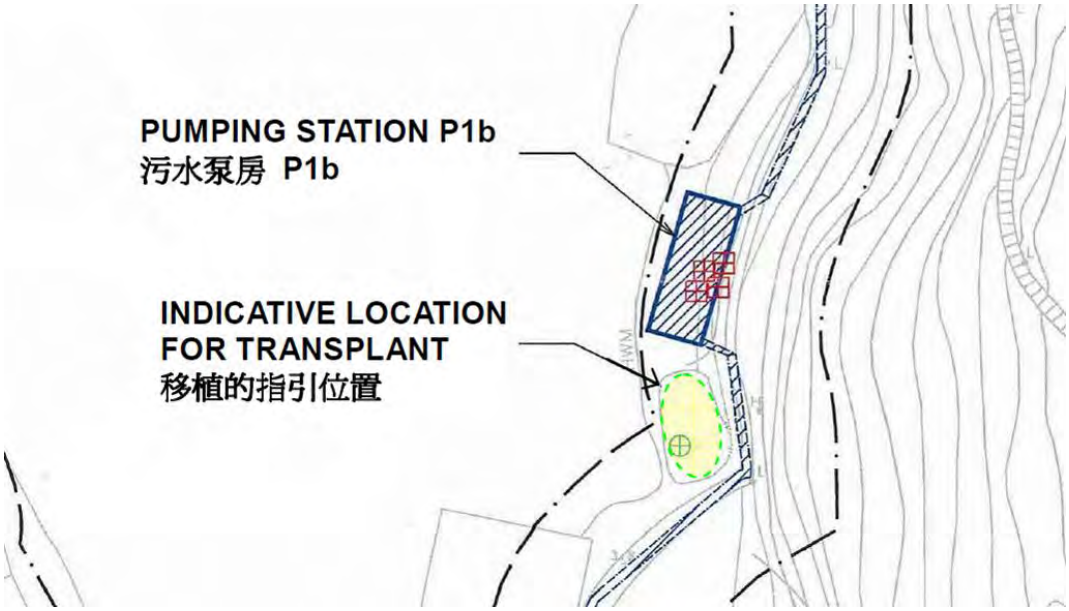
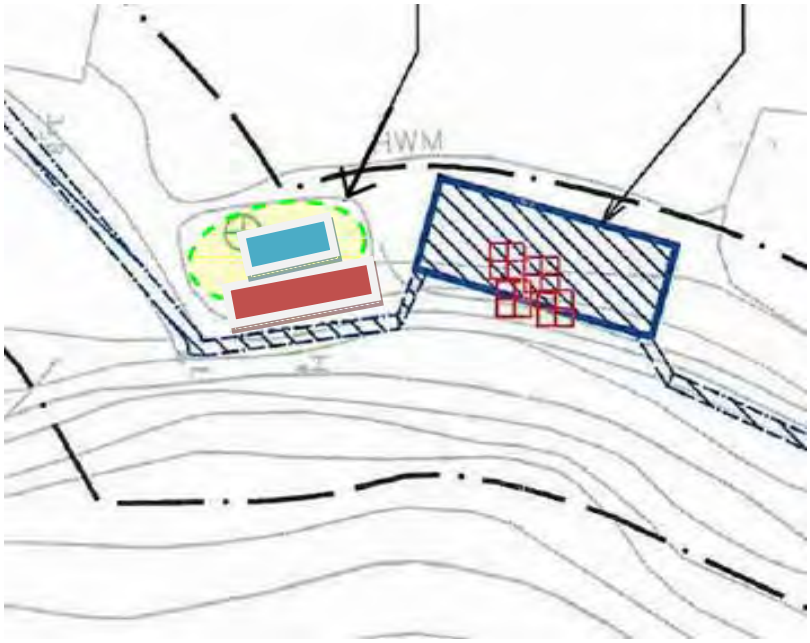
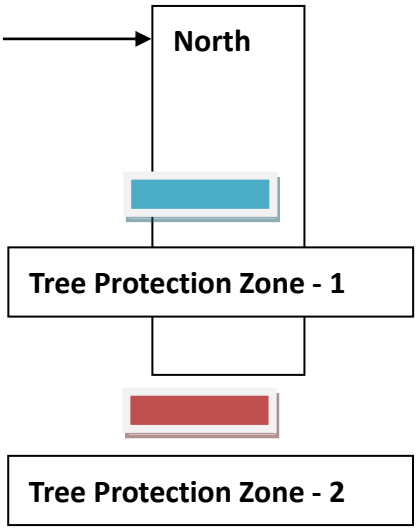
According to the requirement in the Environmental Permit EP-281/2007/A, the uncommon tree species, *Celtis timorensis*, found in the pumping station P1b area as shown in figure below shall be properly transplanted to the area immediately south of the Pumping Station P1b before commencement of construction of the Pumping Station P1b

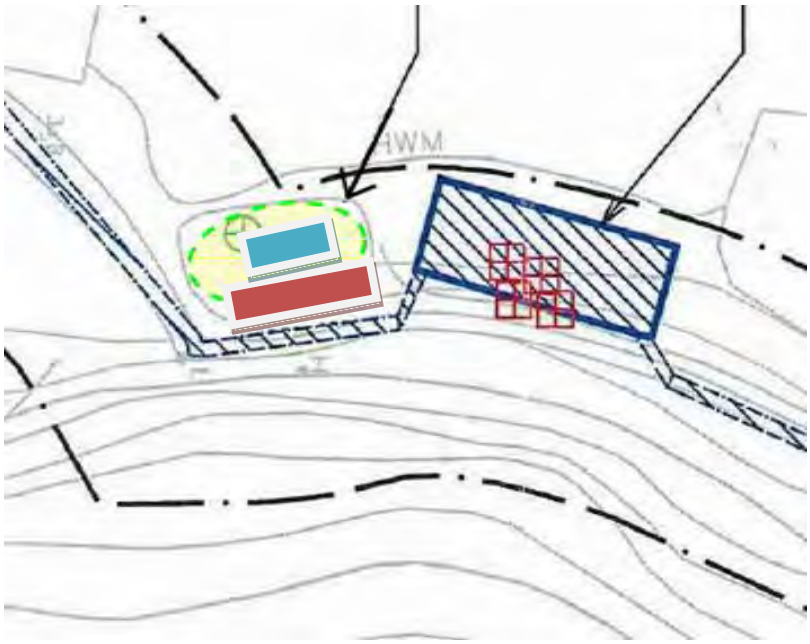
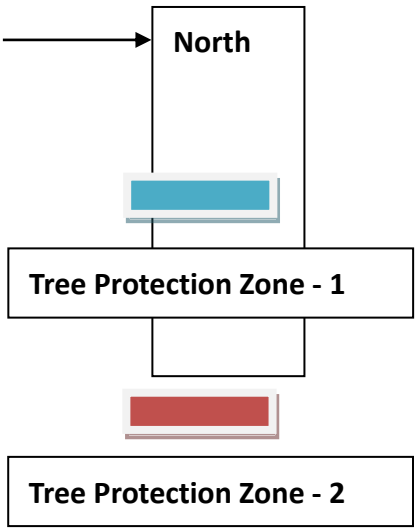
According to the requirement in the Environmental Permit EP-281/2007/A, the uncommon tree species, *Celtis timorensis*, found in the pumping station P1b area as shown in figure below shall be properly transplanted to the area immediately south of the Pumping Station P1b before commencement of construction of the Pumping Station P1b
