PROJECT NO.: TCS/00512/09

DSD CONTRACT NO. DC/2009/13
CONSTRUCTION OF SEWAGE TREATMENT WORKS AT YUNG SHUE WAN AND SOK KWU WAN

SOK KWU WAN PORTION AREA
MONTHLY ENVIRONMENTAL MONITORING AND AUDIT (EM&A) REPORT (NO.56) – MARCH 2015

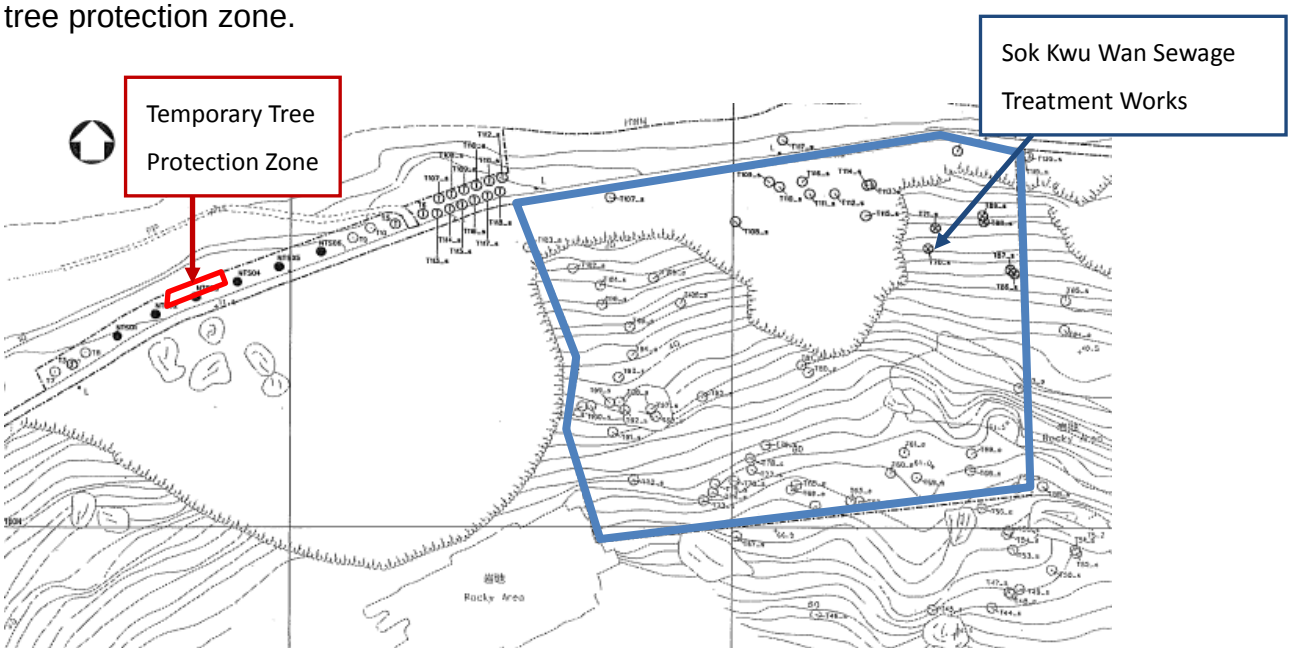
It was reported that on 5 January 2015, a private contractor started their construction in close vicinity of the pumping station P1b and found that part of the tree protection zone was within their private lot. Therefore, the tree protection zone was temporary relocated to the below area adjacent to the Sok Kwu Wan Sewage Treatment Works until a suitable area is provided as the tree protection zone.

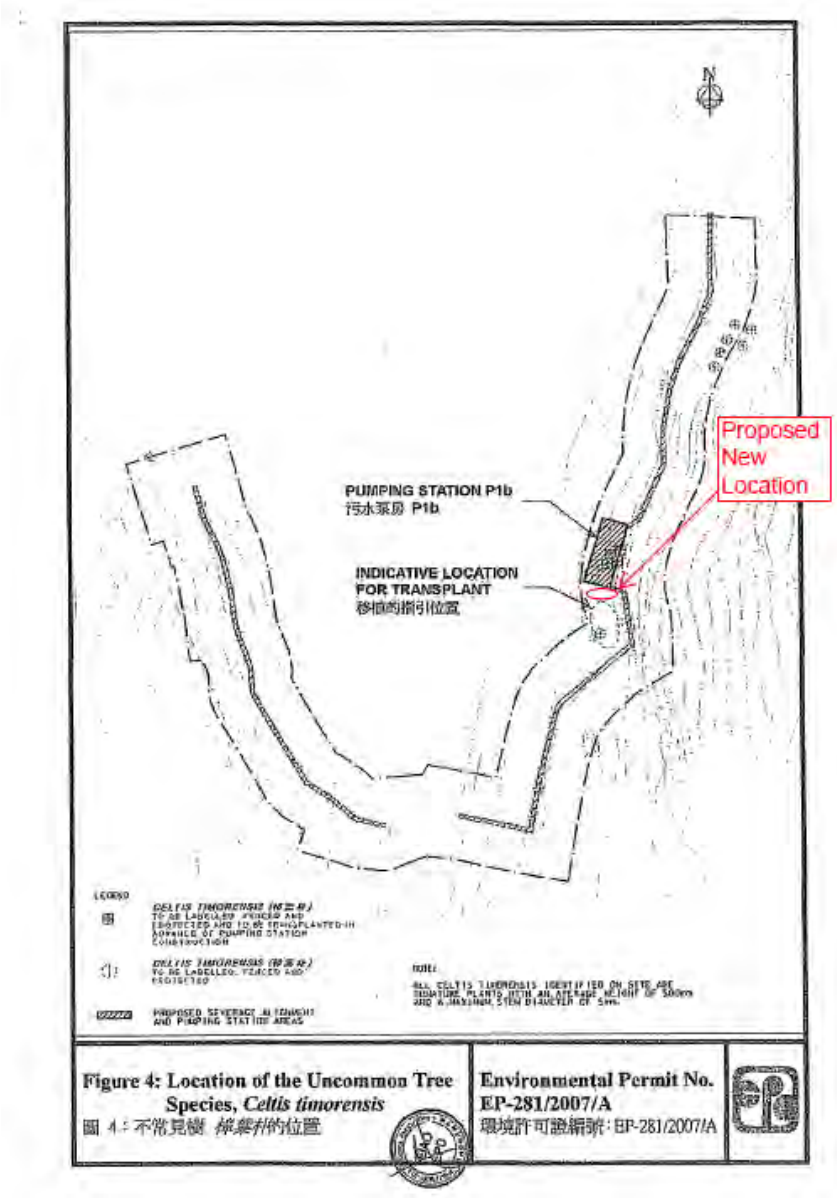
In March 2015, the *Celtis timorensis* were transplanted to the below area near PS1 as the new tree protection zone.
