HONG KONG SECTION OF GUANGZHOU – SHENZHEN – HONG KONG EXPRESS RAIL LINK

Environmental Monitoring and Audit Report No. 9

(November 2010)

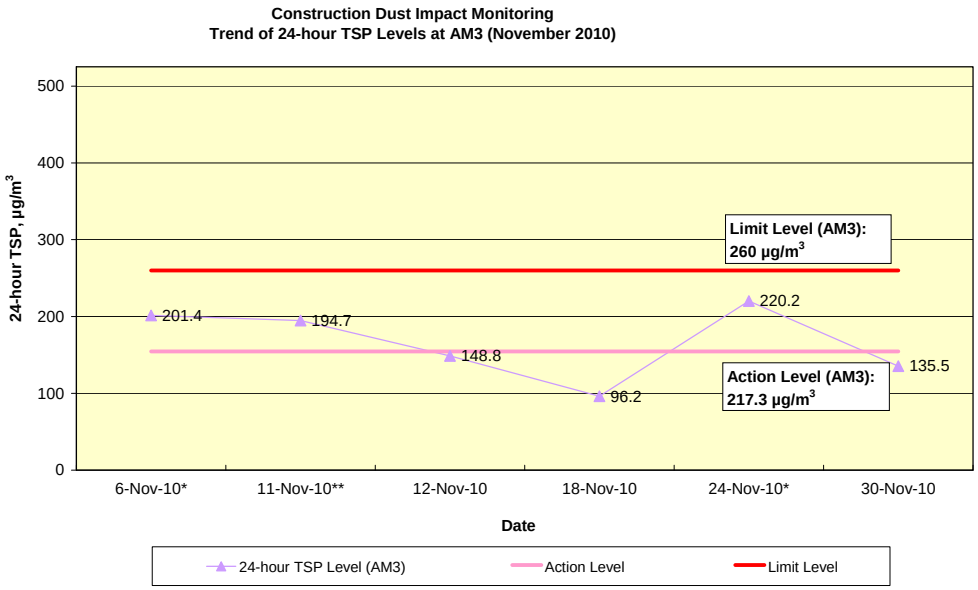
As shown by the monitoring results in the above table, there are exceedances of 24-hr TSP Action Level on 6, 11 and 30 November 2010 at AM 3 recorded in the reporting month. Investigation results revealed that the exceedances might possibly due to site formation work at Tai Kong Po Works Area. IEC also observed some irregularities on site that might lead to dust impact and issued a warning of potential non-compliance to Contractor 824. The 824 Contractor immediately improved the dust mitigation measures, including covering of stockpile and increasing watering frequency. The situation would be continuously reviewed by IEC.

Construction Dust Impact Monitoring
Trend of 24-hour TSP Levels at AM3 (November 2010)
24-hour TSP, µg/m3
500
400
300
200
100
0
Limit Level (AM3):
260 µg/m3
Action Level (AM3):
217.3 µg/m3
201.4
194.7
148.8
96.2
220.2
135.5
6-Nov-10*
11-Nov-10**
12-Nov-10
18-Nov-10
24-Nov-10*
30-Nov-10
Date
24-hour TSP Level (AM3)
Action Level
Limit Level

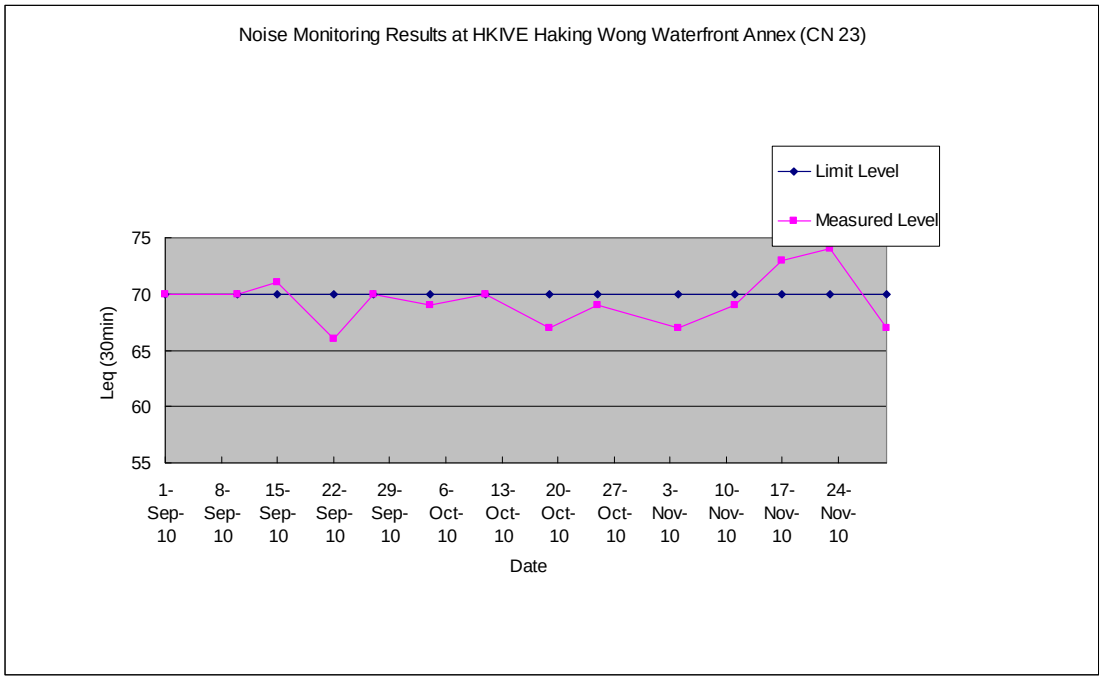
Referring to the table above, two noise exceedances were recorded at HKIVE Haking Wong Waterfront Annex (CN 23) on 17 and 23 November 2010. Actions identified in the Event and Action Plan (Table 3.4 of the EM&A Manual) were undertaken. The ER, IEC and Contractor were informed of the exceedance. It is found from the investigation results that the noise exceedances were not project-related. The investigation results were reviewed by IEC.

Noise Monitoring Results at HKIVE Haking Wong Waterfront Annex (CN 23)
Limit Level
Measured Level
Leq (30min)
75
70
65
60
55
1-Sep-10
8-Sep-10
15-Sep-10
22-Sep-10
29-Sep-10
6-Oct-10
13-Oct-10
20-Oct-10
27-Oct-10
3-Nov-10
10-Nov-10
17-Nov-10
24-Nov-10
Date
