Document Details	
Client	**Drainage Services Department**
Project	**Contract No. DC/2007/24 Harbour Area Treatment Scheme Stage 2A Construction of Sewage Conveyance System from Aberdeen to Sai Ying Pun**
Document Title	**Monthly Environmental Monitoring and Audit Report No. 17 Covering the Period from 1 May 2011 to 31 May 2011**
Document No.	**EMA/019**

Contract No. DC/2007/24
Construction of Sewage Conveyance System from Aberdeen to Sai Ying Pun
Condition 4.4 – Submission of Monthly EM&A Report for May 2011 (no. 17)

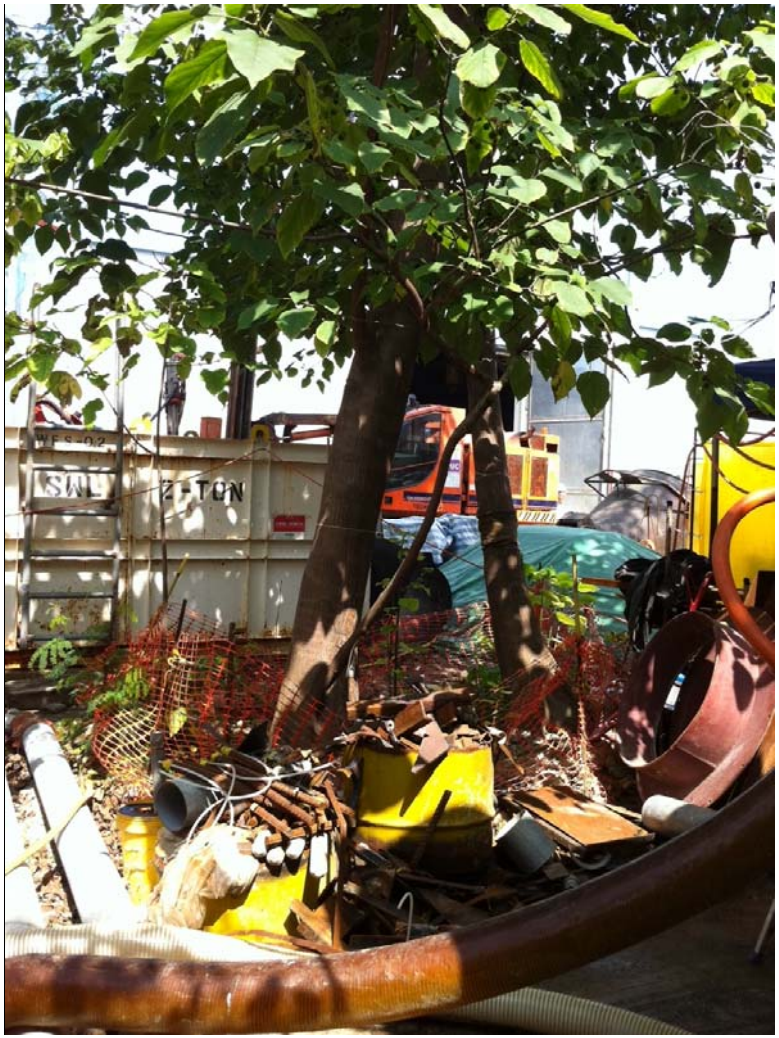
Sandy Bay site --- Photo 1
Construction materials and debris were still stored very near to the roots of retained tree T027(R) and T028(R). .

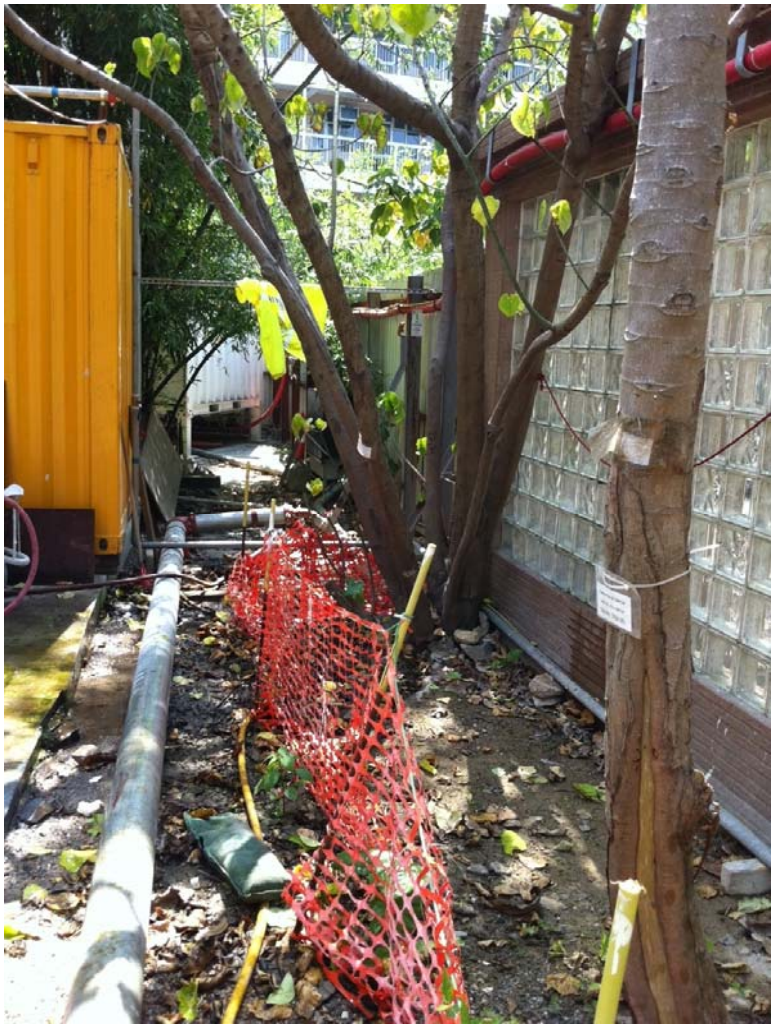
Sandy Bay site --- Photo 2
Retained Trees T036(R), T037(R) and T018(R) were showing poor health condition due to formation of stagnant water in the area.

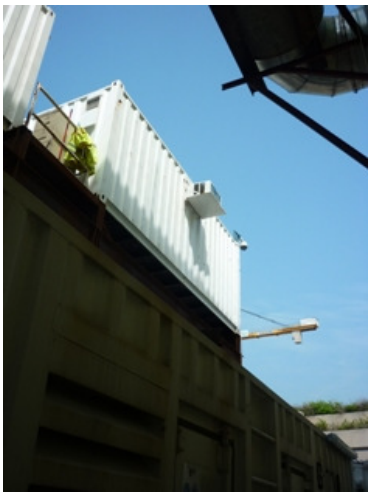
Notes / Issues Recorded On Site: **General Housekeeping:** 1. No improvement on the leaking air-conditioner since last inspection.
Corrective Actions – Mitigation Measures Implemented or Proposed (if any):
Previous Environmental Site Inspection Checklist – Report No. 110524 Nil. **Current Environmental Site Inspection Checklist – Report No. 110531** **General Housekeeping:** 1. The contractor is suggested to provide a temporary duct to the air-conditioner.

Photos 1: No improvement on the leaking air-conditioner since last inspection
