HONG KONG SECTION OF GUANGZHOU – SHENZHEN – HONG KONG EXPRESS RAIL LINK

Environmental Monitoring and Audit Report No.22

(December 2011)

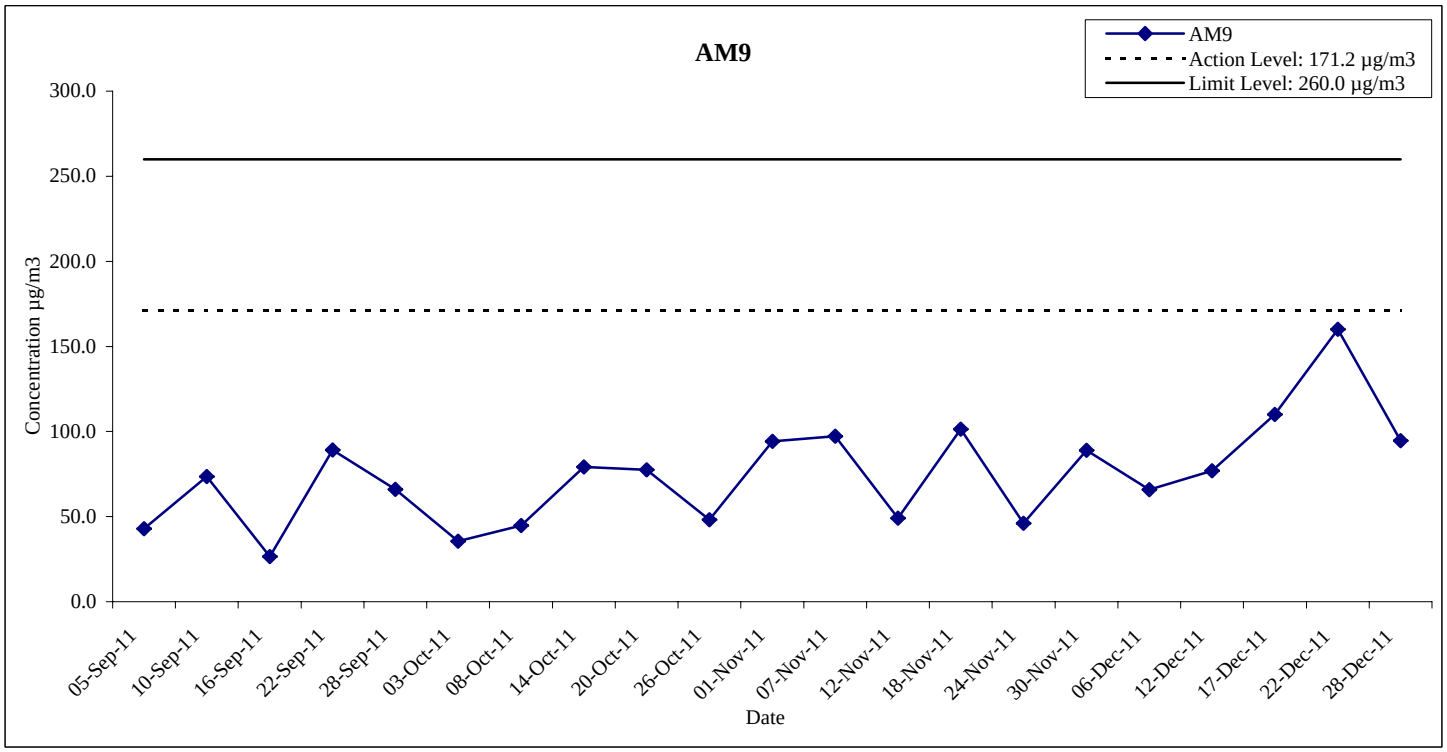
MTR	Hong Kong Section of Guangzhou-Shenzhen-Hong Kong Express Rail Link **Graphical Presentation of 24-hour TSP** **Monitoring Results for Location AM9 and AM10**	**Date**	**2011**
		APPENDIX	**F**

Remarks:
The reason causing the abnormal exceedance on 1 and 7 Nov 2011 is expected due to the excavation and pipe laying works by Towngas just next to AM10. It is not considered as XRL project related exceedance.

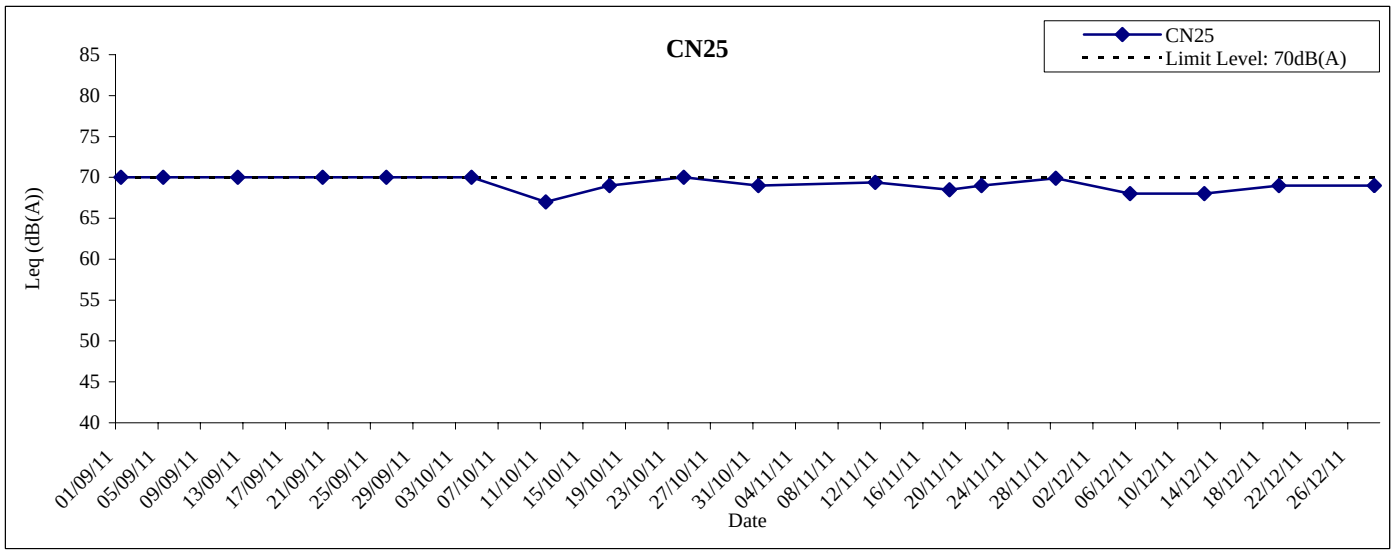
Remarks:
-Noise limit level of CN23, CN24 & CN25, which are school, is 70dB(A) on normal weekdays and 65dB(A) during examination period.

- For CN 23, the monitoring dates on 3, 11, 17, 24 & 31 August 2011 were school holiday. Noise level measured was for reference only.
- For CN 24, as the monitoring results on 31 Oct 11 is equal or lower than the background noise level of 67dB(A), it is not classified as noise exceedance..

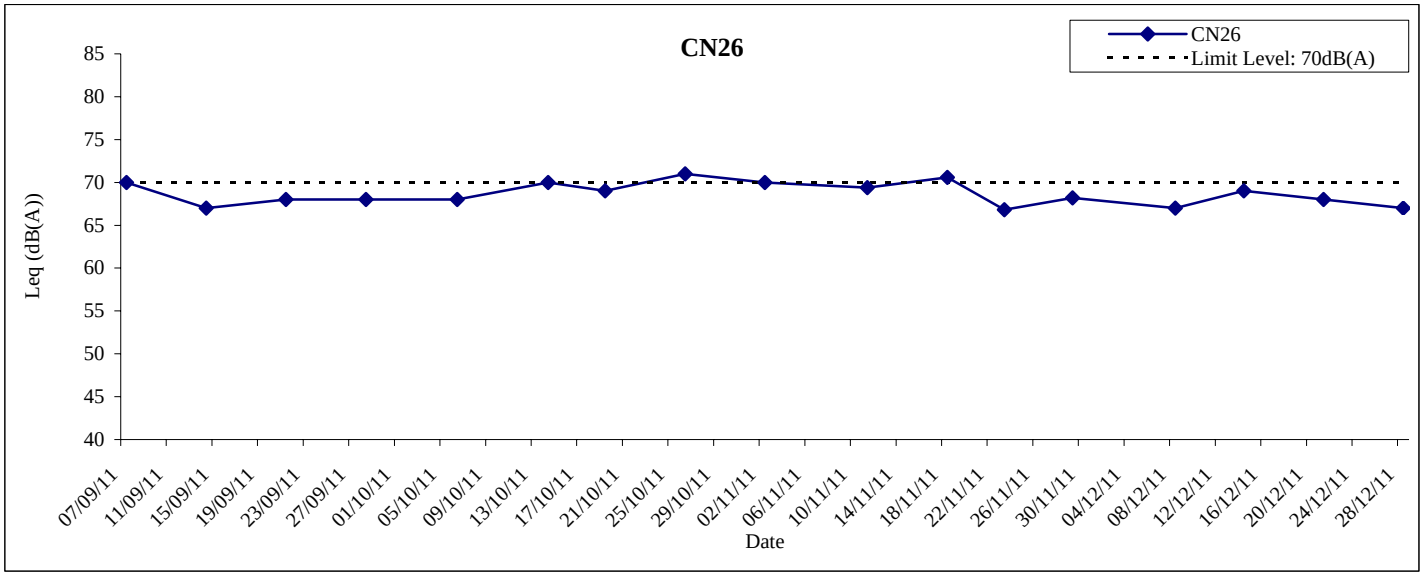
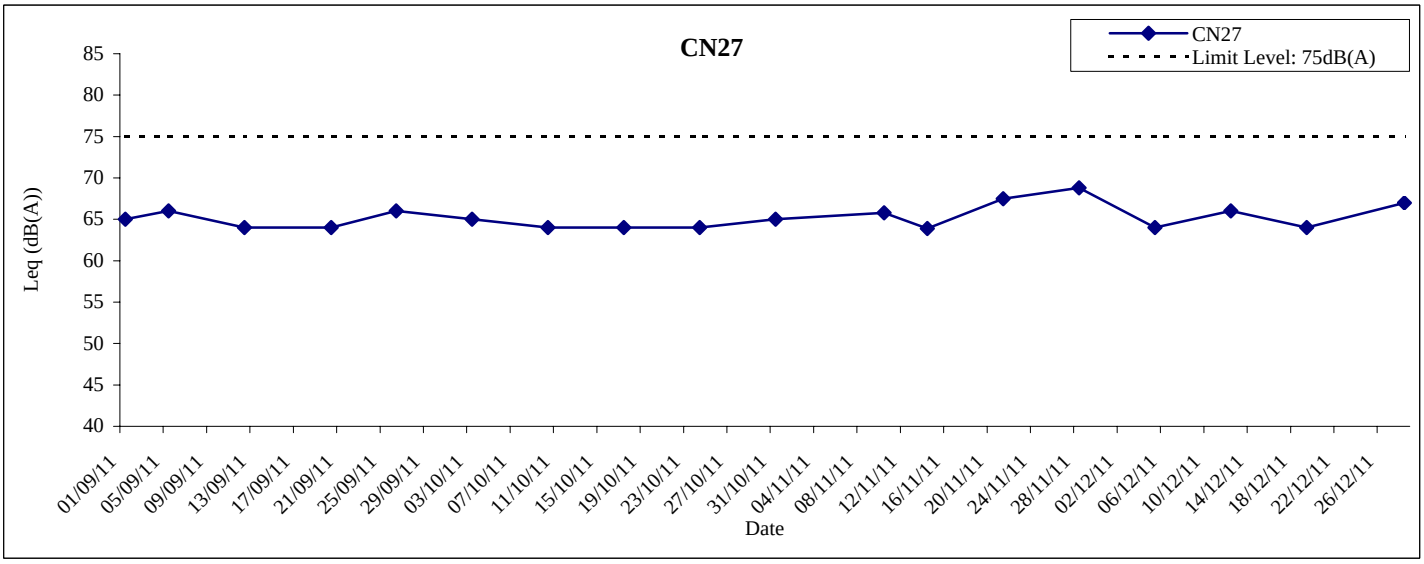
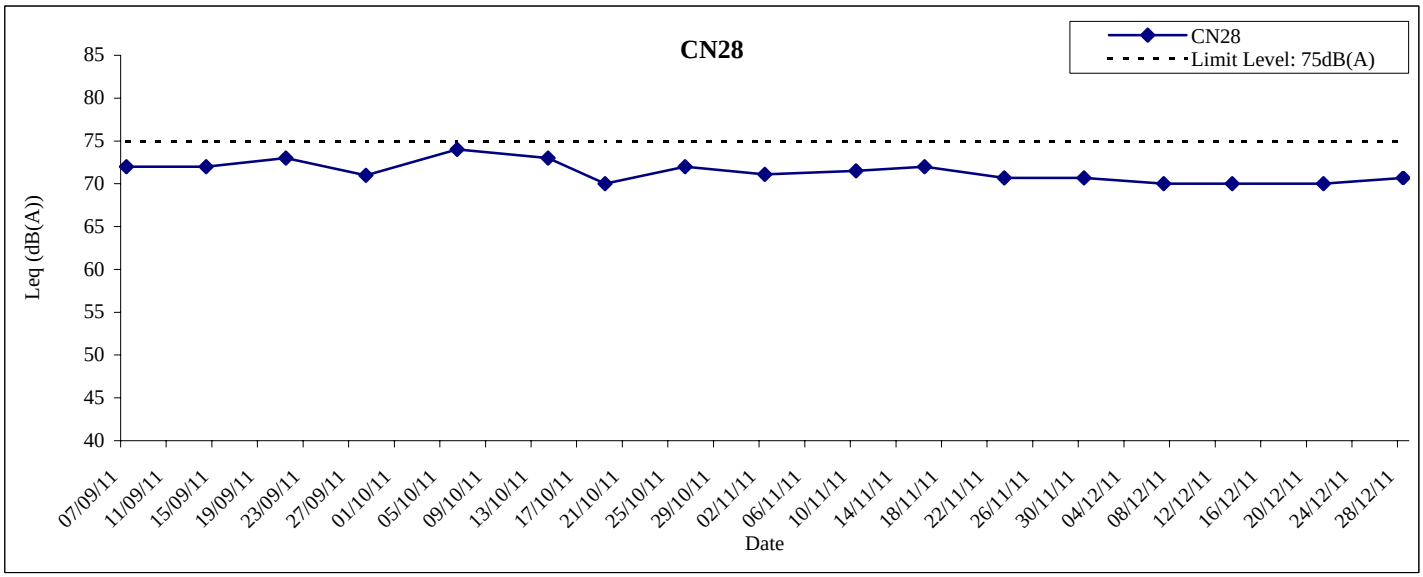
MTR	Hong Kong Section of Guangzhou-Shenzhen-Hong Kong Express Rail Link **Graphical Presentation of Noise** **Monitoring Results for Location CN26, CN27 and CN28**	**Date**	**2012**
		APPENDIX	**F**

Noise limit level of CN26, which is school, is 70dB(A) on normal weekdays and 65dB(A) during examination period.

For CN 26, the monitoring dates on 5, 11, 17, 25 & 31 August 2011 were school holiday. Noise level measured was for reference only.

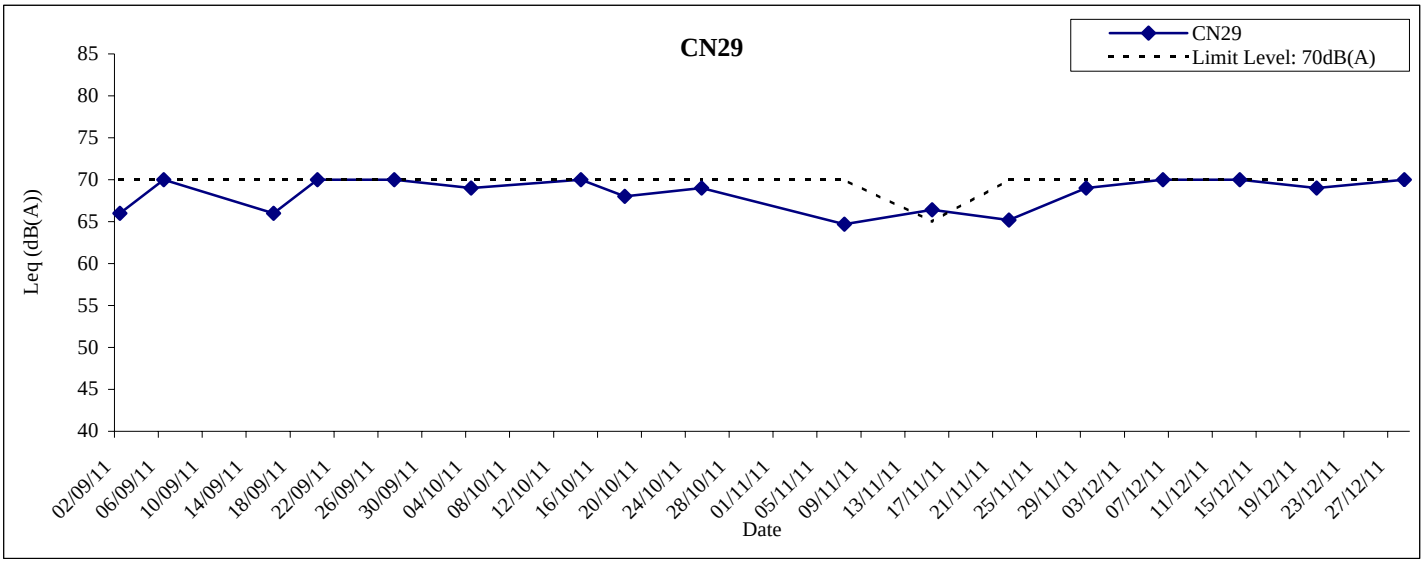
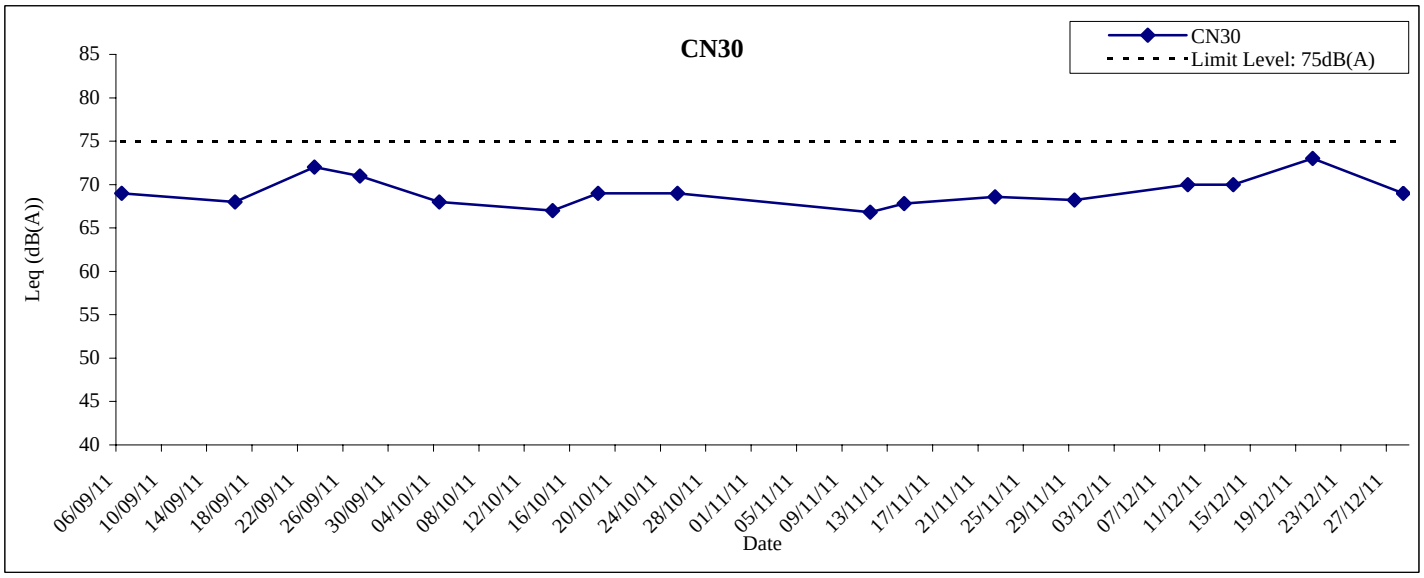
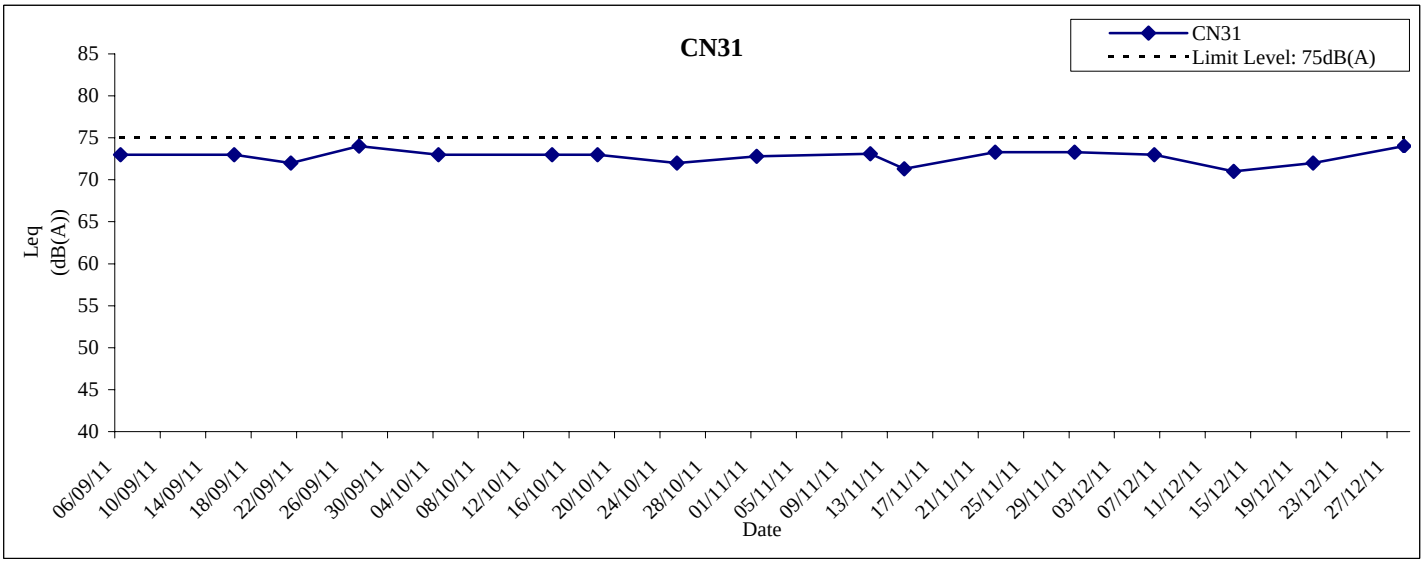
MTR	Hong Kong Section of Guangzhou-Shenzhen-Hong Kong Express Rail Link **Graphical Presentation of Noise** **Monitoring Results for Location CN29, CN30 and CN31**	**Date**	**2012**
		APPENDIX	**F**

Noise limit level of CN29, which is school, is 70dB(A) on normal weekdays and 65dB(A) during examination period.

- For CN 29, as the monitoring results on 15 Nov 11 is equal or lower than the background noise level of 68dB(A), it is not classified as noise exceedance..
