The Jockey Club CPS Limited

Central Police Station Conservation and Revitalisation Project:
Eleventh Monthly EM&A Report (1 September to 30 September 2012)

Issue Date: October 2012

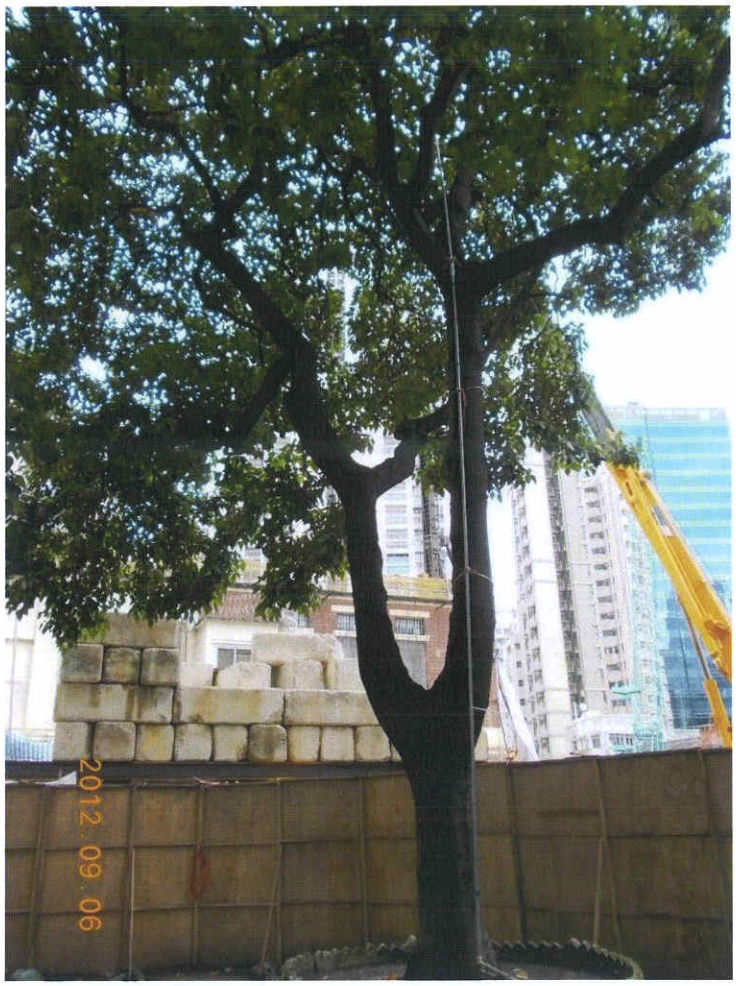
1. Overall health condition of the tree is fair.
2. Cleanliness of the site and the planter are acceptable.
3. Lots of bulky items are placed outside the cordon zone.
4. Cracks at the planter and the nearby ground surface are getting worse.
5. The access outside the cordon zone appears clean and tidy.

Fig. 3 Cracks are getting worse, remedial work for these cracks are recommended.

1. To take remedial work for the cracks.

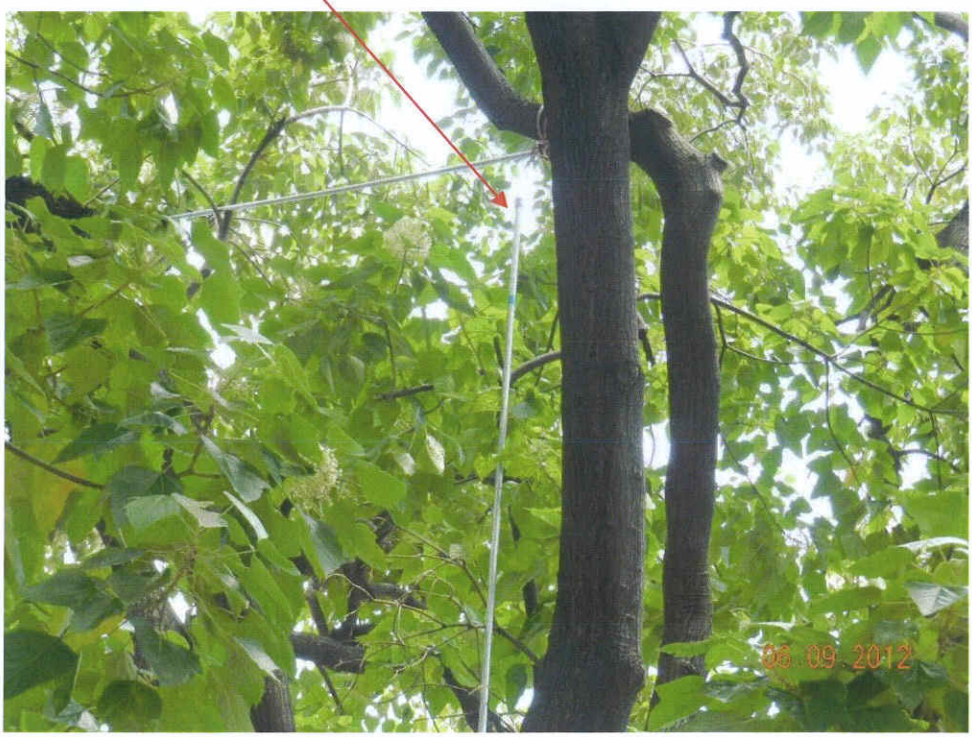
1. Overall health condition of the tree is fair.
2. The site and the planter are clean and tidy.
3. Cracks are getting worse at the planter as well as the nearby ground surface.
4. The water pipe on tree-top has been broken.
5. Many bulky items are placed near the tree outside the cordon zone.

Fig. 4 Cracks are getting worse during inspection on 6th September 2012.

Fig. 5 The water pipe on tree top has been broken.

1. To take remedial work for the cracks.
2. To repair the broken water pipe.

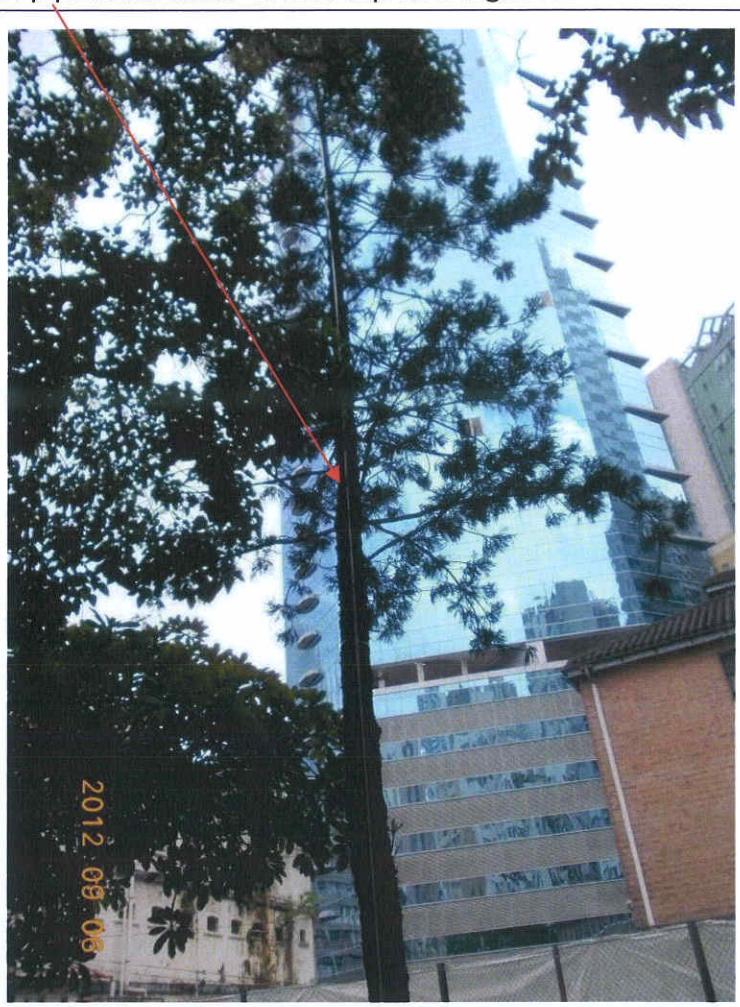
Fig. 4 A pipe leads water to tree top for irregation.
