The Jockey Club CPS Limited

Central Police Station Conservation and Revitalisation Project:
Seventeenth Monthly EM&A Report (1 March to 31 March 2013)

Issue Date: April 2013

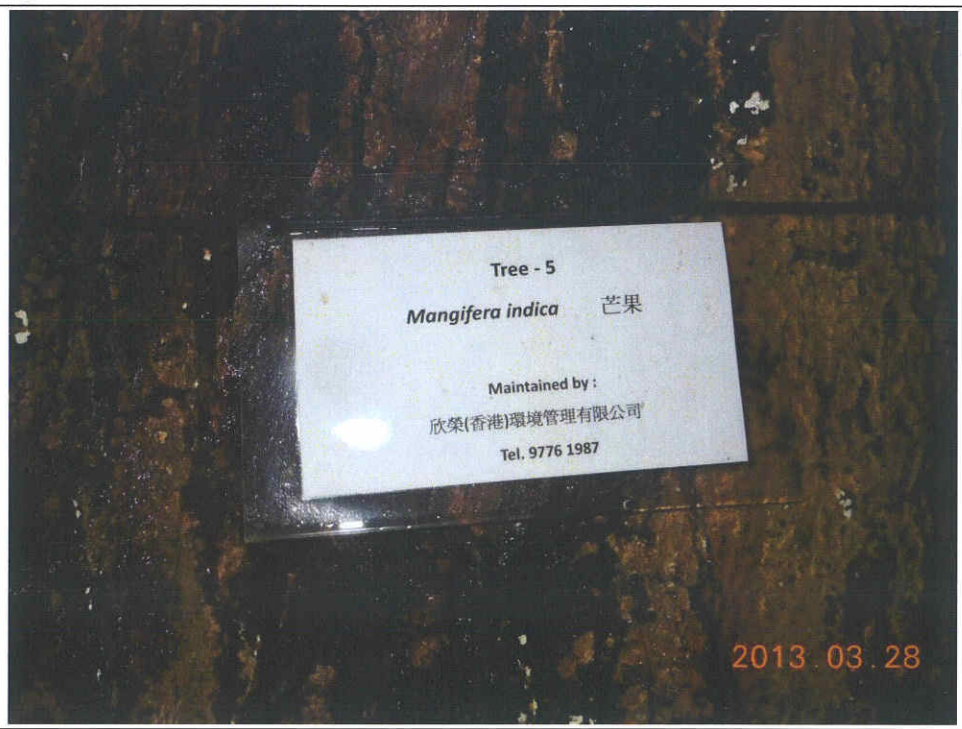
Fig 1. Tree number

1. Overall health condition of the tree is good.
2. Cleanliness of the planter is acceptable.
3. The site appears clean and tidy.
4. The tree is in blossom at the time of inspection.
5. Construction works in progress outside the cordon zone.

Fig 2. Cleanliness of the planter is acceptable.

Fig. 3 The site appears clean and tidy

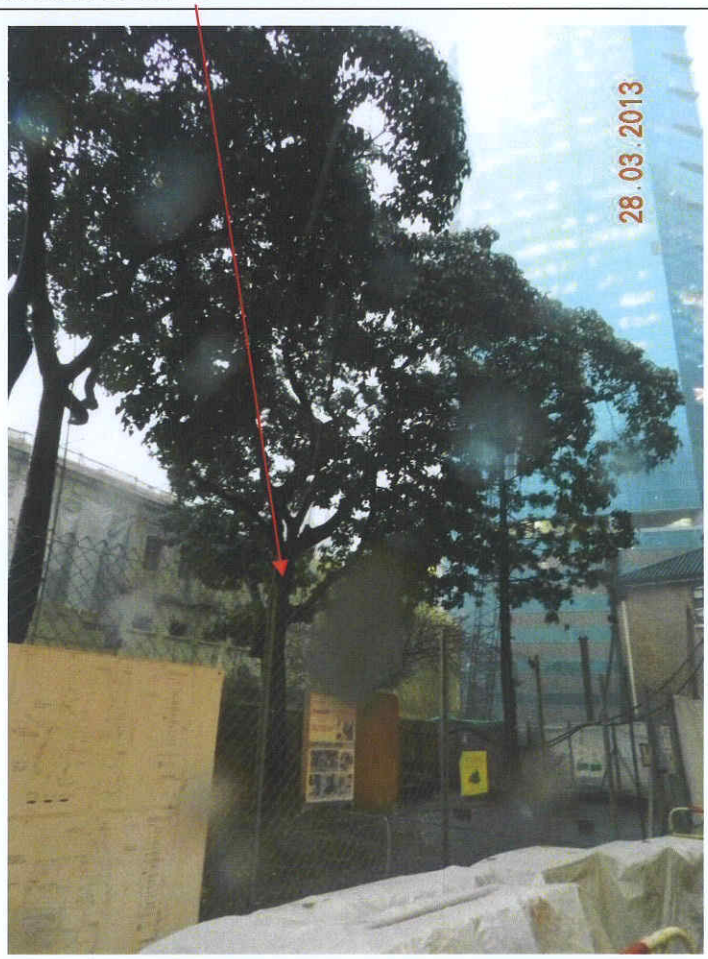
1. Overall health condition of the tree is fair.
2. Cleanliness of the planter is acceptable.
3. Cleanliness of the site is acceptable.
4. Appropriate notices display in front of the cordon zone.

Fig. 4 Appropriate notices display in front of the cordon zone.

Fig. 5 Side view of Tree 7

Fig. 6 Overall view of Tree-7 during inspection on 28.3.2013.

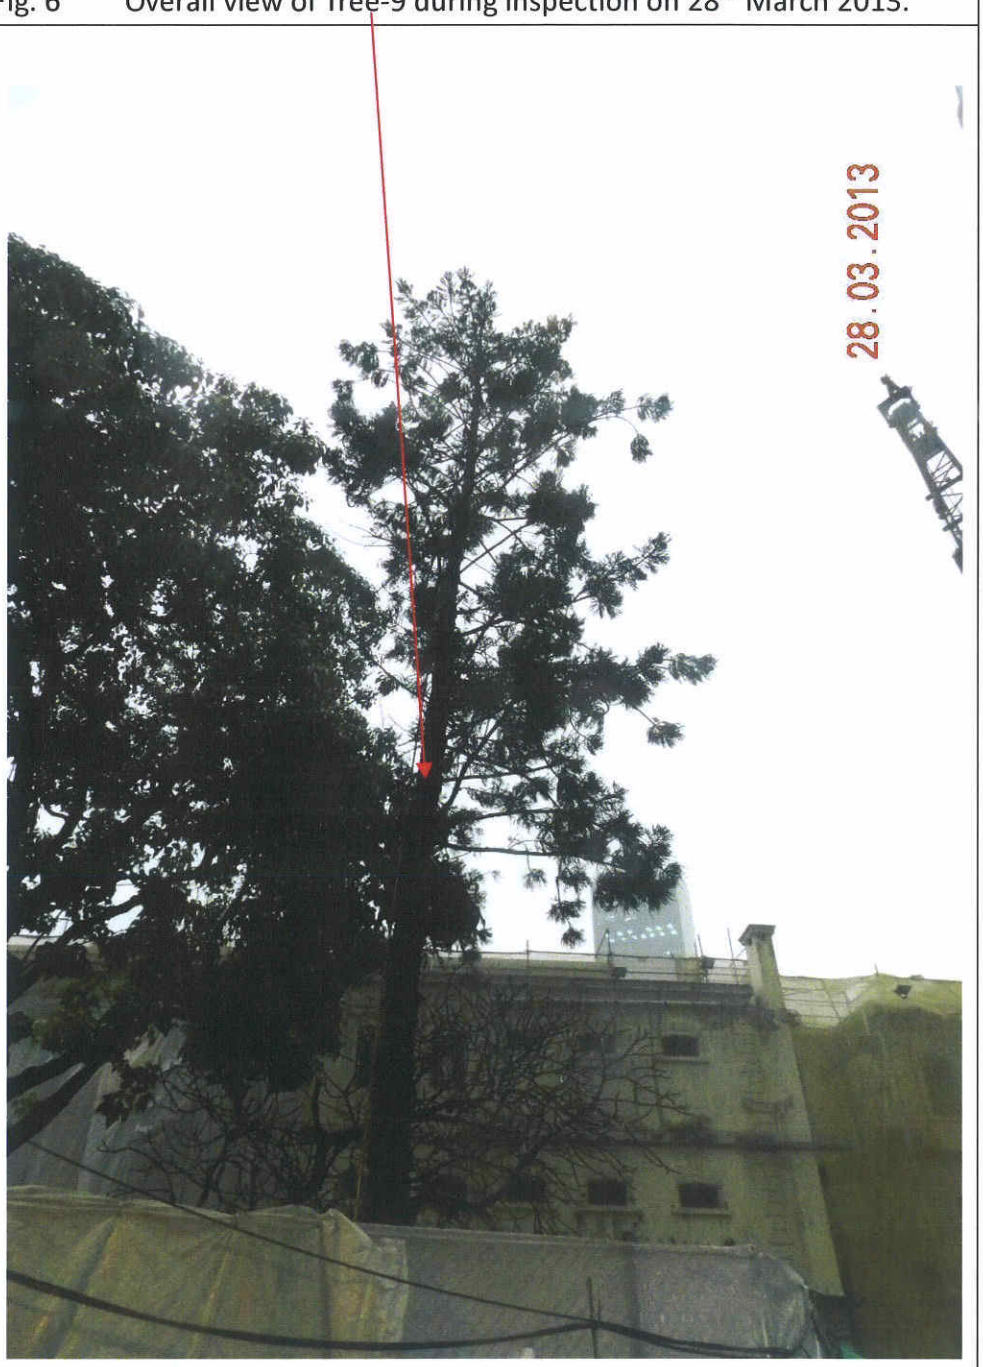
Landscape and visual monitoring has commenced since October 2011 on a monthly basis. Tree inspection was conducted on 28 March 2013 by the arborist during the reporting period. Sap flow was still observed on the mid-trunk of Tree-9 and close monitoring by the Contractor was recommended.

Fig. 5 It is raining at the time of inspection, the site outside the cordon zone is clean and tidy.

Fig. 6 Overall view of Tree-9 during inspection on 28th March 2013.

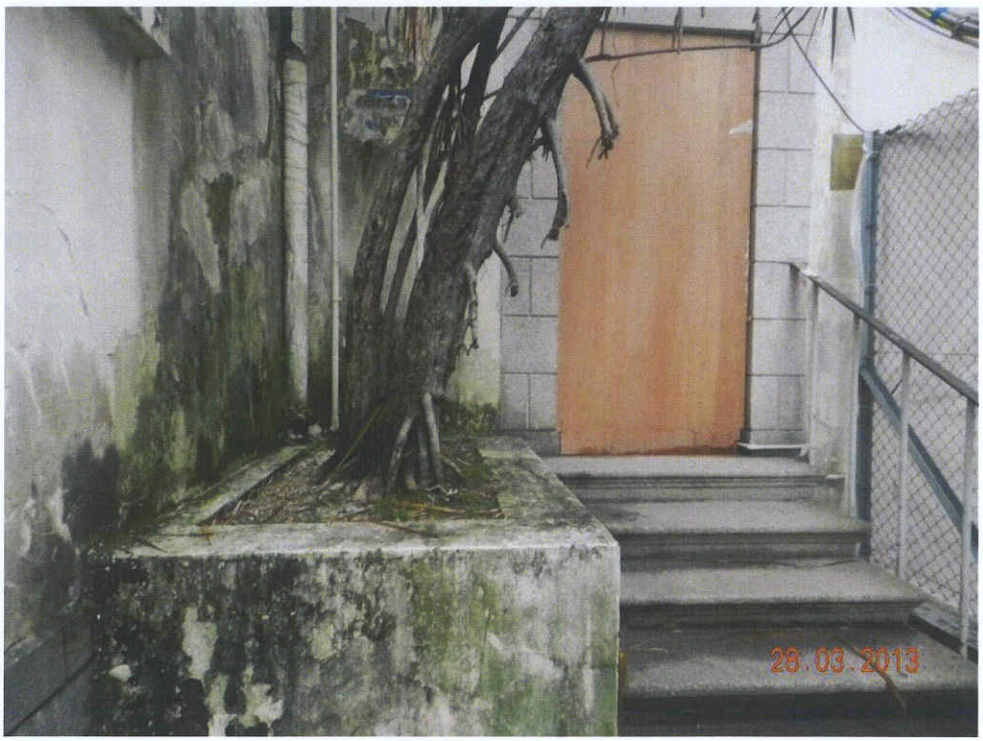
Fig. 2 The planter is clean and tidy.

Fig. 3 The site is clean and tidy at the time of inspection.

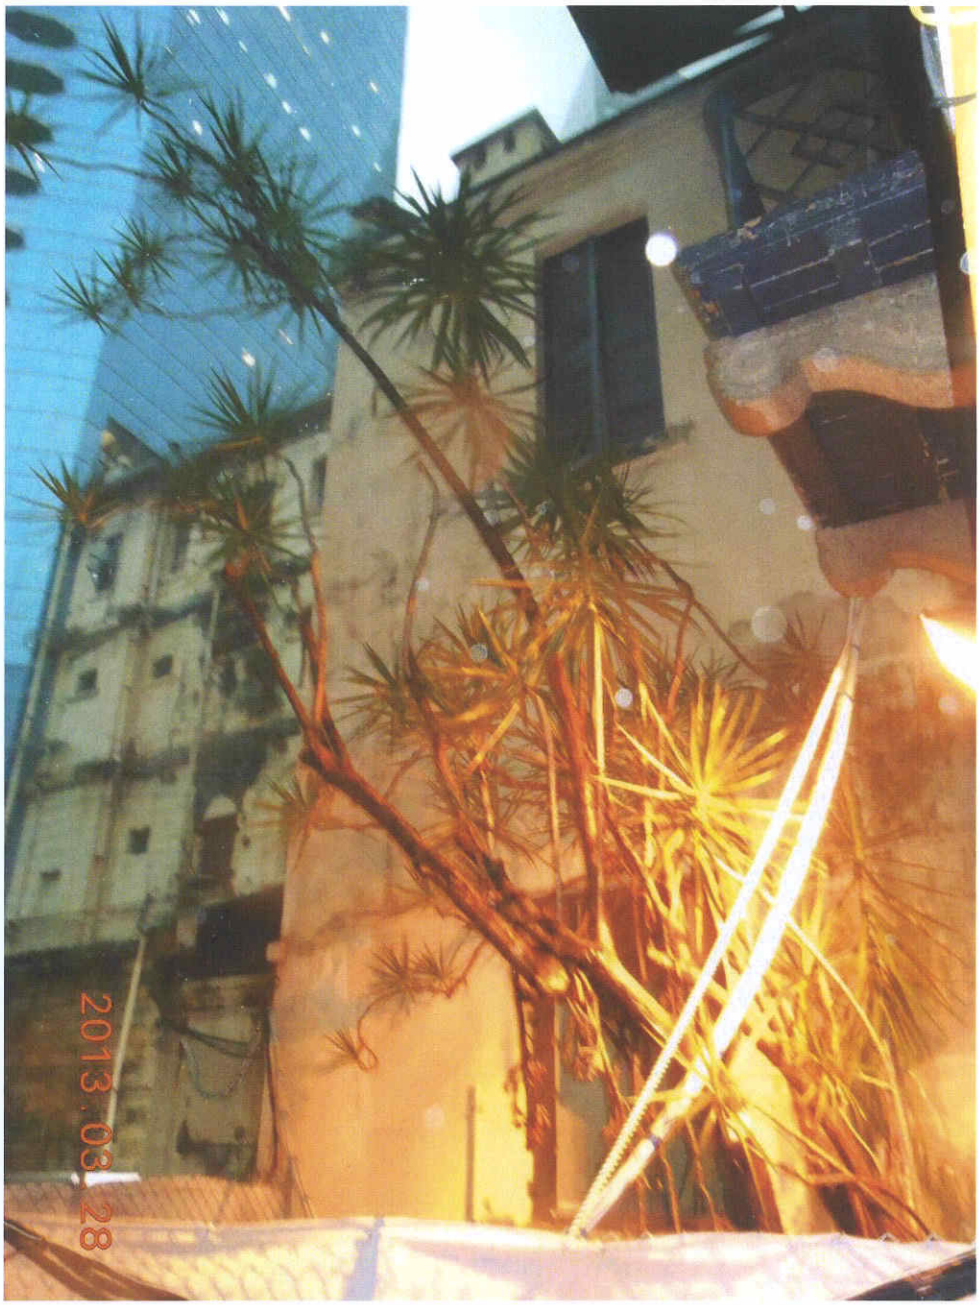
Fig. 4 The tree is growing healthily at site.

Fig. 5 The site outside the cordon zone is clean and tidy.

Fig. 6 Overall view of Tree-11 during inspection on 28th March 2013.

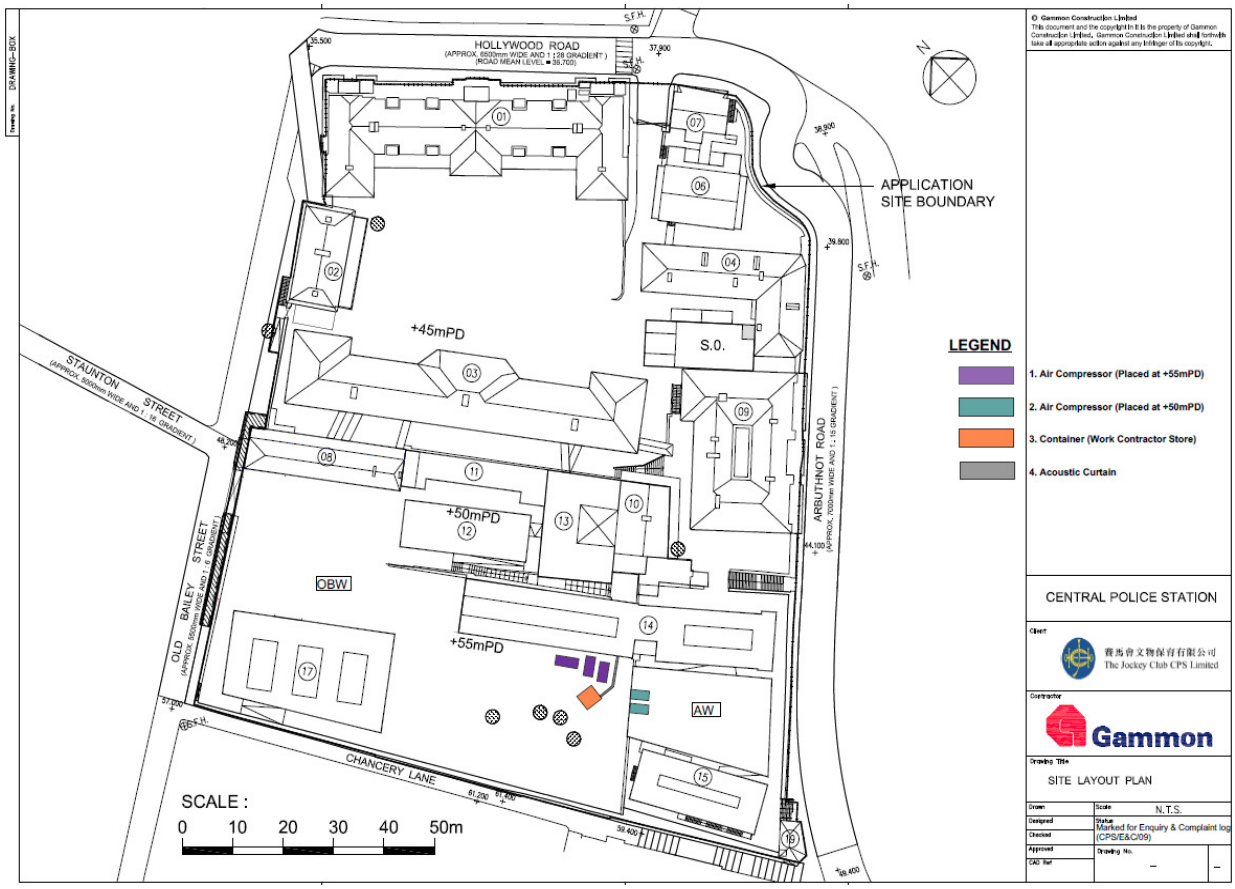
Figure 1 – Site layout plan showing locations of air compressors and noise barrier

2. According to the information provided by the Contractor, the air compressors were only operating during daytime and the air compressor in the open area near Block 14 was provided with noise barriers on the side *(Figure 2)*.

Figure 2 – Noise barrier for air compressors near Block 14

The Contractor should follow all relevant noise requirements specified in EIA, EM&A Manual, EMP, Method Statements, General and Particular Specifications of this Project. The Contractor was recommended to conduct regular inspection of the air compressors and other machineries to ensure that they are well-maintained and operating in normal condition without generating any abnormal or excessive noise. The Contractor was also reminded that machines and plants that may be in intermittent use should be shut down if not in use or throttled down to a minimum.
