Contract No. EP/SP/58/08

Sludge Treatment Facilities

Environmental Monitoring and Audit Report

July 2012

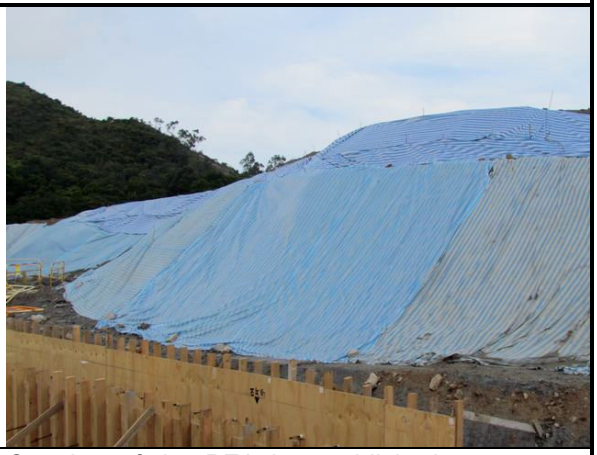
1. Photographic Record of the PFA Treatment

The PFA excavated has been dehydrated under sunlight, and will be buried back to its original position inside the site boundary.	Capping of the PFA is established to prevent spreading in air.
2. Photographic Record of Protection to the Fell / Retained Trees

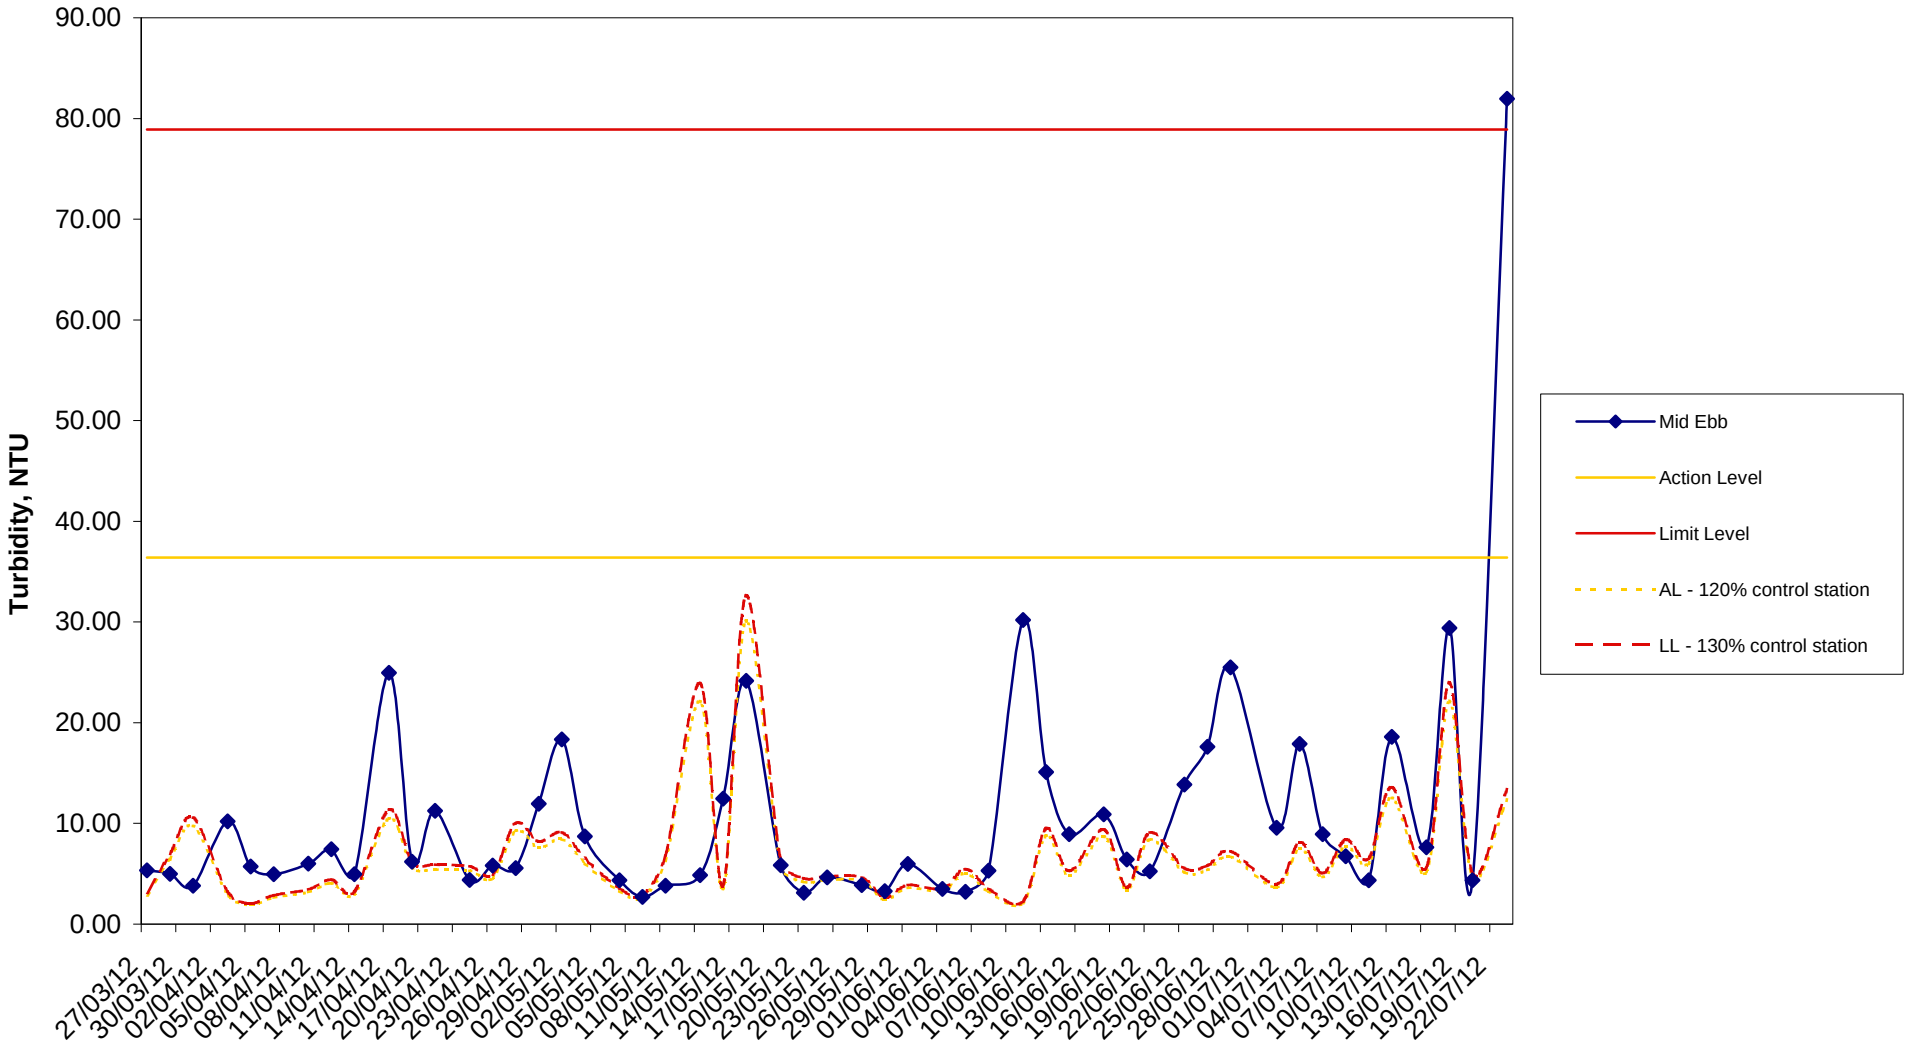
W1 - Turbidity (Mid-Ebb)

1 event of exceedance of turbidity was recorded at mid-ebb on 23 July 2012 at W1. 1 event of exceedance of SS was recorded at mid-ebb on 23 July 2012 at W1. The events were caused by heavy rainstorm occurred in the afternoon, soil and other runoff were flushed into the river and the riverbed sediment at upstream of W1 was stirred up by the runoff. Muddy discharge from the WENT Landfill also contributed to the turbidity and suspended solids levels at W1. Hence, the exceedances should not be related to the Project.

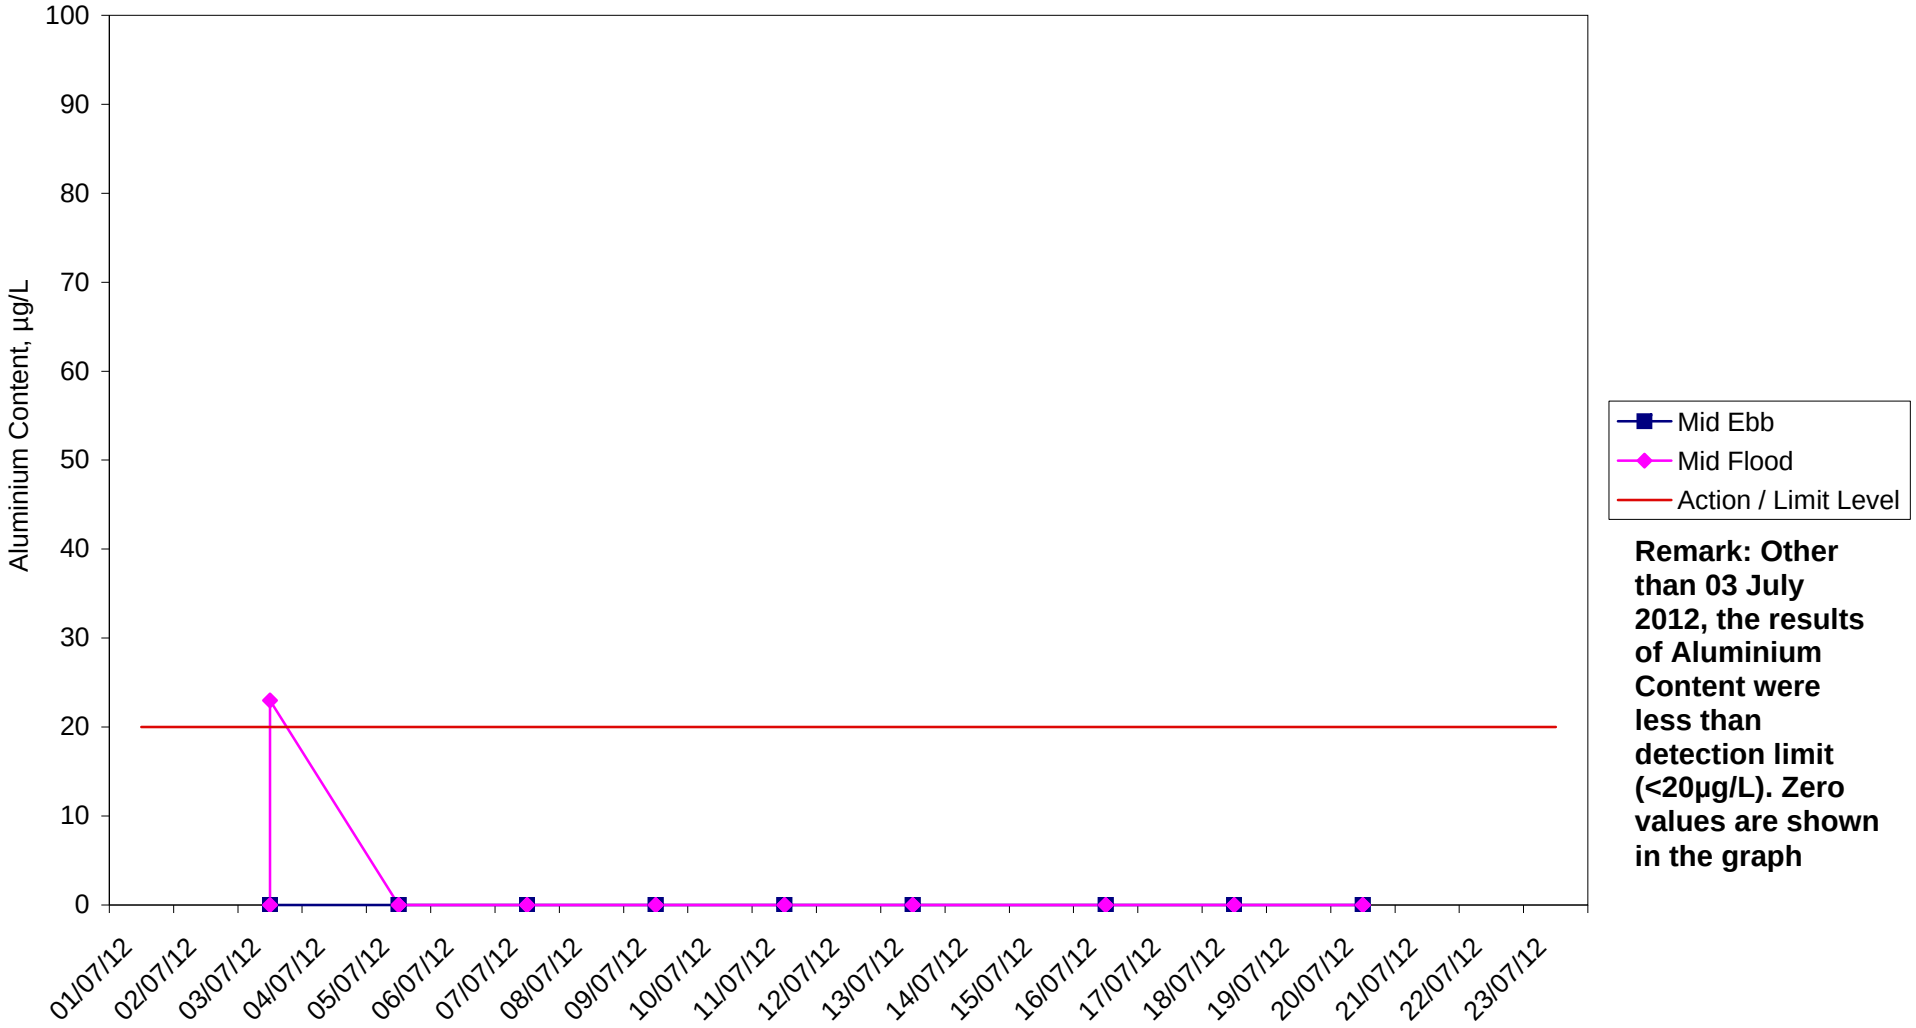
M1 - Aluminium Content

1 event of exceedance of aluminium was recorded at mid-flood on 03 July 2012 at M1. Since the pre-bore operation for sheet piling has not commenced yet, so that the exceedance was not caused by the construction work. The aluminium content in the afternoon (mid-ebb) returned to <20 µg/L. No potential source of impact was identified and hence, the exceedance should not be related to the Project.

Remark: Other than 03 July 2012, the results of Aluminium Content were less than detection limit (<20µg/L). Zero values are shown in the graph
