MTR Corporation Limited

Shatin to Central Link –
Tai Wai to Hung Hom Section

Monthly EM&A Report No. 2

[Period from 1 to 31 October 2012]

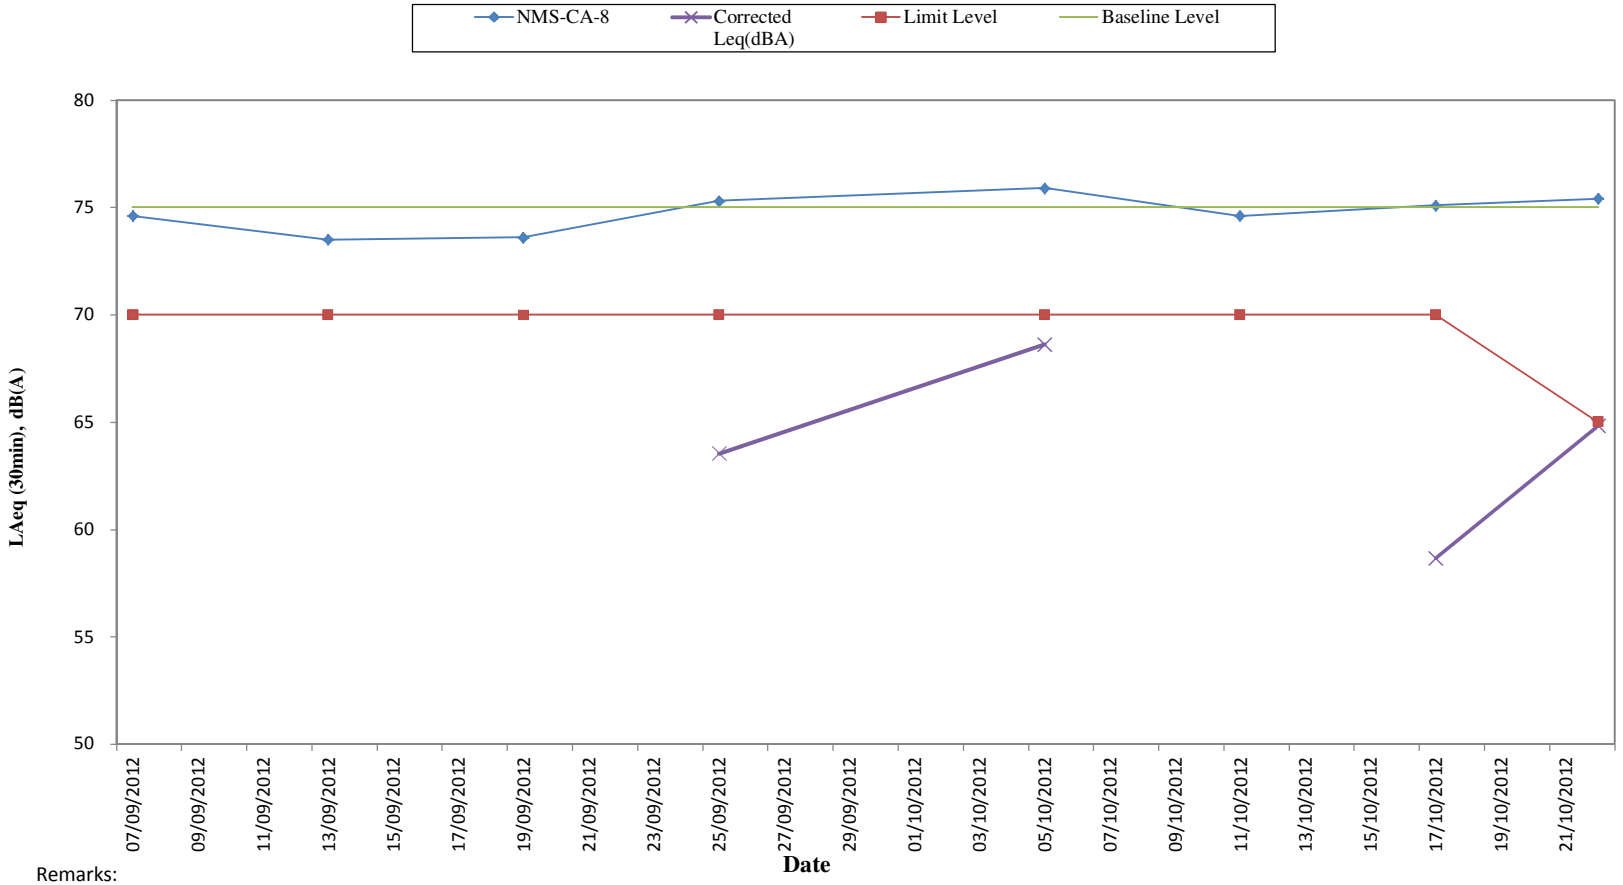
Regular Noise Monitoring Results at NMS-CA-8 (Leq, 30min) for the Past 2 Months

Examination was undertaking during the monitoring on 22th October 2012. The limit level is 65dB(A).
The noise monitoring results of the measurements carried out on 5, 11, 17 and 22 have exceeded the construction noise criterion. However, the results are considered as compliance if they are either below the baseline level or the results after deducting the baseline noise level are below the construction noise criterion

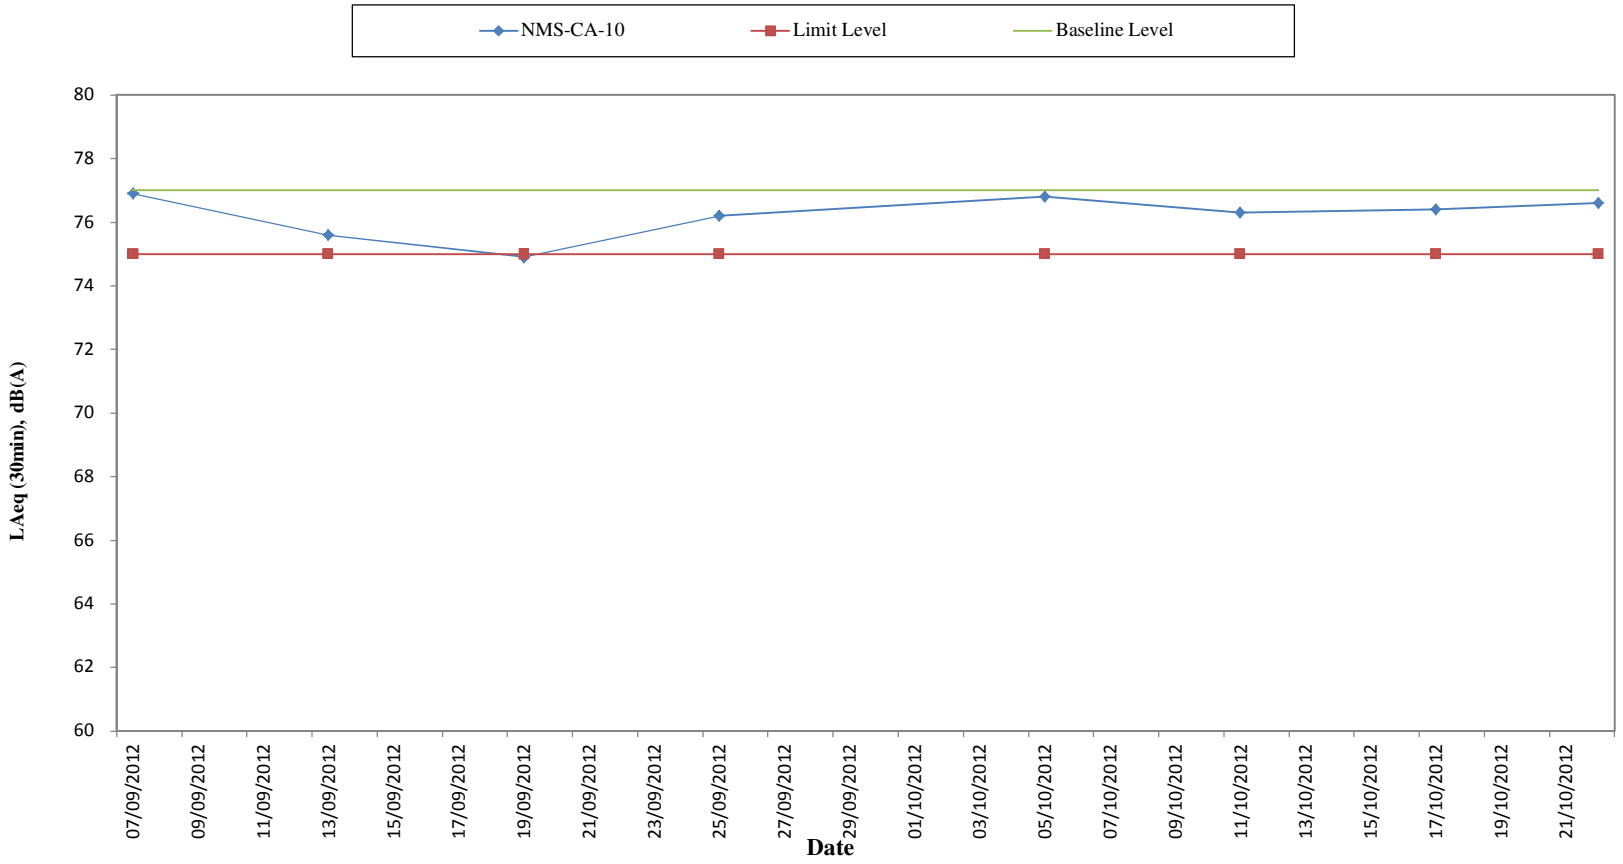
Regular Noise Monitoring Results at NMS-CA-10 (Leq, 30min) for the Past 2 Months

The noise monitoring results of the measurements carried out on 5, 11, 17 and 22 have exceeded the construction noise criterion. However, the results are considered as compliance if they are either below the baseline level or the results after deducting the baseline noise level are below the construction noise criterion
