Contract No.: CV/2015/07
Handling of Surplus Public Fill
(2016-2018)

TUEN MUN AREA 38 FILL BANK

MONTHLY EM&A REPORT NO.16

(AUGUST 2018)

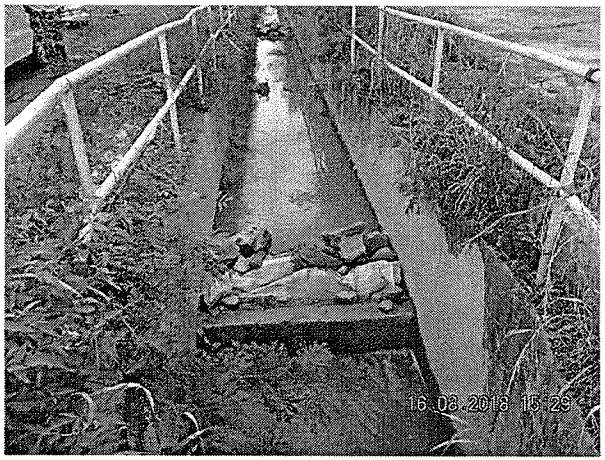
Photo 180816_001(Near Tipping Hall No.3) (Improved)

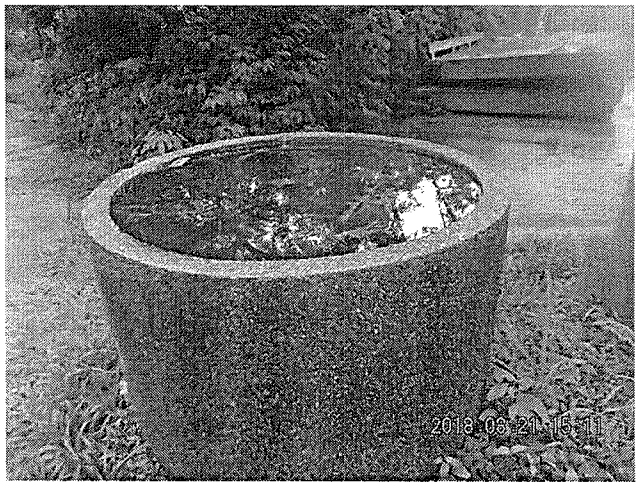
Photo 180821_001(Near China Harbour' Office)
