Civil Engineering and Development Department

Agreement No. CE 59/2015 (EP)
Environmental Team for
Tseung Kwan O – Lam Tin Tunnel
Design and Construction

Monthly Environmental Monitoring and Audit Report for July 2018

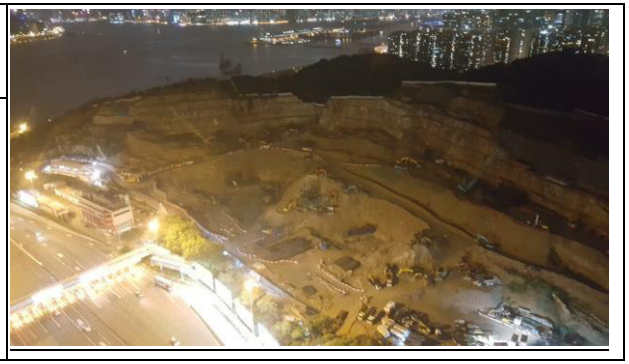
Part B – Conclusion: The exceedances of night time noise limit level were not due to the Project. Only blasting associated works inside the tunnel were being conducted with blast door closed. As the blasting works was about 400 meters away from the blasting door, noise generated within the tunnel should not be associated with the exceedance.
