China Harbour – Zhen Hua Joint Venture

Contract No.: CV/2015/07
Handling of Surplus Public Fill
(2016-2018)

TUEN MUN AREA 38 FILL BANK

MONTHLY EM&A REPORT NO.18

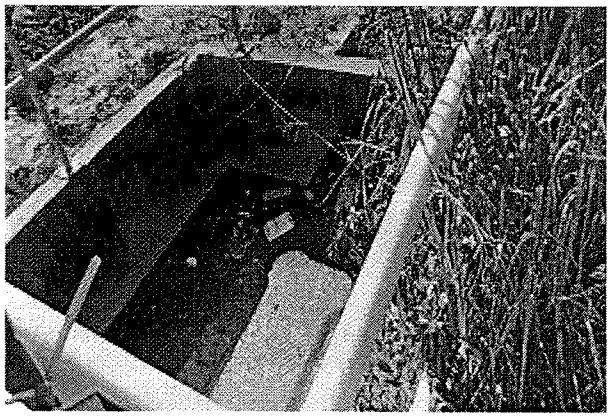
Photo 181004_001(Near Tipping hall no.3)

Item	Details of defective works or observations	Proposed Follow Up Action	Photo Ref.	Further Action Required (Yes/No)	Target Completion Date
1	Mud and silt were found accumulated inside the main drainage channel near tipping hall No.3.	To clear the accumulated mud and silt to avoid any blockage.	181004_001	Yes	11/10/18
