Monthly EM&A Report
(April 2021)

Contract No.	**:**	DPW 01/2020
Contract Name	**:**	Environmental Team for Drainage Improvement Works at Ngong Ping (Contract No. DC/2019/06)
Report No.	**:**	0118/20/ED/0332A
EP No.	**:**	EP-456/2013/A

Project Title	Drainage Improvement Works at Ngong Ping
Document Title	Monthly EM&A Report (April 2021)
Fugro Project No.	0118/20
Fugro Document No.	0118/20/ED/0332A
Issue Number	01

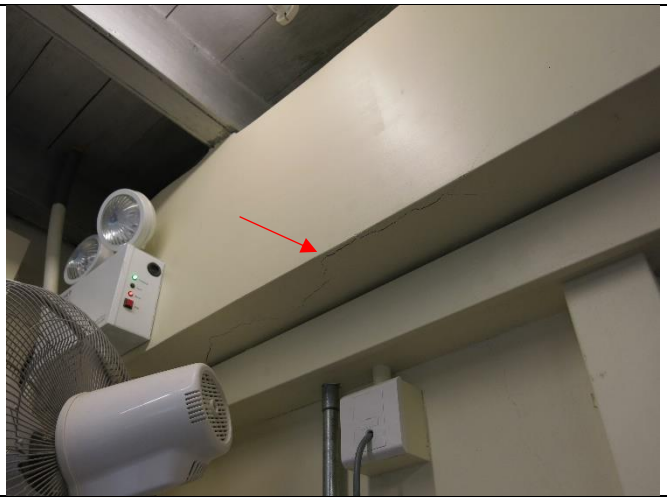
Photo 8: No crack monitoring devices were found at locations as recommended in the approved survey report of NP-11
