Contract No.: CV/2015/07
Handling of Surplus Public Fill
(2016-2018)

TUEN MUN AREA 38 FILL BANK

MONTHLY EM&A REPORT NO.39

(JULY 2020)

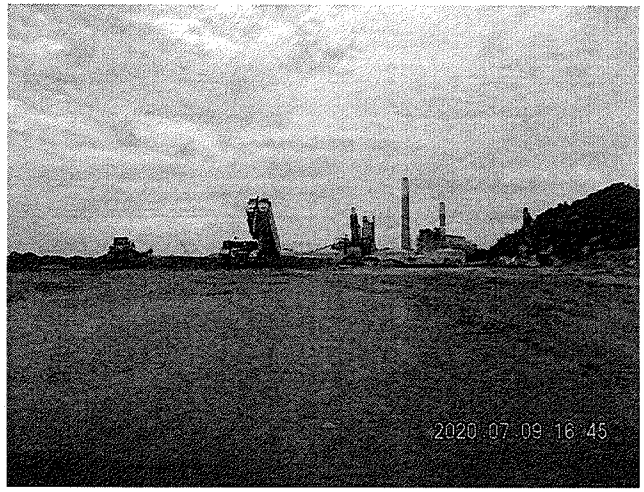
Photo 200709_001 (Near Dry Soil Platform)

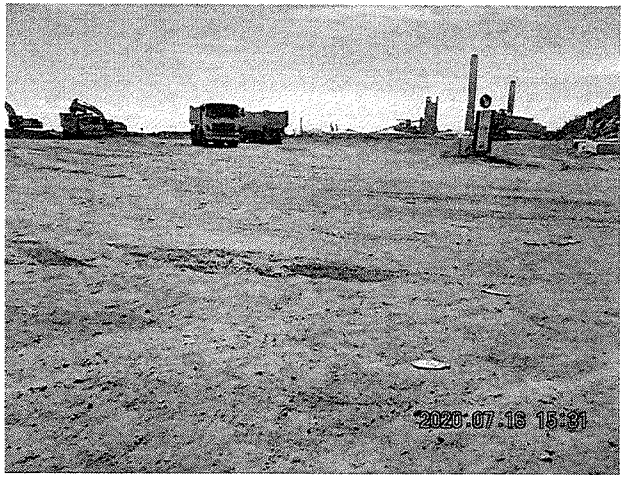
16 July 2020	*Dust emission were observed near dry soil platform (Previous item)*	*Provide the water spray to control the dust emission properly.*	*Water spray were provided*	*Closed*
	Overgrown weeds were observed near China Harbour's Office (New item)	*To clean the overgrown weeds properly.*	*---*	*Follow-up*
	Oil stains were observed near Tipping hall no.1 (New item)	*To clean the oil stains properly.*	*---*	*Follow-up*
23 July 2020	*Overgrown weeds were observed near China Harbour's Office (Previous item)*	*To clean the overgrown weeds properly.*	*Overgrown weeds were cleaned.*	*Closed*
	Oil stains were observed near Tipping hall no.1 (Previous item)	*To clean the oil stains properly.*	*Oil stains were cleaned*	*Closed*
28 July 2020	*Overgrown weeds were observed near weighbridge (New item)*	*To clean the overgrown weeds properly.*	*---*	*Follow-up*

Photo 200716_001 (Near Dry Soil Platform) (Improved)

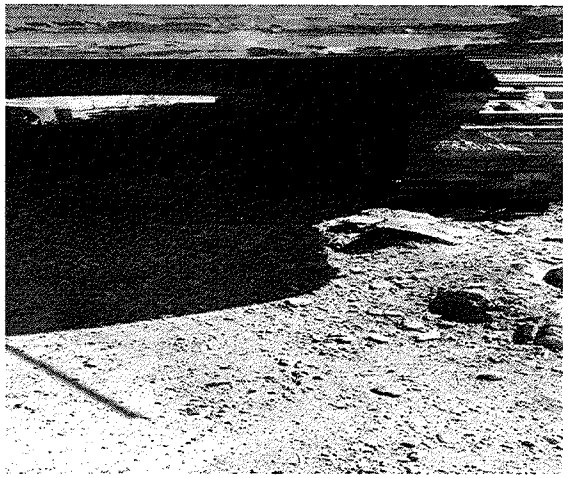
Photo 200723_002 (Near Tipping Hall no.1) (Improved)
