Contract No.: CV/2015/07
Handling of Surplus Public Fill
(2016-2018)

TUEN MUN AREA 38 FILL BANK

MONTHLY EM&A REPORT NO.48

(APRIL 2021)

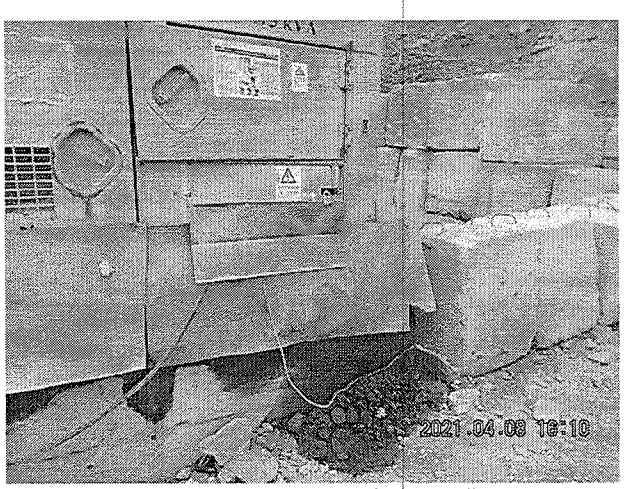
Photo 210408_001 (Near U-Channel)

Date	*Key Findings*	*Action(s) Taken recommended by ET*	*Action(s) Taken by the Contractor during the site audit*	*Rectification Status by ET*
08 April 2021	*Oil stains were observed beside the generator near U-channel (New item)*	*To clean the oil stains properly*	---	*Follow-up*
15 April 2021	*Oil stains were observed beside the generator near U-channel (Previous item)*	*To clean the oil stains properly*	*Oil stains were cleaned*	*Closed*
22 April 2021	*No defective work or observation was recorded during the weekly ET site inspection*			
29 April 2021	*No defective work or observation was recorded during the weekly ET site inspection*

The Contractor should provide sufficient preventive measures during equipment maintenance works so as to avoid oil leakage on the ground. In the event of any oil leakage, the Contractor should clean up the polluted soil and handle all the materials used for this cleaning works as chemical waste.
