Re: Contract No. CM 10/2018

Independent environmental checker services for inter-reservoirs transfer scheme (IRTS)

– water tunnel between Kowloon byewash reservoir and lower shing mun reservoir

24th Monthly EM&A Report (Rev. 1)

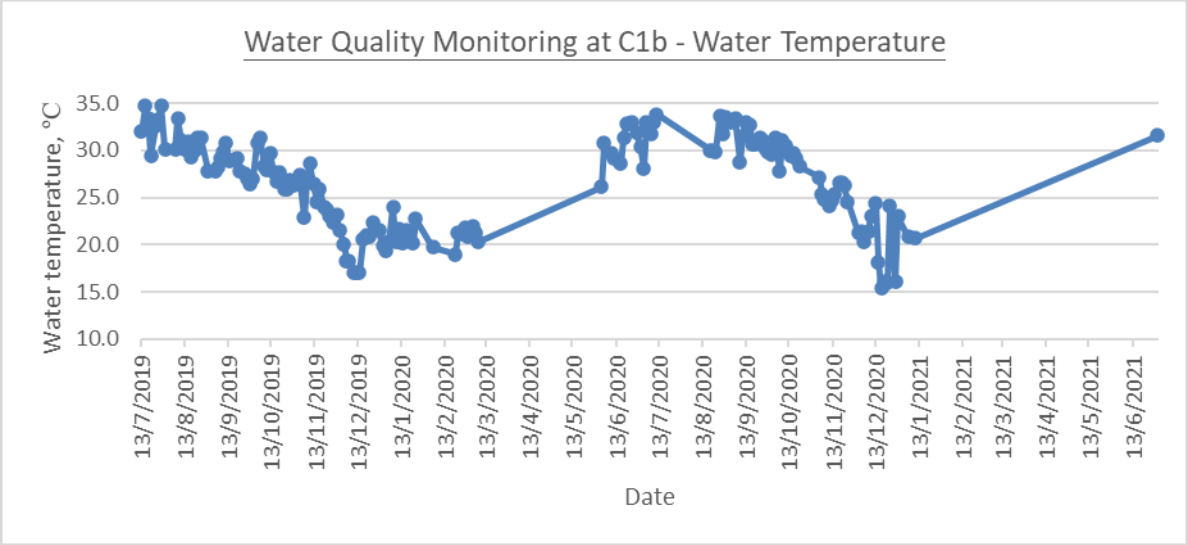
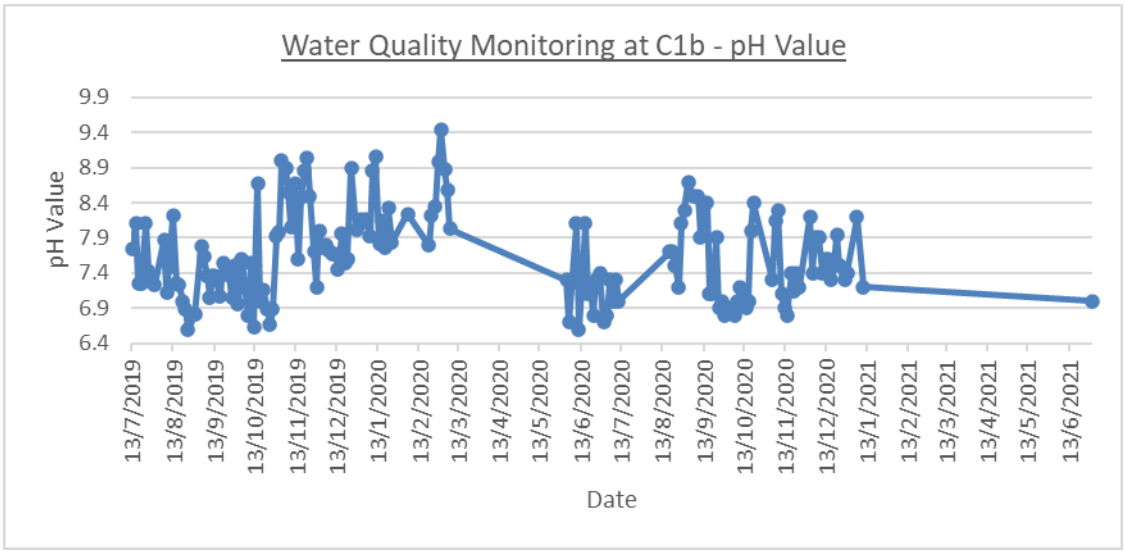
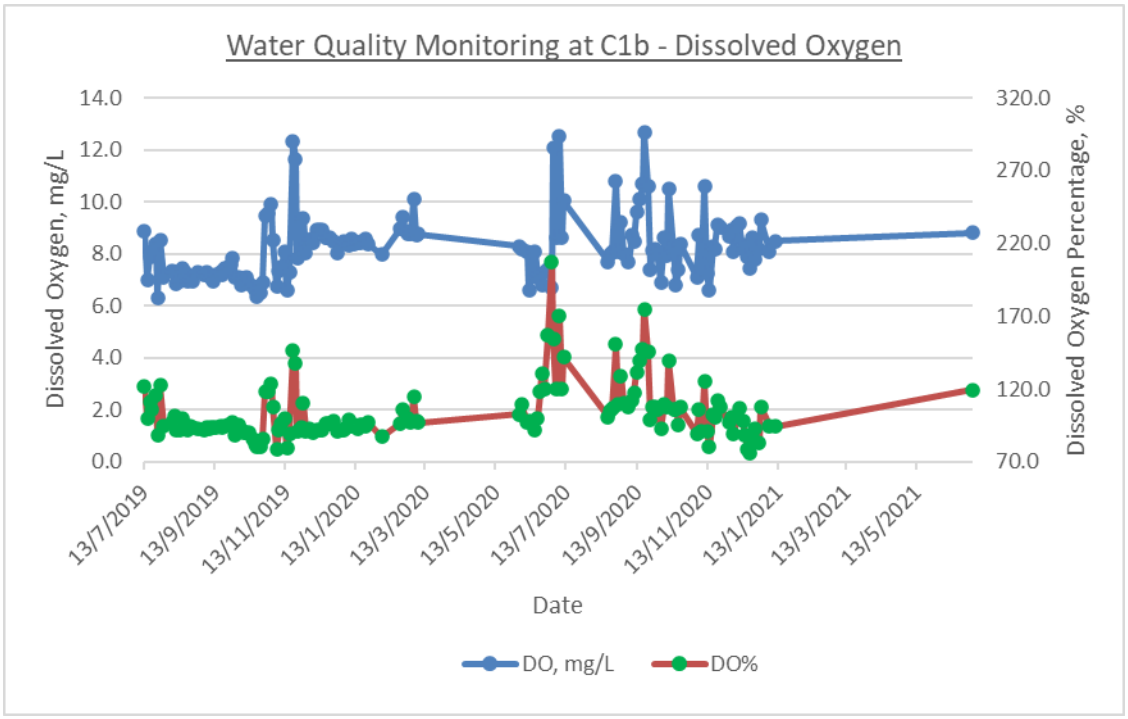
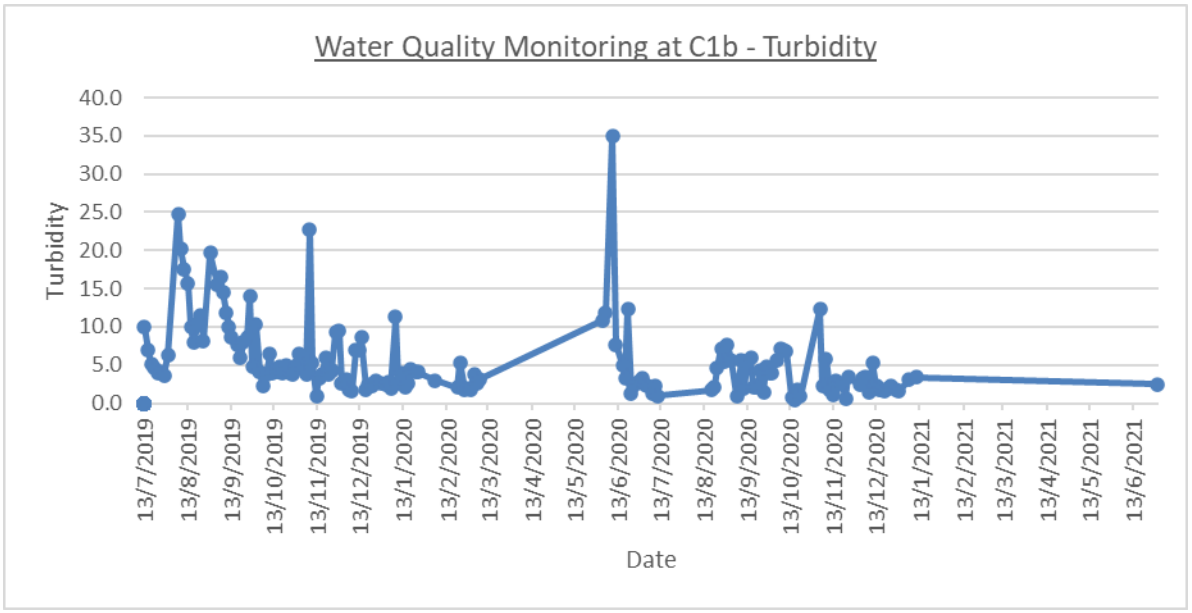
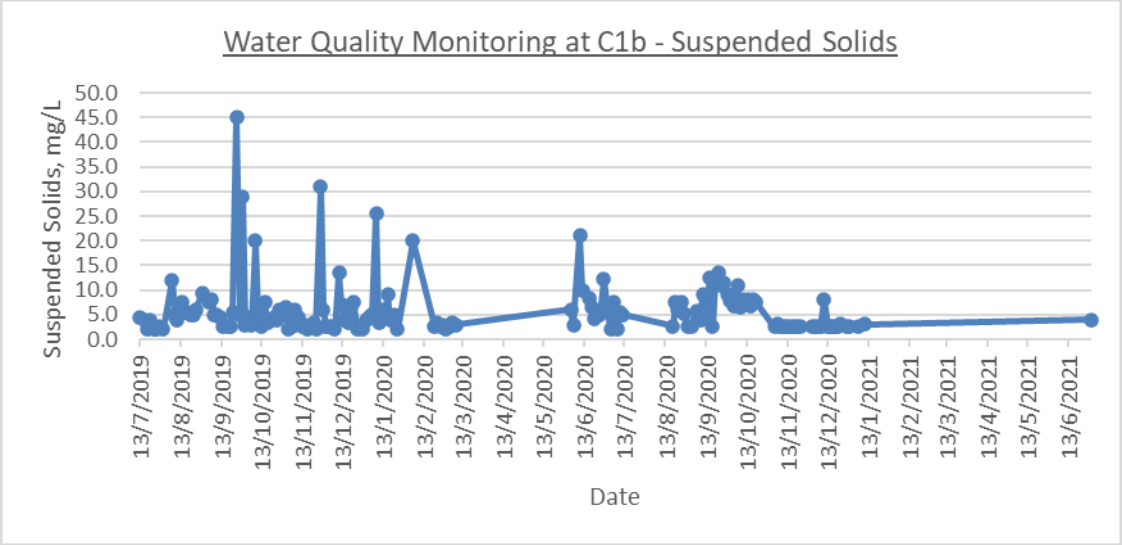
Note 1: Period without data implied that water in location C1b was dried up, insufficient water was available for sample collection

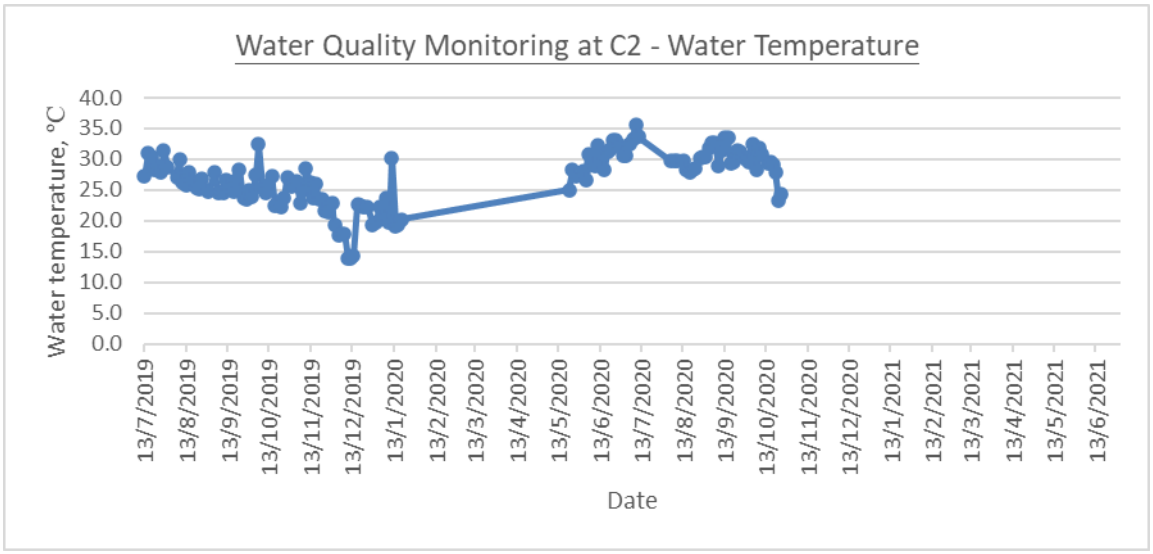
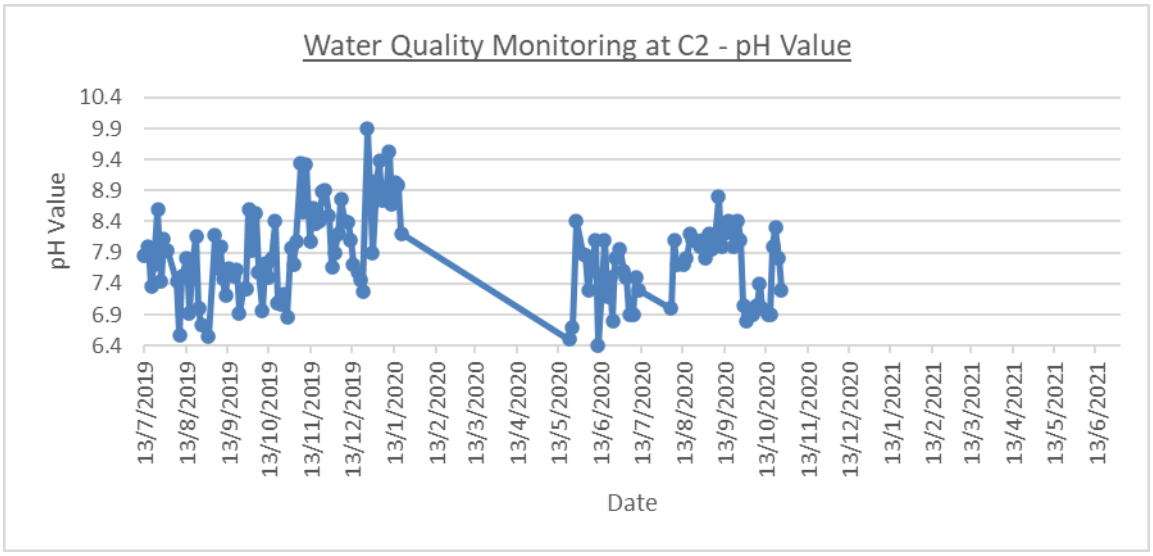
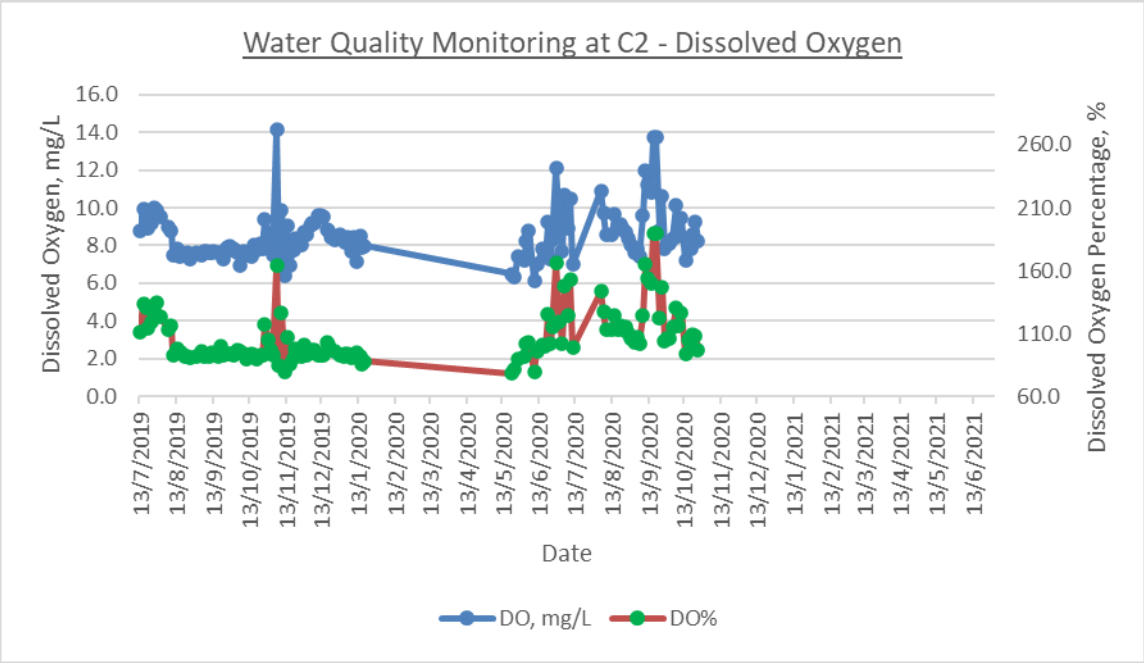
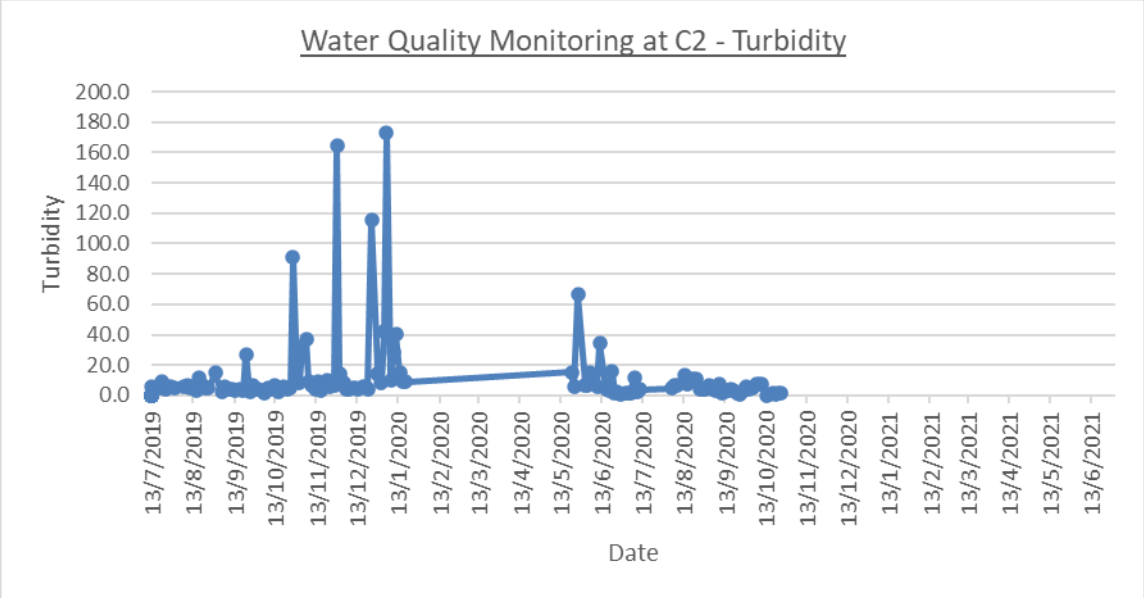
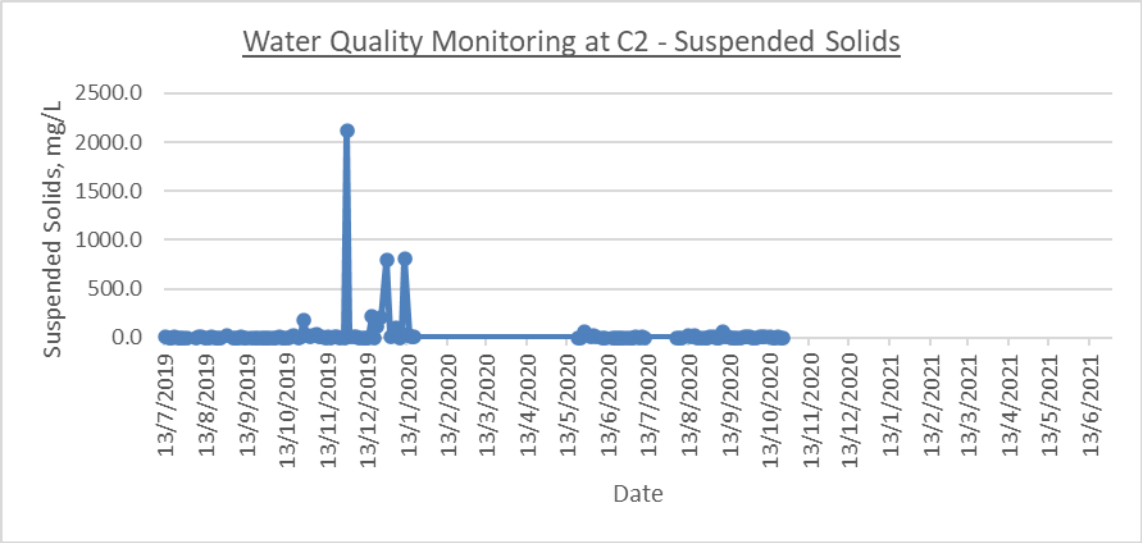
Note 1: Period without data implied that water in location C2 was dried up, insufficient water was available for sample collection

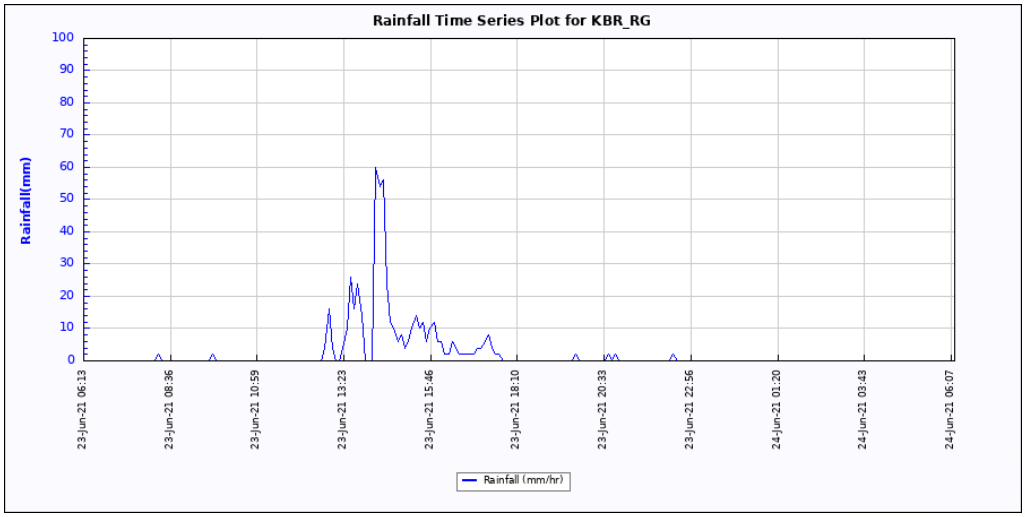
Figure 1

Remark	The exceedance is considered project unrelated. The Contractor is advised to improve the drainage control within the site to ensure no wastewater from the land-based construction activities shall enter the nearby water bodies.
