Monthly EM&A Report
(January 2022)

Contract No.	**:**	DPW 01/2020
Contract Name	**:**	Environmental Team for Drainage Improvement Works at Ngong Ping (Contract No. DC/2019/06)
Report No.	**:**	0118/20/ED/0440
EP No.	**:**	EP-456/2013/B

Drainage Improvement Works at Ngong Ping
Monthly EM&A Report for January 2022

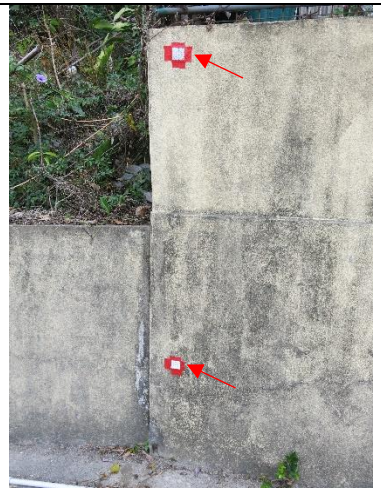
Photo 1: General View of NP-10	Photo 2: Reflective targets for settlement monitoring were installed on the fence wall at NP-10.	Photo 3: Tell-tales for crack monitoring were installed at NP-10.

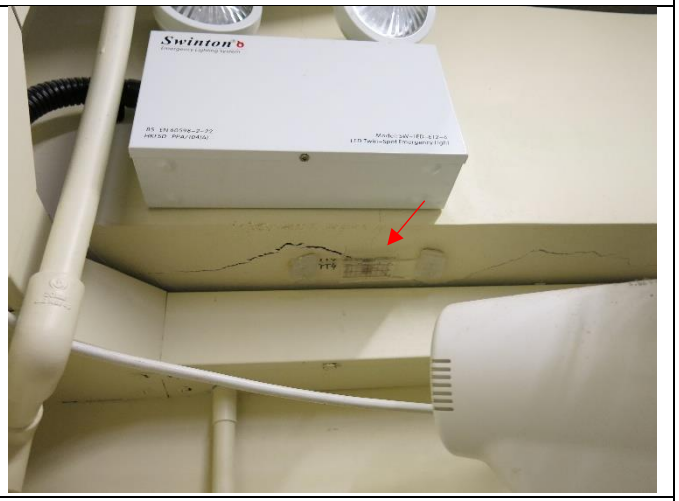
Photo 4: General View of NP-11	Photo 5: Ground settlement marker for settlement monitoring was installed at the entrance of NP-11.	Photo 6: Tell-tale for crack monitoring was installed at NP-11.
