Monthly EM&A Report
(October 2023)

Contract No.	**:**	DPW 01/2020
Contract Name	**:**	Environmental Team for Drainage Improvement Works at Ngong Ping (Contract No. DC/2019/06)
Report No.	**:**	0118/20/ED/0625A
EP No.	**:**	EP-456/2013/B

Drainage Improvement Works at Ngong Ping
Monthly EM&A Report for October 2023

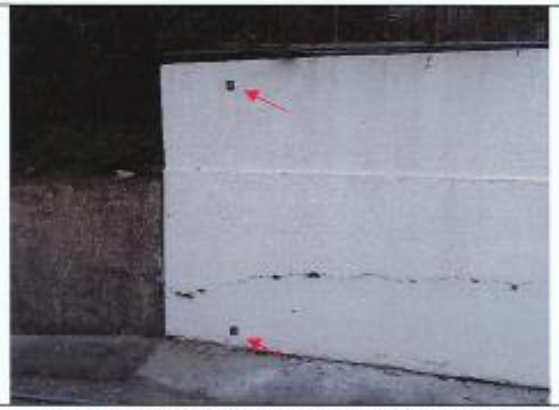
Photo 1: General View of NP-10	Photo 2: Reflective targets for settlement monitoring were installed on the fence wall at NP-10.	Photo 3: Tell-tales (TT1 & TT2) for crack monitoring were removed by the owner at NP-10 due to renovation works; Crack was repaired.
