Monthly EM&A Report
(December 2023)

Contract No.	**:**	DPW 01/2020
Contract Name	**:**	Environmental Team for Drainage Improvement Works at Ngong Ping (Contract No. DC/2019/06)
Report No.	**:**	0118/20/ED/0627A
EP No.	**:**	EP-456/2013/B

Drainage Improvement Works at Ngong Ping
Monthly EM&A Report for December 2023

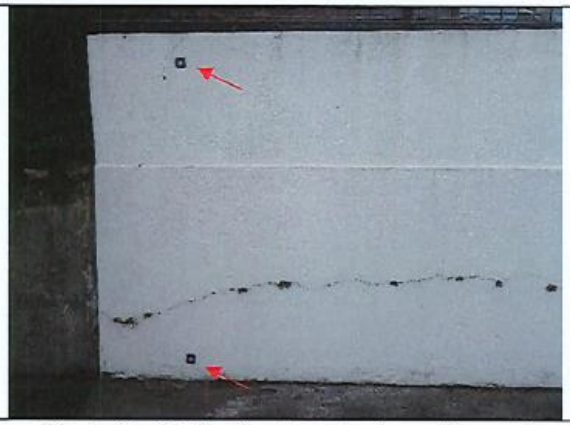
Photo 1: General View of NP-10	Photo 2: Reflective targets for settlement monitoring were installed on the fence wall at NP-10.	Photo 3: Tell-tales (TT1 & TT2) for crack monitoring were removed by the owner at NP-10 due to renovation works; Crack was repaired.

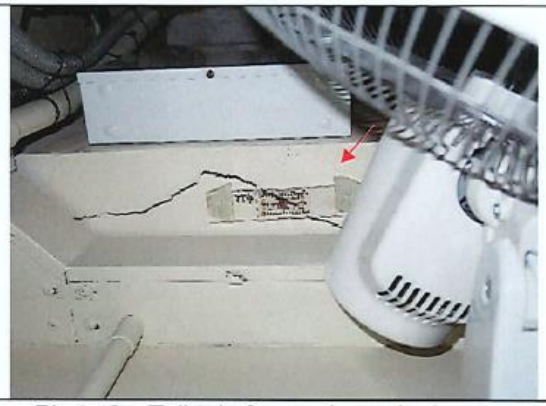
Photo 7: Ground settlement marker for settlement monitoring was installed at the entrance of NP-11.	Photo 8: Tell-tale for crack monitoring was installed at NP-11.	Photo 9: NP-19 has been fenced off in accordance to EM&A Manual.
