**Independent Environmental Checker for
Contract No. YL/2009/01 – Hang Hau Tsuen Channel at
Lau Fau Shan**

**Post-Construction Mangrove Monitoring
2nd Quarterly Mangrove Monitoring Report
(September 2013)**

Prepared for:
Civil Engineering and Development Department

Prepared by:
ENVIRON Hong Kong Limited

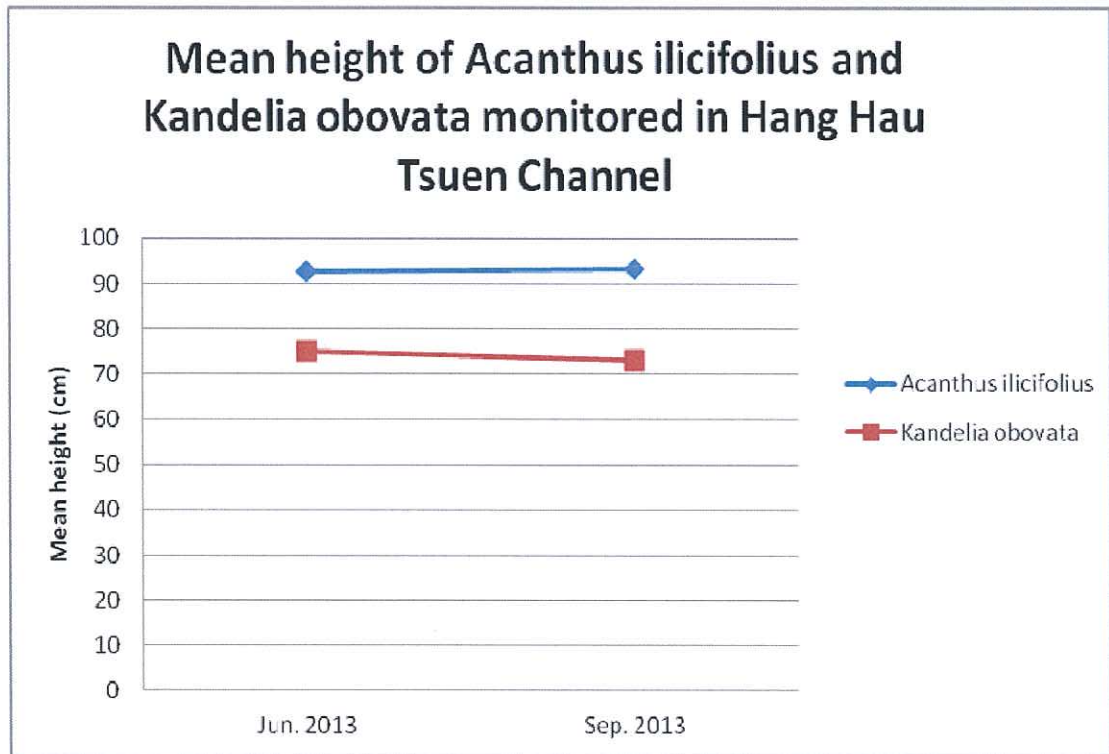
Figure 1 - Mean height (cm) of *Acanthus ilicifolius* and *Kandelia obovata* monitored at Hang Hau Tsuen Channel from Jun 2013 to Sep 2013

- 3.2.2 Mean height & diameter of *Acanthus ilicifolius* and *Kandelia obovata* was calculated and shown in **Table 3 & 4**. The change of measurement parameters since June 2013 was shown in **Figures 1 & 2**.

- 4.1.3 Maximum height and stem diameter of maximum 5 selected individual of each species in each quadrat was measured, the result of the measurement was shown in **Table 1**. Mean height & diameter of *Acanthus ilicifolius* and *Kandelia obovata* was calculated and shown in **Table 3**. The change of measurement parameters since June 2013 was shown in **Figures 1 & 2**. Generally, most mangrove trees were recorded in positive growth and there was increase in height and diameter.
