**Independent Environmental Checker for
Contract No. YL/2009/01 – Hang Hau Tsuen Channel at
Lau Fau Shan**

Post-Construction Mangrove Monitoring

**8th Quarterly Mangrove Monitoring Report
(March 2015)**

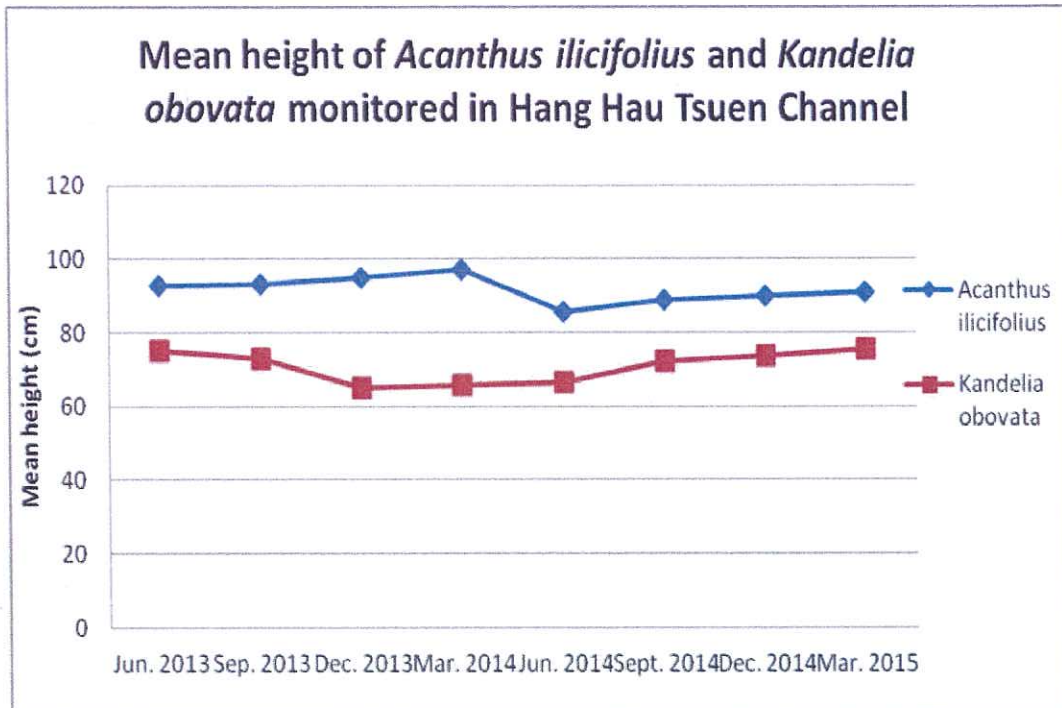
Figure 1 - Mean height (cm) of *Acanthus ilicifolius* and *Kandelia obovata* monitored at Hang Hau Tsuen Channel from Jun 2013 to Mar 2015

- 3.2.1 Maximum height and stem diameter of maximum 5 selected individual of each species in each quadrat was measured during the monitoring survey. Result of the measurement was shown in **Table 1**.
- 3.2.2 Mean height & diameter of *Acanthus ilicifolius* and *Kandelia obovata* was calculated and shown in **Tables 3 & 4**. The change of measurement parameters since June 2013 was shown in **Charts 1 & 2**.
- 3.2.3 By compare the measurement record for both last and current inspection, most mangrove trees were recorded in positive growth and increment in height or diameter was observed. The comparison for the measurement was shown on **Tables 1 to 4**.

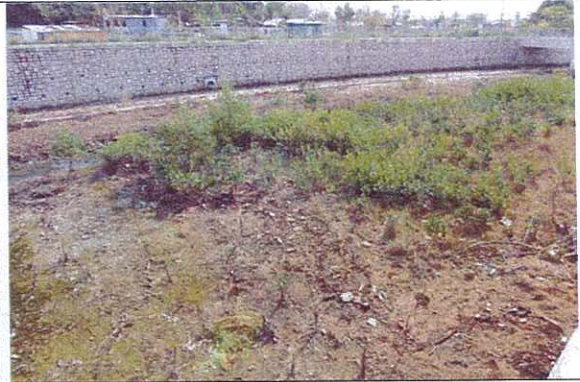
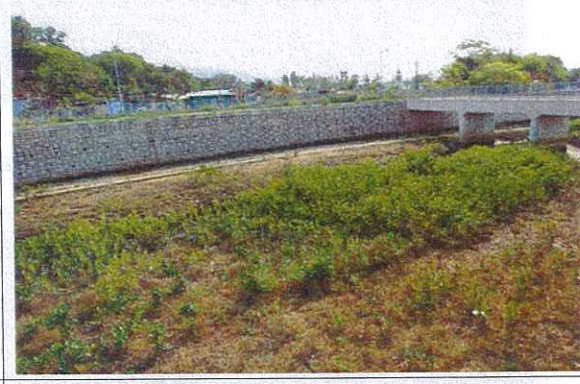
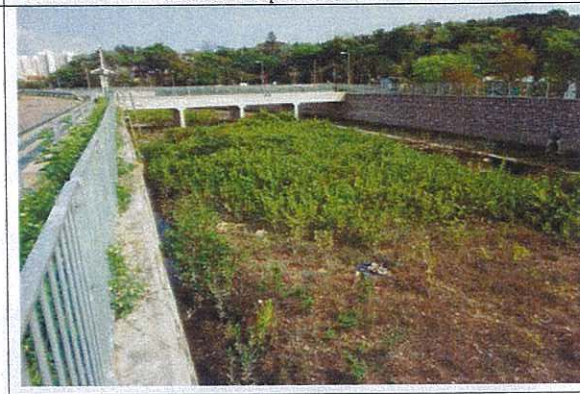
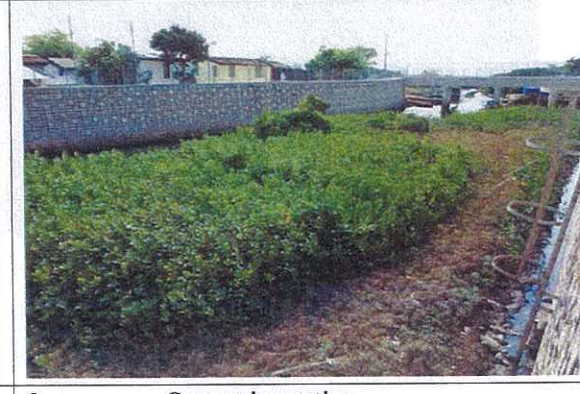
- 4.1.5 The overall view of the mangrove compensation area and each quadrat was presented in **Photos 1-4** and **Photos 5-9** respectively.
- 4.1.6 Monitoring should be conducted once every quarter for two years after completion of the mangrove planting in accordance with Section 6.4 of the EM&A Manual. Thus this is the eighth and the last post-construction quarterly mangrove monitoring report, and a final report summarizing the monitoring results over the entire operational monitoring period and its findings will be prepared separately.

2. Current inspection

4. Current inspection

6. Current inspection

8. Current inspection
