**CEDD CONTRACT NO. CV/2012/05 –
BATHING BEACH AT LUNG MEI, TAI PO**

**POST-CONSTRUCTION MONITORING AND AUDIT
REPORT**

PREPARED FOR
WELCOME CONSTRUCTION CO., LTD.

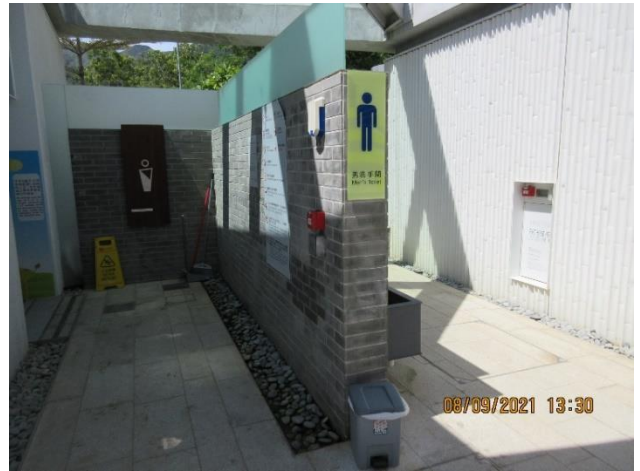
Photo J.

No plant in the planter outside the male (Planter P14) changing room

1. Two nos. of new trees (*Michelia x alba*) are found dead, contractor is required to replace the concerned trees. (Photo I)
2. There is no planting with bare soil in the planters outside the male (Planter P14) and female (Planter P3b) changing rooms. (Photo J and Photo K).
3. The contractor is required to plant *Schefflera arboricola* instead of *Rhapis excelsa* as shown on the plan for the planter (Planter P7) close to the male changing room. (Photo L)
4. *Bauhinia glauca* is required to plant as shown on plan but it was not found within the site. The Contractor is required to follow the approved plan and complete all planting including the planting of *Bauhinia glauca* before the next audit checking.

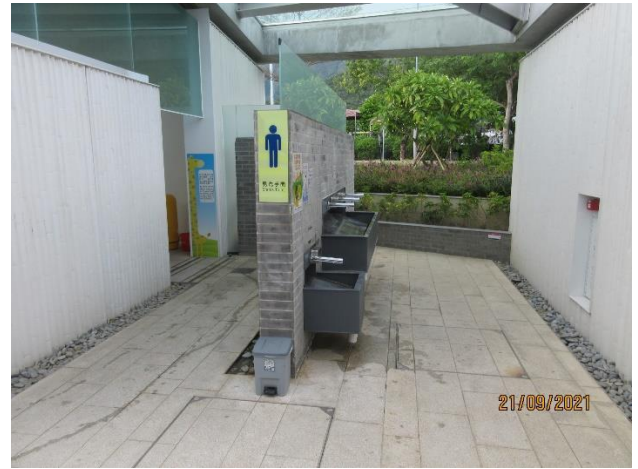
Photo J.

No plant in the planter outside the male (Planter P14) changing room

1. Two nos. of new trees (*Michelia x alba*) are found dead, contractor is required to replace the concerned trees. (Photo I)
2. There is no planting with bare soil in the planters outside the male (Planter P14) and female (Planter P3b) changing rooms. (Photo J and Photo K).
3. The contractor is required to plant *Schefflera arboricola* instead of *Rhapis excelsa* as shown on the plan for the planter (Planter P7) close to the male changing room. (Photo L)
4. *Bauhinia glauca* is required to plant as shown on plan but it was not found within the site. The Contractor is required to follow the approved plan and complete all planting including the planting of *Bauhinia glauca* before the next audit checking.

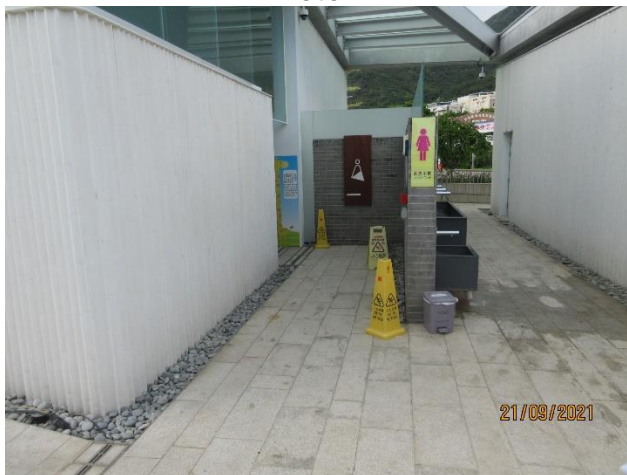
Photo K.

No plant in the planter outside the female (Planter P3b) changing room

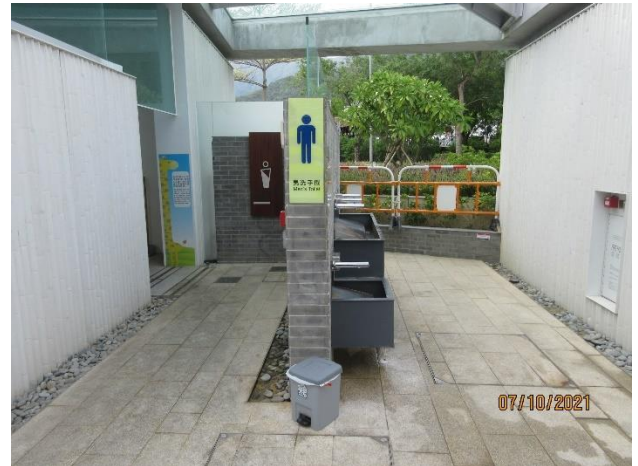
Photo J.

No plant in the planter outside the male (Planter P14) changing room

1. Two nos. of new trees (*Michelia x alba*) are found dead, contractor is required to replace the concerned trees. (Photo I)
2. There is no planting with bare soil in the planters outside the male (Planter P14) and female (Planter P3b) changing rooms. (Photo J and Photo K).
3. The contractor is required to plant *Schefflera arboricola* instead of *Rhapis excelsa* as shown on the plan for the planter (Planter P7) close to the male changing room. (Photo L)
4. *Bauhinia glauca* is required to plant as shown on plan but it was not found within the site. The Contractor is required to follow the approved plan and complete all planting including the planting of *Bauhinia glauca* before the next audit checking.

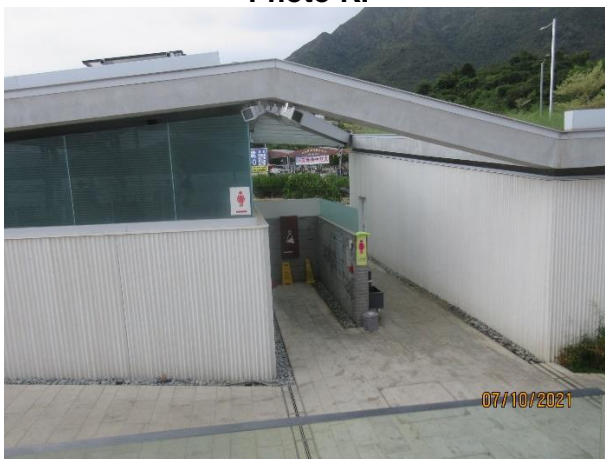
Photo K.

No plant in the planter outside the female (Planter P3b) changing room

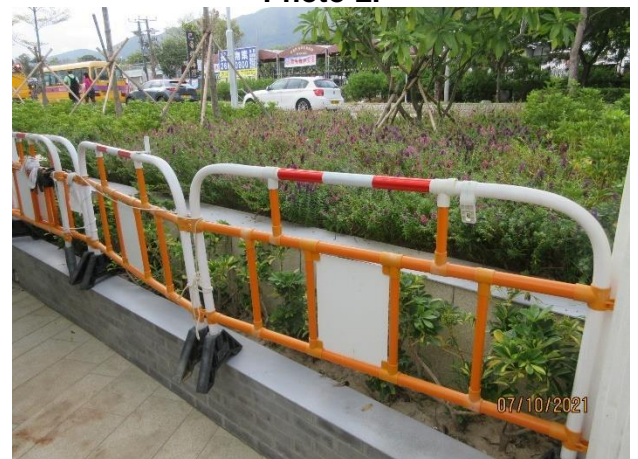
Photo L.

1.8	Are the planting including species, size and plants quality completed following the landscape plan?		✓		<ul style="list-style-type: none"> ● The plant near the male changing room (Planter P7) is <i>Schefflera arboricola</i> instead of <i>Rhapis excelsa</i> in the plan ● No <i>Bauhinia glauca</i> could be found
2	Protection of trees

The plant near the male changing room (Planter P7) is *Schefflera arboricola* instead of *Rhapis excelsa* shown in the plan

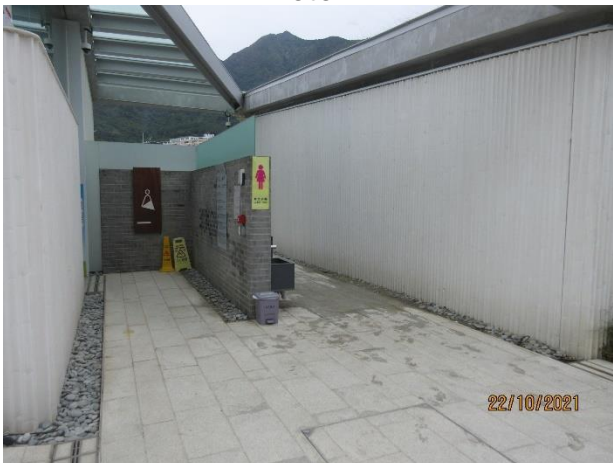
Photo K.

No plant in the planter outside the female (Planter P3b) changing room

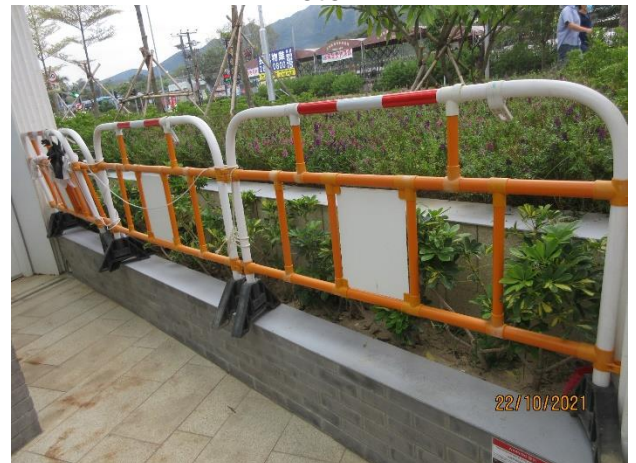
Photo L.

The plant near the male changing room (Planter P7) is *Schefflera arboricola* instead of *Rhapis excelsa* shown in the plan
