PROJECT No.: TCS/00874/16

**CEDD CONTRACT NO. CV/2012/05 –
BATHING BEACH AT LUNG MEI, TAI PO**

**POST-CONSTRUCTION MONITORING AND AUDIT
REPORT (NOVEMBER TO DECEMBER 2021)**

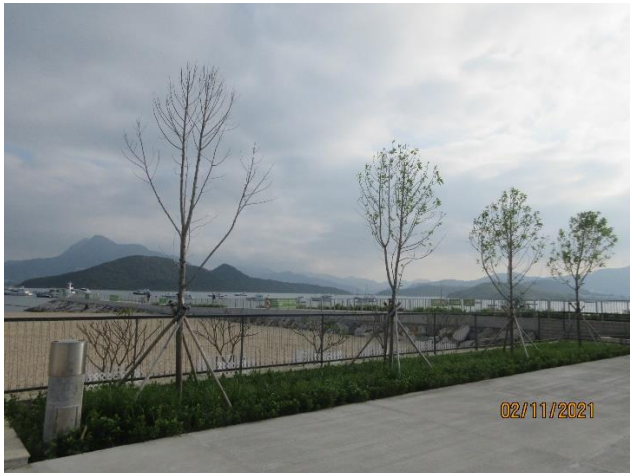
Photo I.

1. Two nos. of new trees (*Michelia x alba*) are found dead, contractor is required to replace the concerned trees. (Photo I)
2. There is no planting with bare soil in the planters outside the male (Planter P14) and female (Planter P3b) changing rooms. (Photo J and Photo K).

Dead *Michelia x alba*

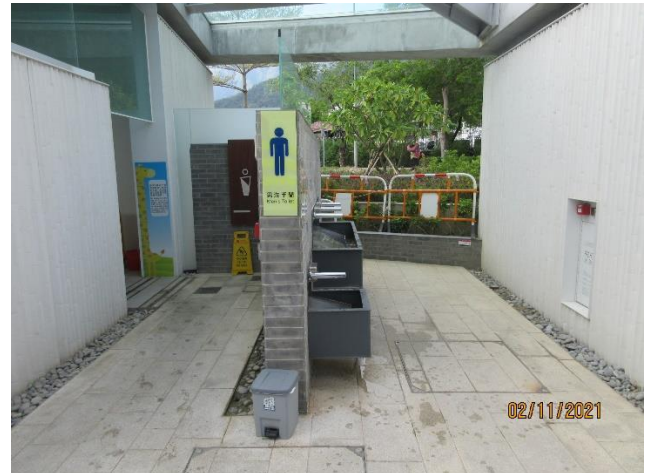
Photo J.

No plant in the planter outside the male (Planter P14) changing room

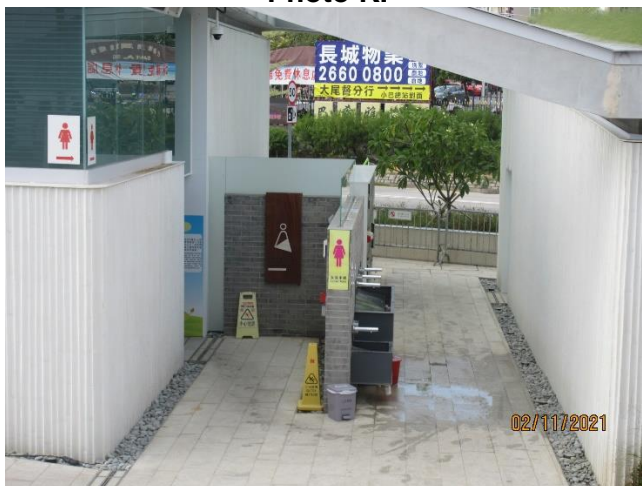
Photo K.

No plant in the planter outside the female (Planter P3b) changing room

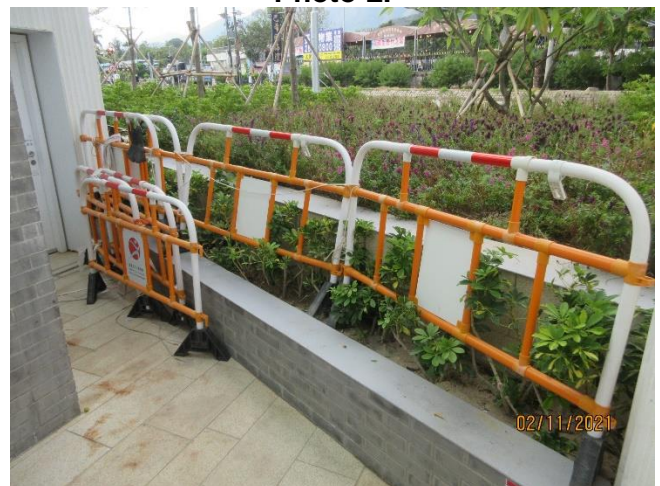
Photo L.

The plant near the male changing room (Planter P7) is *Schefflera arboricola* instead of *Rhapis excelsa* shown in the plan

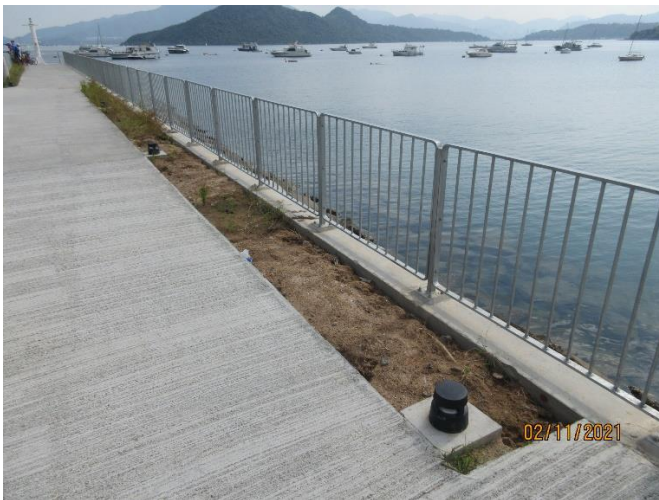
Photo M.

Some of the plants in the planters on the Western groyne were wilted and removed

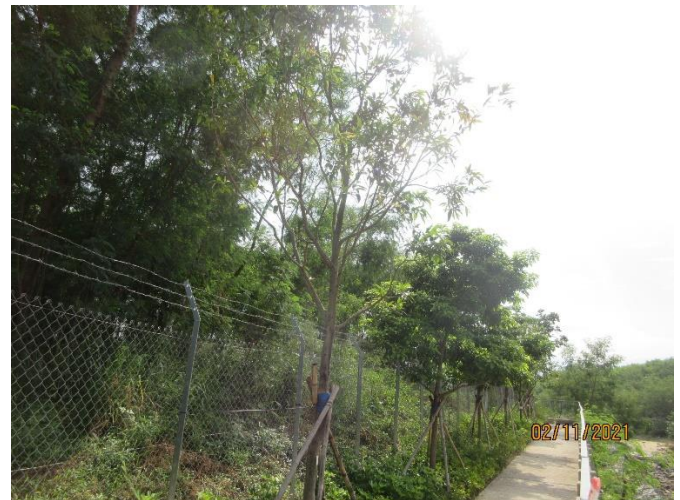
Photo N.

2.4	Are the trees planted in right place according to the landscape plan?	✓			
2.5	The tree supporting system are in good condition?	✓			Some ties and stakes already girdled and affected the growth of the trees

Some ties and stakes already girdled and affected the growth of the trees

1. Contractors are reminded to check the guying and staking of the tree to prevent the damage of the tree by rubbing and girdling from ties and stakes.
2. Contractors are reminded to update the planting plan in the drawings

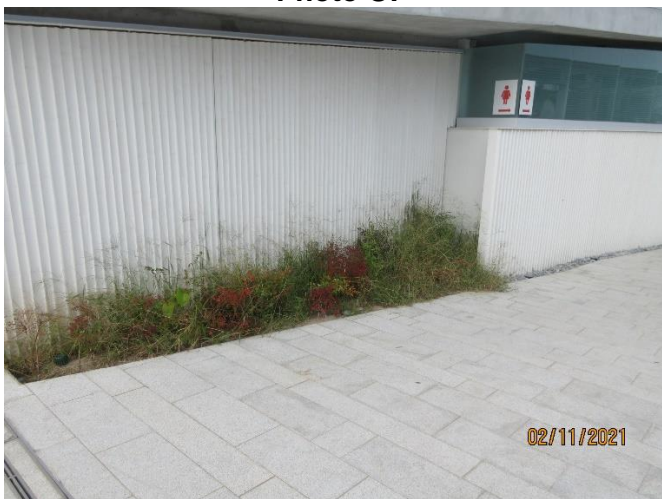
Photo O.

There are certain amounts of weeds in the planters "p3a" and "p4a"

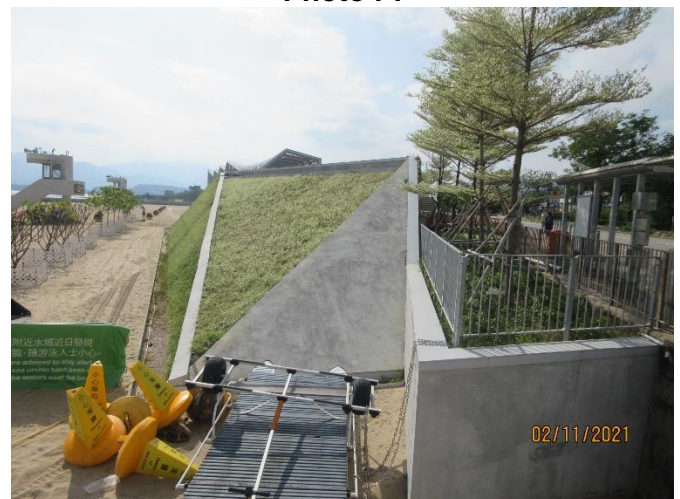
Photo P.

The weeds were removed in the planters "p6a" and "p6b"

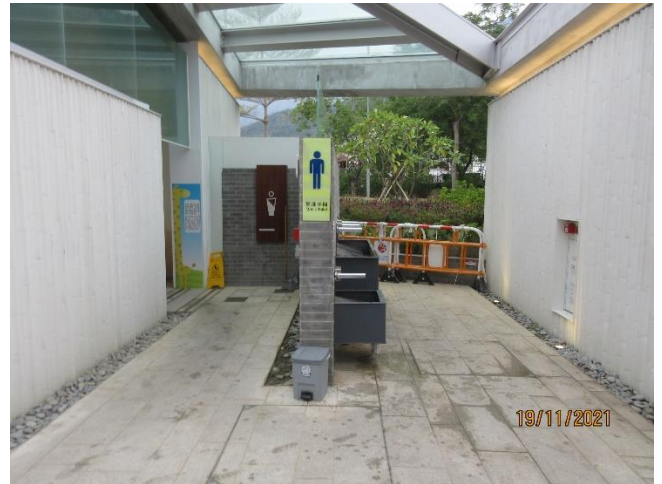
Photo J.

No plant in the planter outside the male (Planter P14) changing room

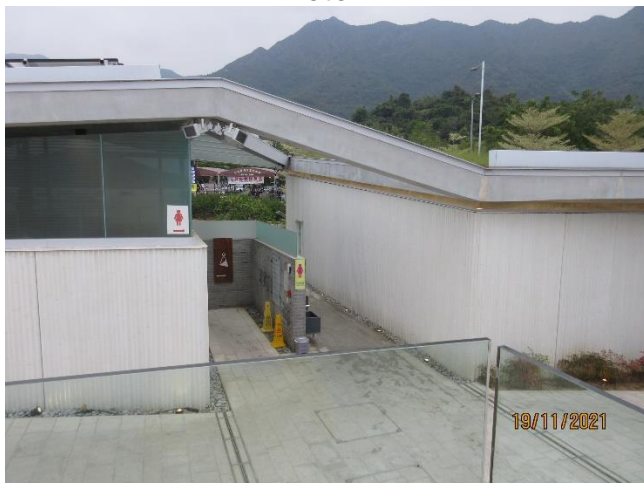
Photo K.

No plant in the planter outside the female (Planter P3b) changing room

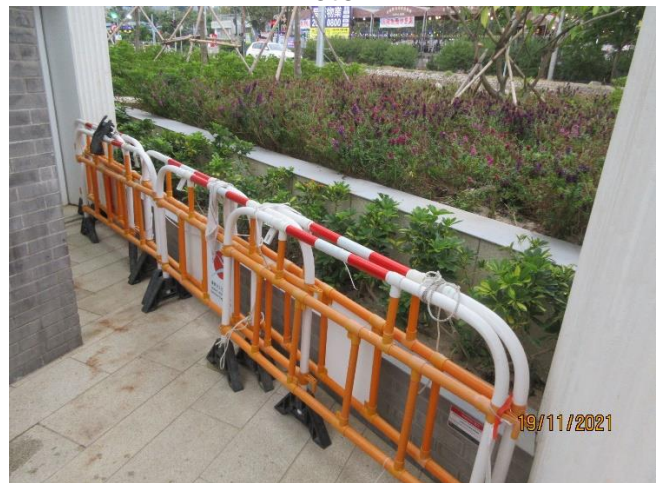
Photo L.

The plant near the male changing room (Planter P7) is *Schefflera arboricola* instead of *Rhapis excelsa* shown in the plan

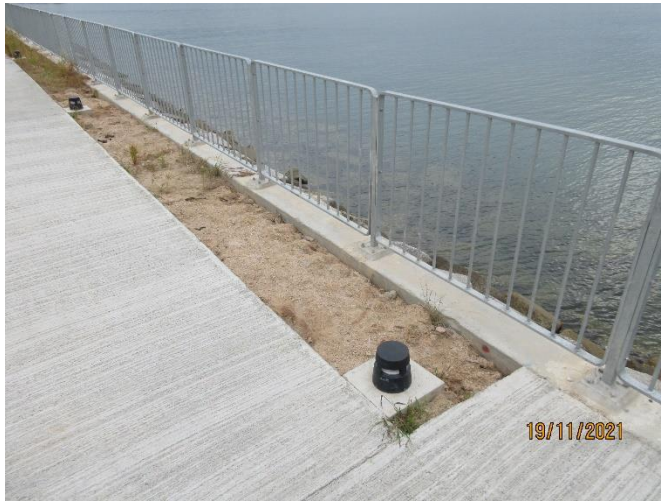
Photo M.

Some of the plants in the planters on the Western groyne were wilted and removed

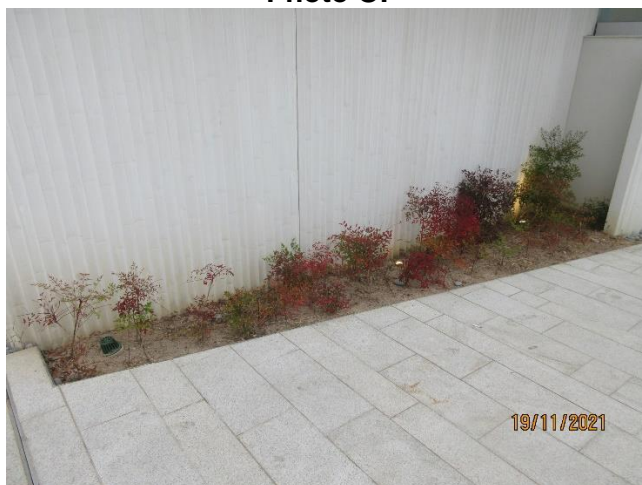
Photo O.

The weeds in the planters "p3a" and "p4a" were removed

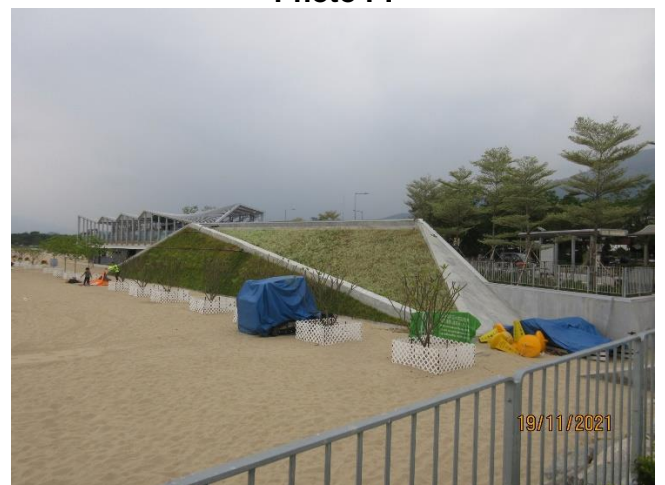
Photo P.

No weeds observed in the planters "p6a" and "p6b"

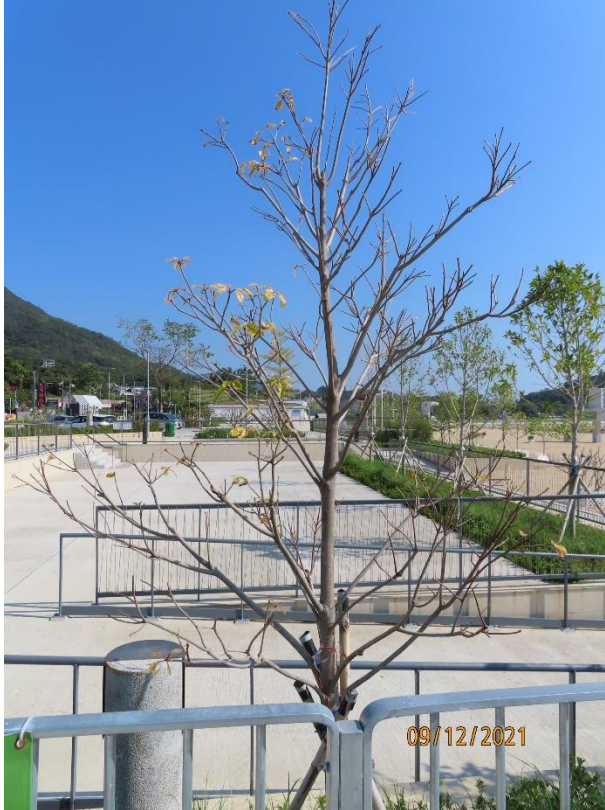
Photo I.

Dead *Michelia x alba*

2.1	The physical protection (fencing) is in place?	✓			
2.2	Any poor health condition or dead tree observed?	✓			Two <i>Michelia x alba</i> are dead
2.3	Any poor practice of pruning observed?		✓

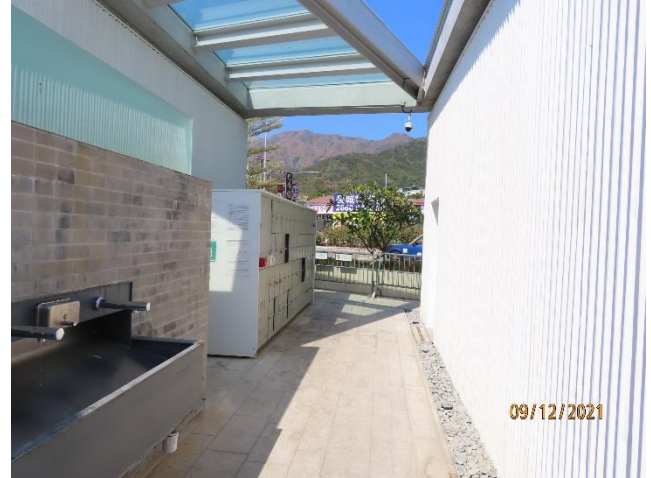
Photo J.

No plant in the planter outside the male (Planter P14) changing room

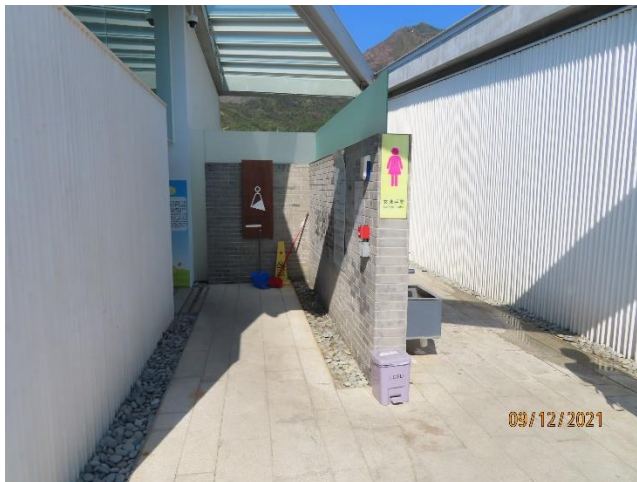
Photo K.

No plant in the planter outside the female (Planter P3b) changing room

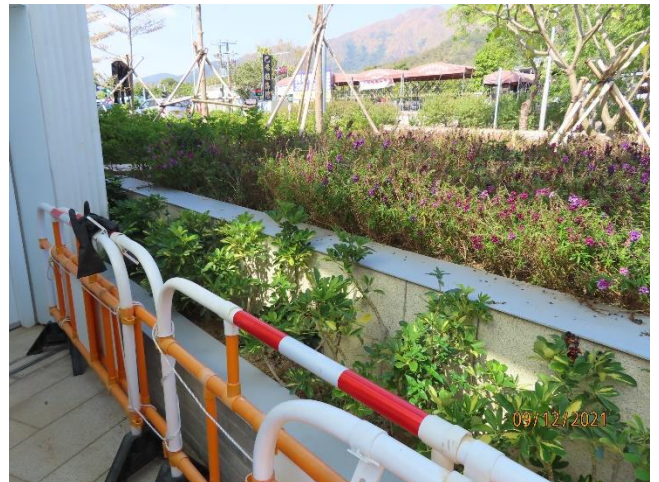
Photo L.

The plant near the male changing room (Planter P7) is *Schefflera arboricola* instead of *Rhapis excelsa* shown in the plan

1.8	Are the plantings including species, size and plants quality completed following the landscape plan?		✓		<ul style="list-style-type: none"> ● The plant near the male changing room (Planter P7) is <i>Schefflera arboricola</i> instead of <i>Rhapis excelsa</i> in the plan) ● No <i>Bauhinia glauca</i> could be found
2	Protection of trees

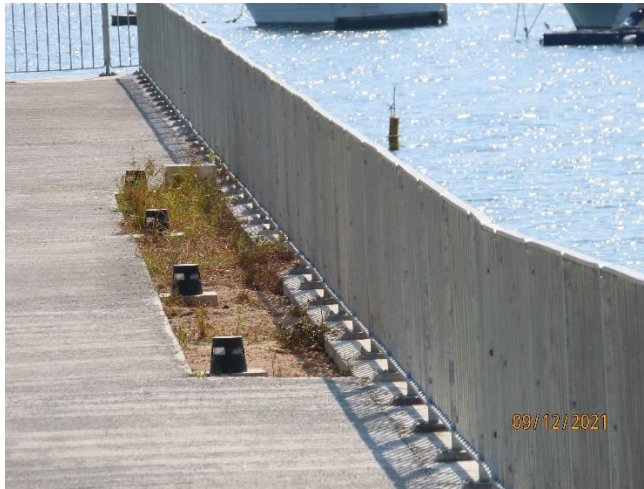
Photo M.

Some of the plants in the planters on the Western groyne were wilted and removed

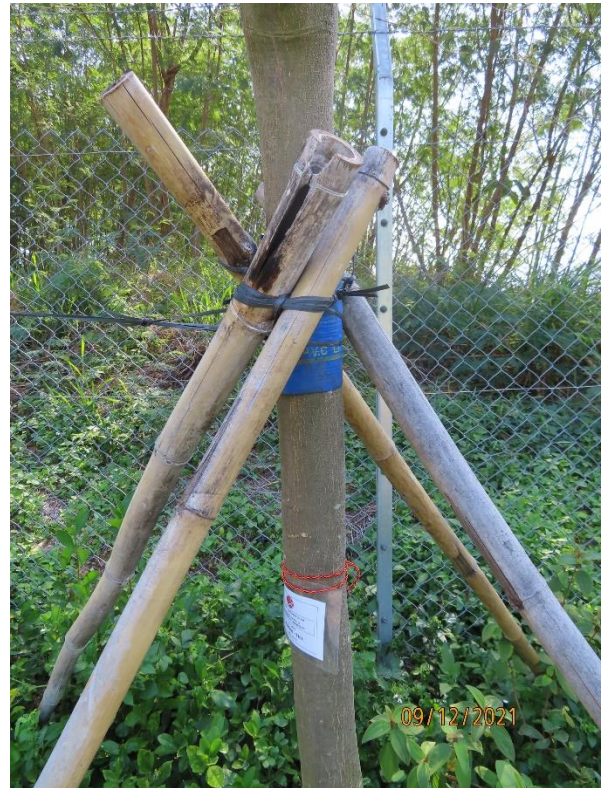
Photo N.

Some ties and stakes have been adjusted

2.4	Are the trees planted in right place according to the landscape plan?	✓			
2.5	The tree supporting system are in good condition?		✓		Some ties and stakes were detached at Western Box Culvert

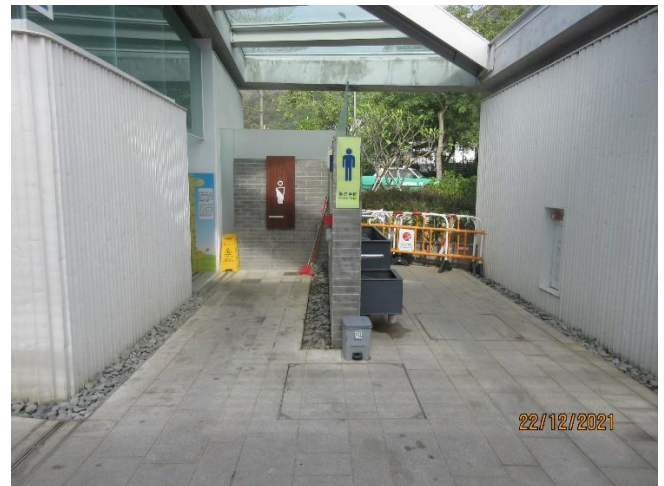
Photo J.

No plant in the planter outside the male (Planter P14) changing room

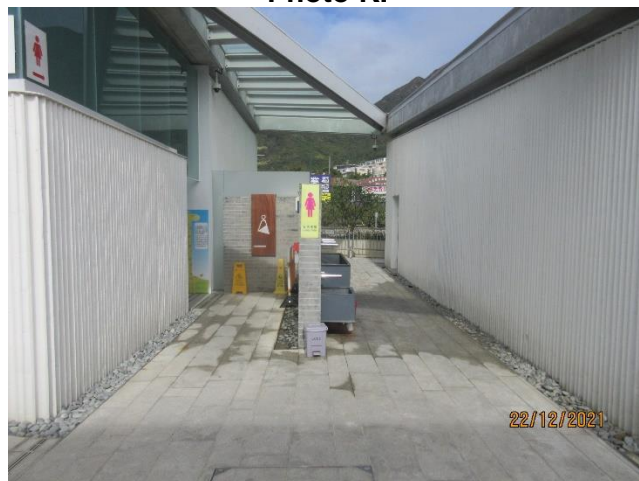
Photo K.

No plant in the planter outside the female (Planter P3b) changing room

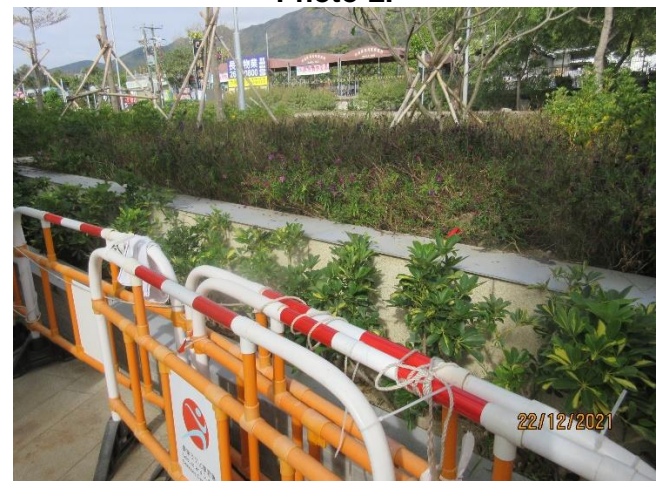
Photo L.

The plant near the male changing room (Planter P7) is *Schefflera arboricola* instead of *Rhapis excelsa* shown in the plan

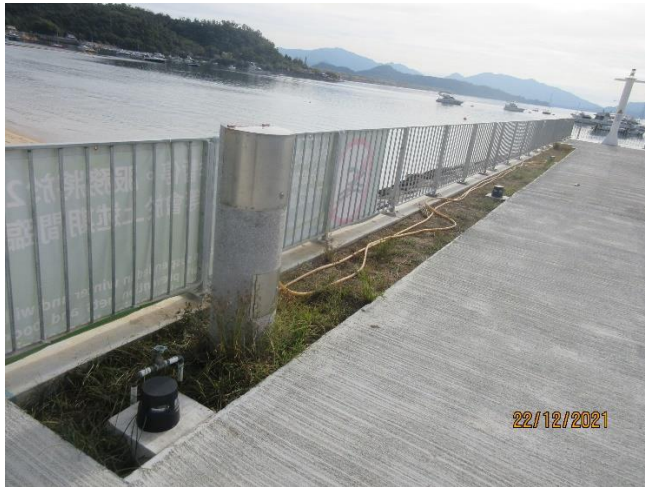
Photo M.

Some of the plants in the planters on the Western groyne were wilted and removed

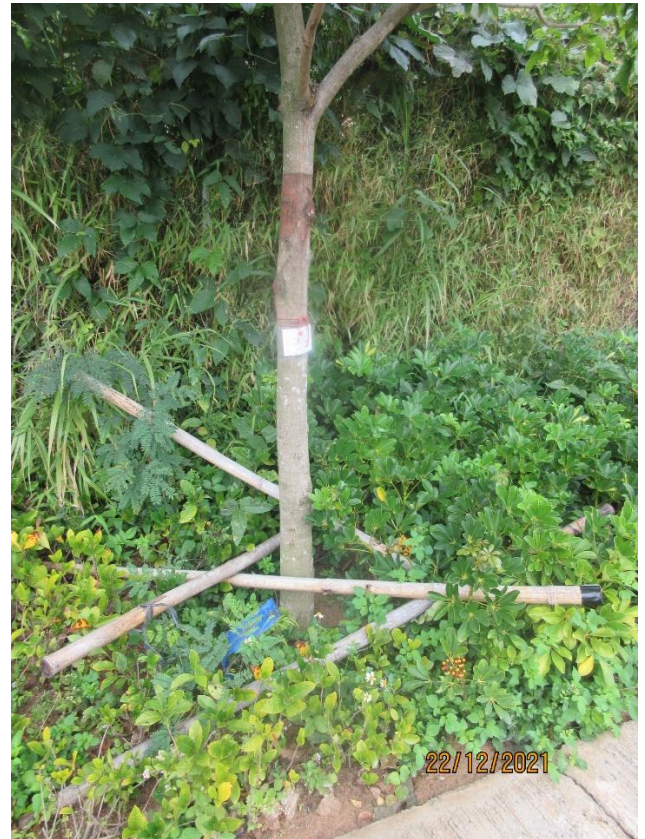
Photo N.

Some ties and stakes were detached at Western Box Culvert

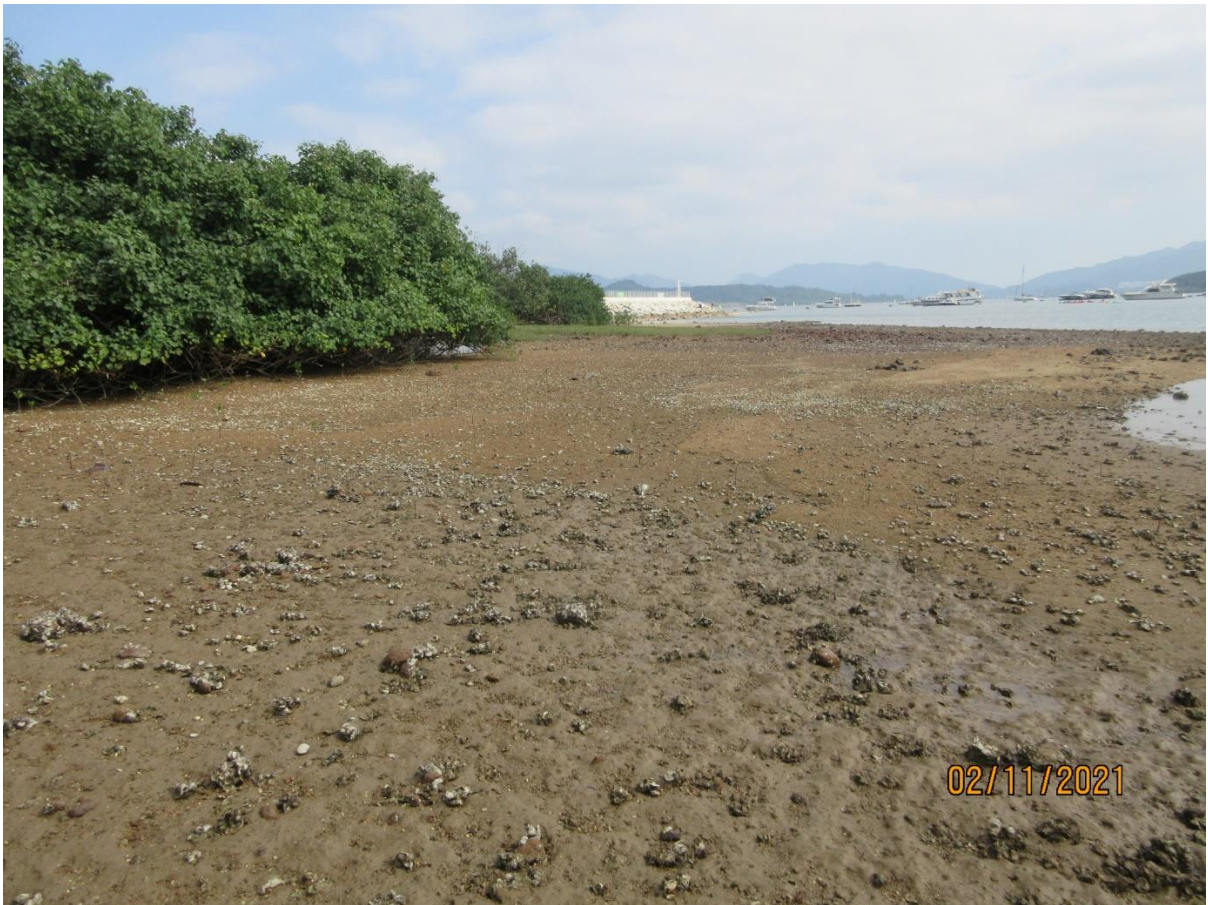
For location 1, Nearly half of the seedlings were alive, however, only a few of the seedlings on the most landward side have leaves (Photo 3.1). Many of the seedlings were in poor condition (no leaves but still alive (Photo 3.2)) and approximate half of the seedlings were dead (Photo 3.3).

Photo 3.1 A few of the seedlings on the most landward side have leaves

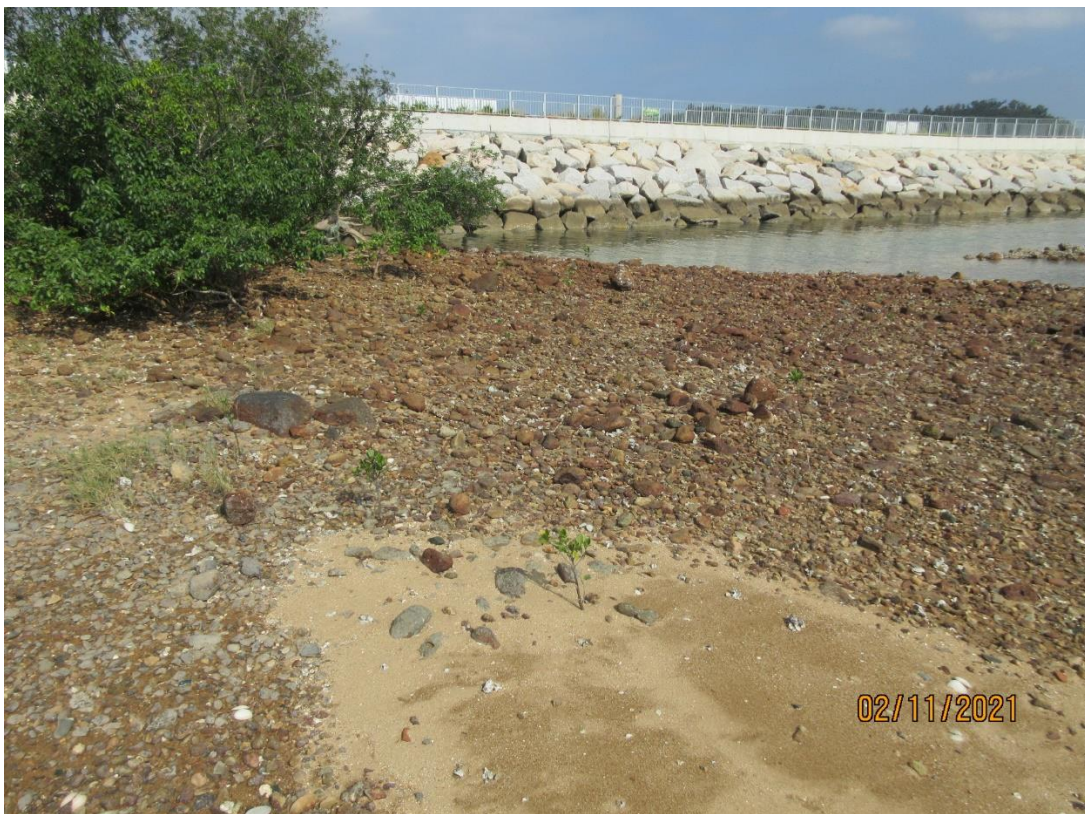
For location 2, A large amount of the seedlings were dead (Photo 3.4), some of them with very short dead stem remain, few of the seedlings on the most landward side have leaves (Photo 3.5) and several seedlings are in poor condition (no leaves but still alive)

Photo 3.5 Few of the seedlings on the most landward side have leaves

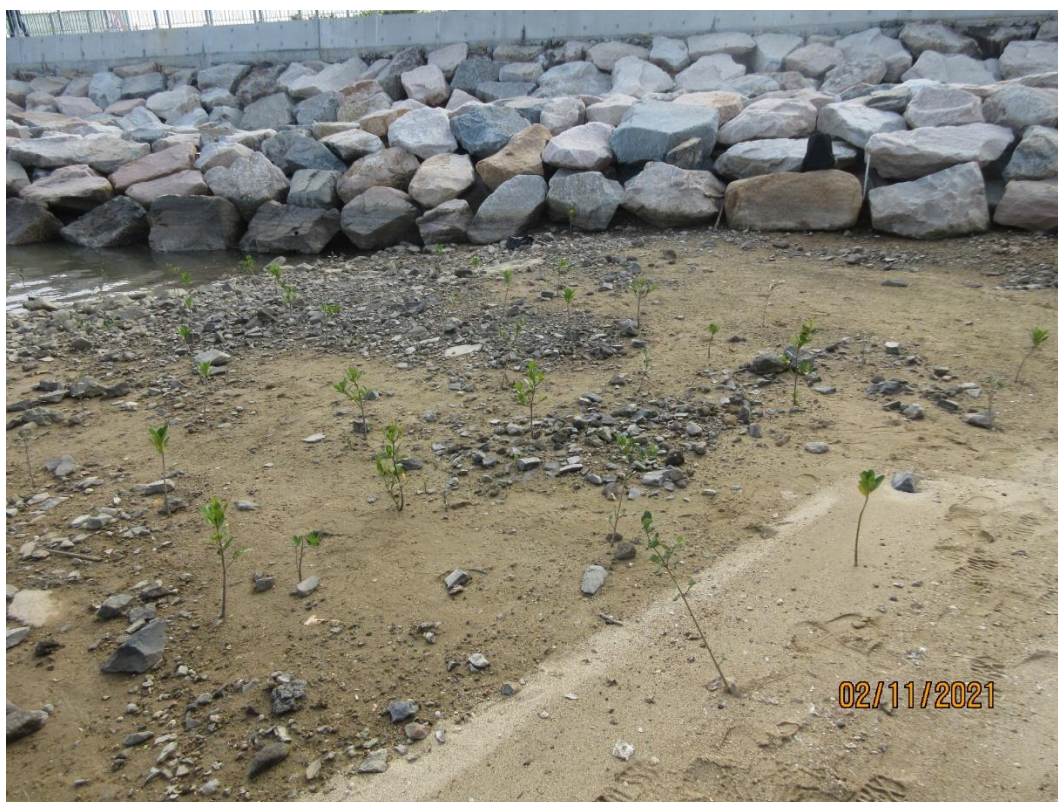
For location 3, most of the seedlings have normal foliage density and are in good condition (Photo 3.6). A small portion of the seedlings at the seaward side was in poor condition (no leaves but still alive) and dead (Photo 3.7).

Photo 3.6 Seedling with good condition

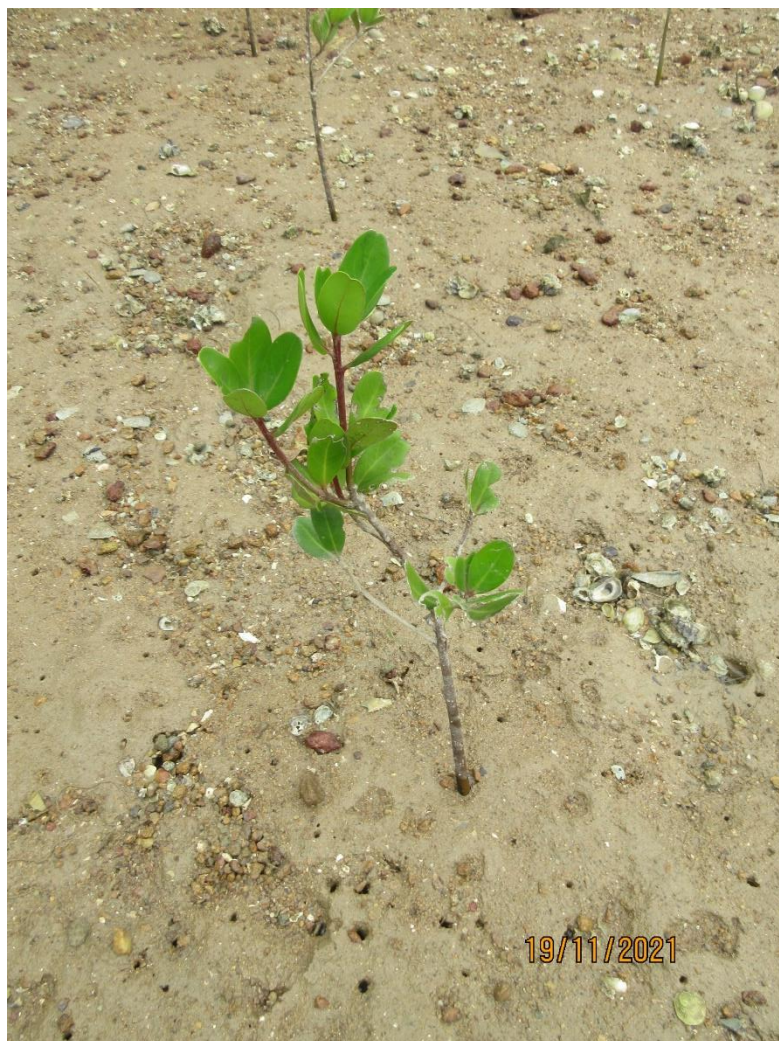
For location 1, Nearly half of the seedlings were alive, however, only a few of the seedlings on the most landward side have leaves (Photo 3.1). Many of the seedlings were in poor condition (no leaves but still alive (Photo 3.2)) and approximate half of the seedlings were dead (Photo 3.3).

Photo 3.1 The seedling on the most landward side has leaves and is in good condition

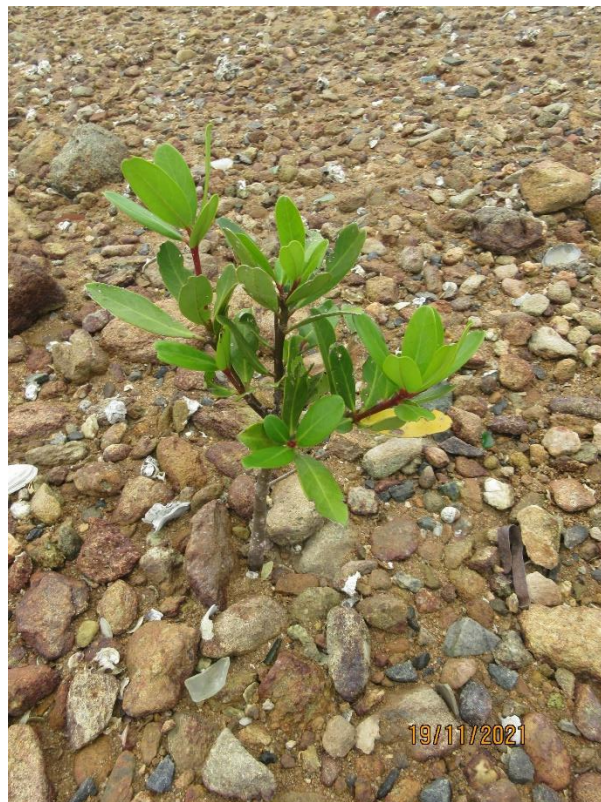
For location 2, A large amount of the seedlings were dead (Photo 3.4) and disappeared, some of them with very short dead stem remain. A certain amount of the dead seedlings were disappeared, it is suspected that the dead seedling is dried out, decayed and washed away by the tidal wave (Photo 3.5a and Photo 3.5b). Few of the seedlings on the most landward side have leaves (Photo 3.6) and several seedlings are in poor condition (no leaves but still alive)

Photo 3.6 The seedling on the most landward side has leaves and is in good condition

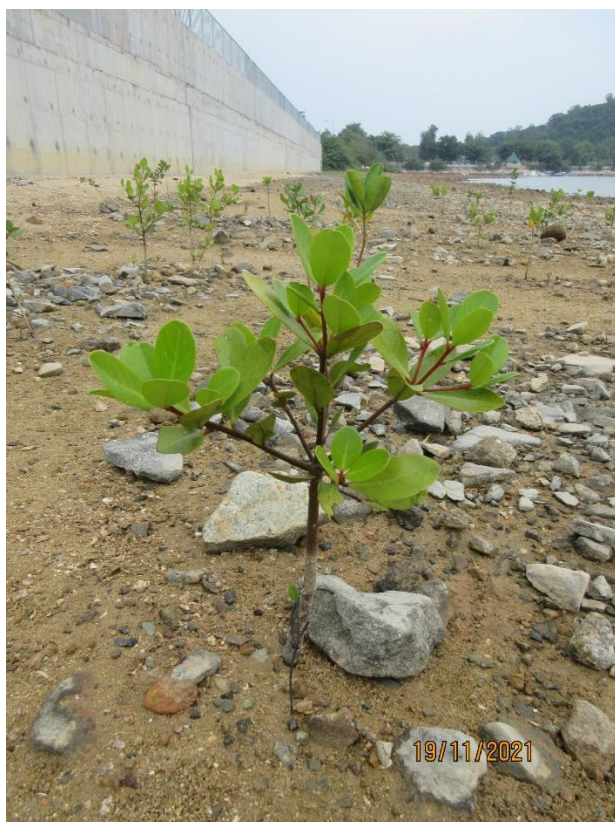
For location 3, most of the seedlings have normal foliage density and are in good condition (Photo 3.7). A small portion of the seedlings at the seaward side was in poor condition (no leaves but still alive) and dead (Photo 3.8).

Photo 3.7 Seedling with good condition

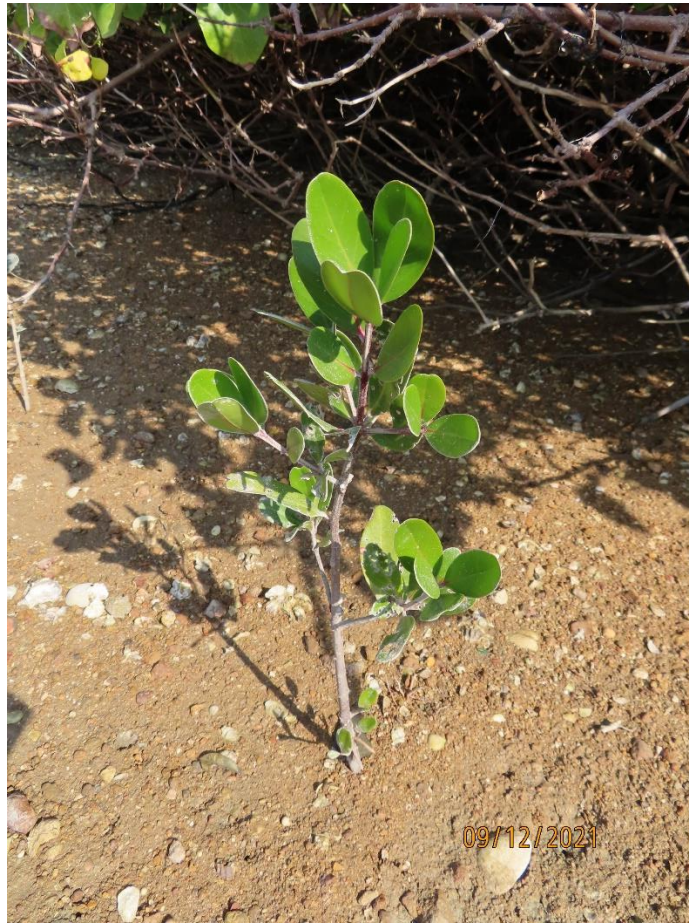
For location 1, fewer than half of the seedlings were alive, only a few of the seedlings on the most landward side have leaves (Photo 3.1). The poor health seedlings (no leaves but still alive (Photo 3.2)) are gradually declining and more than half of the seedlings were dead (Photo 3.3).

Photo 3.1 The seedling on the most landward side has leaves and is in good condition

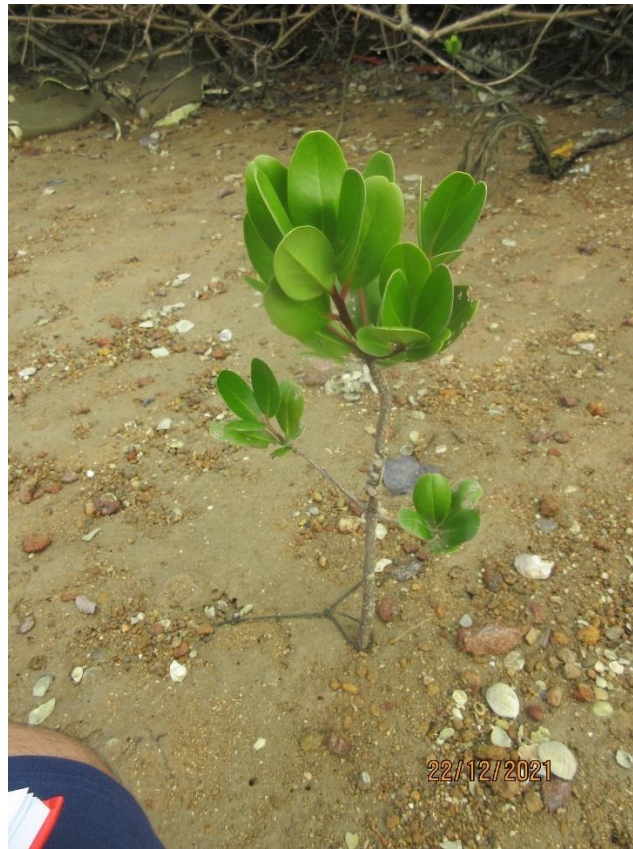
Photo 3.1 The seedling on the most landward side has leaves and is in good condition

For location 1, fewer than half of the seedlings were alive, only a few of the seedlings on the most landward side have leaves (Photo 3.1). The poor health seedlings (no leaves but still alive (Photo 3.2)) are gradually declining and more than half of the seedlings were dead (Photo 3.3).

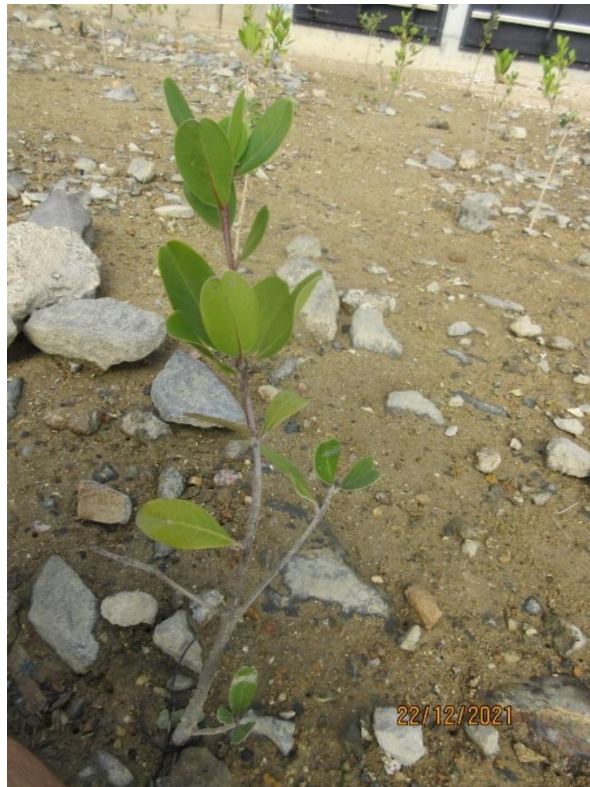
Photo 3.6 The seedling on the most landward side has leaves and is in good condition

For location 2, A large amount of the seedlings were dead (Photo 3.4) and disappeared, some of them with very short dead stem remain. A certain amount of the dead seedlings was disappeared, it is suspected that the dead seedling is dried out, decayed and washed away by the tidal wave (Photo 3.5a and Photo 3.5b). Few of the seedlings on the most landward side have leaves (Photo 3.6) and several poor health seedlings (no leaves but still alive) are also gradually declining.

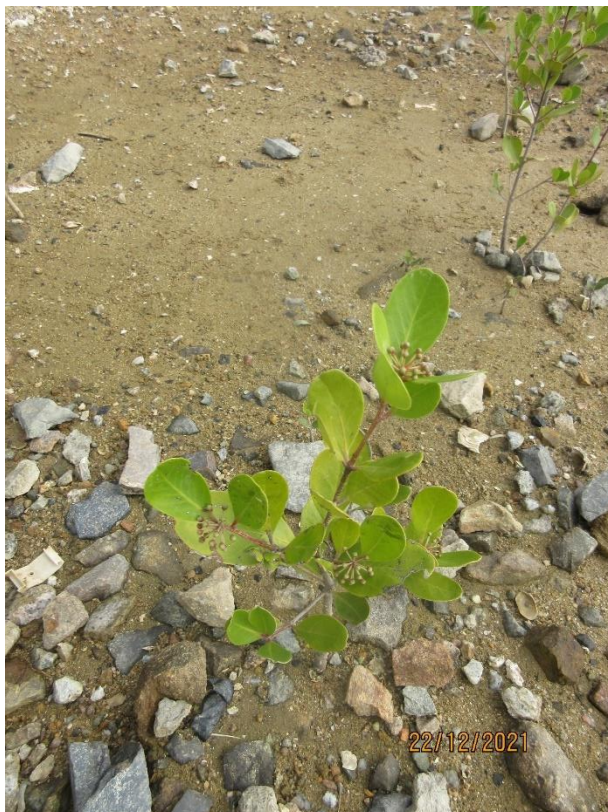
Photo 3.7 Seedling with good condition

For location 3, most of the seedlings have normal foliage density and are in good condition (Photo 3.7). A small portion of the seedlings at the seaward side was in poor condition (no leaves but still alive) and dead (Photo 3.8).
