PROJECT No.: TCS/00874/16

**CEDD CONTRACT NO. CV/2012/05 –
BATHING BEACH AT LUNG MEI, TAI PO**

**POST-CONSTRUCTION MONITORING AND AUDIT
REPORT (JANUARY TO FEBRUARY 2022)**

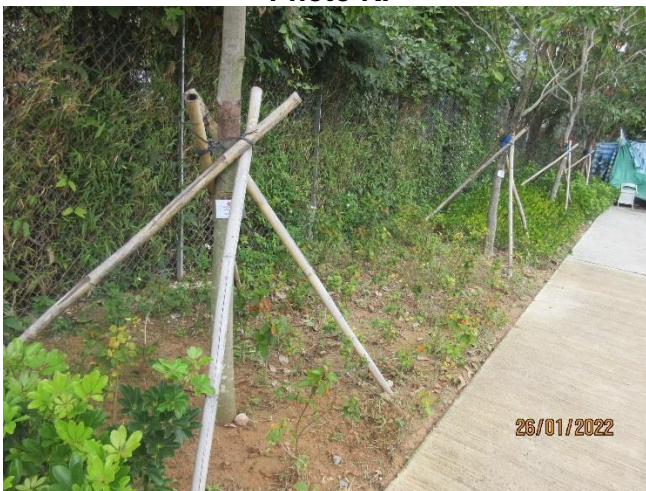
Photo K.

Some ties and stakes were detached at Western Box Culvert

1. Some of the plants in the planters on the Western groyne were wilted and should be removed and replaced. (Photo I)
2. Some ties and stakes were detached at Western Box Culvert should be tightened up to standard. (Photo J and Photo K)
3. The planters at the Eastern box culvert were repaired and enlarged and the plants in the planters were removed. Replacement planting should be provided. (Photo L)
4. Some ties and stakes already girdled and affected the growth of the trees. (Photo M and Photo N)

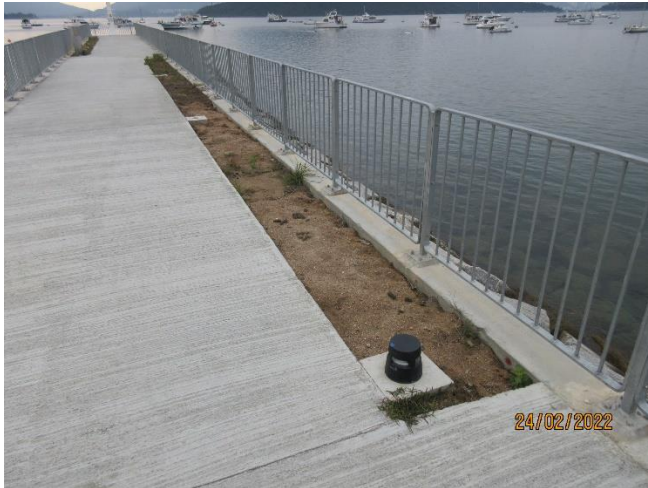
Photo I.

Some of the plants in the planters on the Western groyne were wilted and removed
